CAPITAL NEEDS ASSESSMENT

RECREATIONAL CENTER

***55 Barre Street
Montpelier, VT 05602***

Inspection Date: 16 April 2015

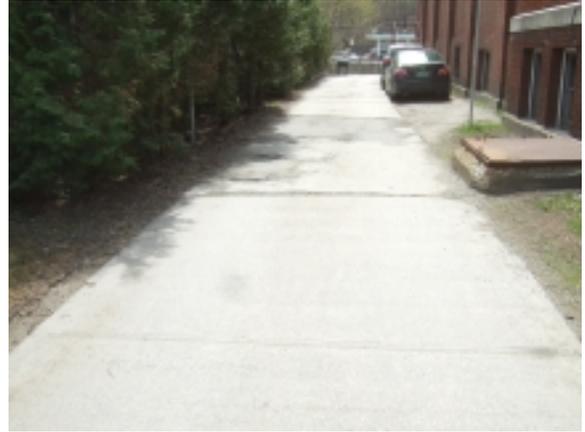
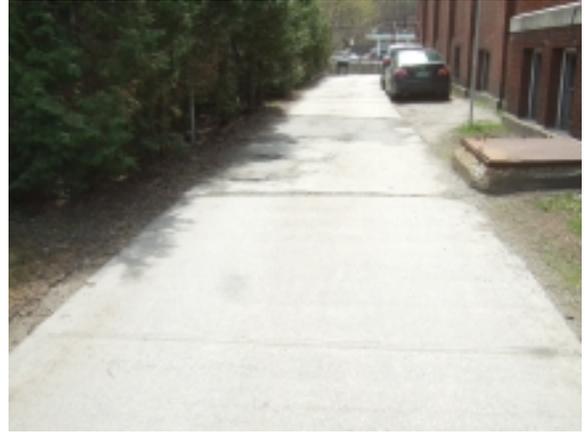
There is a concrete paved access road located on the south side of the building. The concrete is in fair but variable condition. Some isolated areas of spalling concrete patched repairs were noted. There is a short walkway from the city sidewalk to the main entrance stairs. The concrete walkway is in very good condition and replacement is not anticipated during the term of the plan.

2. View of the side driveway. The driveway has some worn areas. Gravel sections are at the back of the building.

- We have included costs in the near term to replace the concrete driveway.

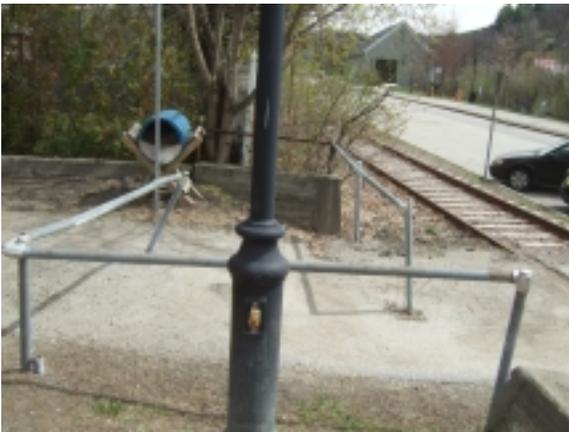
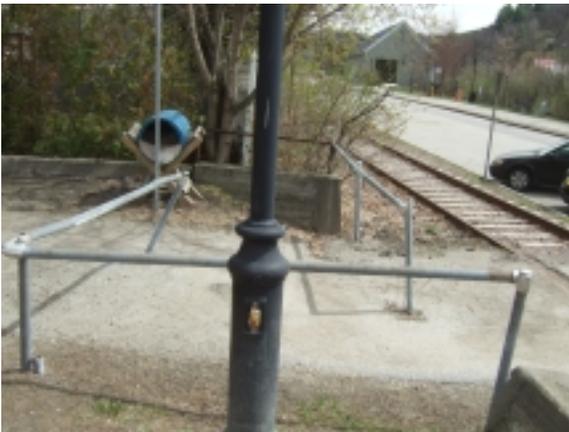
3. View of the metal railings at the back of the building. The railings are leaning and damaged.

- We have included costs to replace the metal poles in the near term.
- Costs for the retaining wall are shown later in the plan.

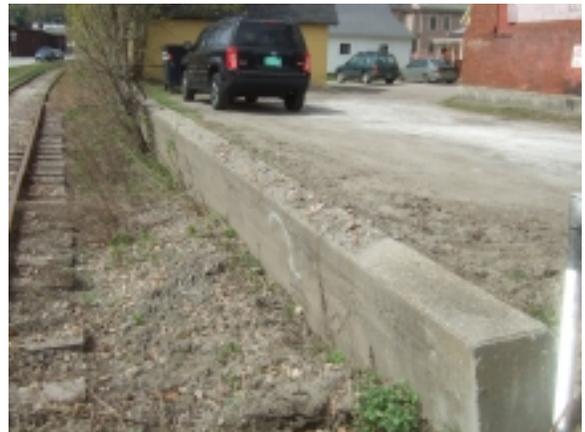
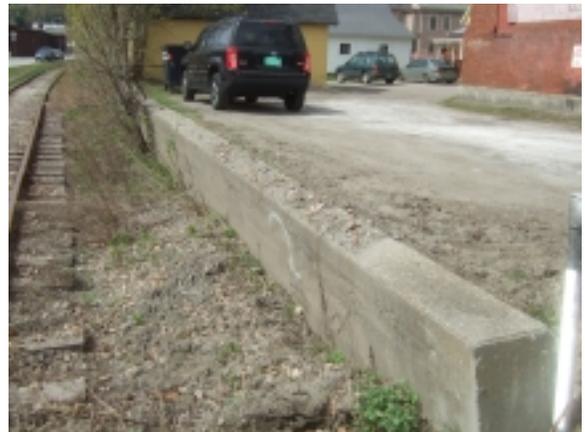
4. View of the low retaining wall at the back of the site. The wall is leaning.

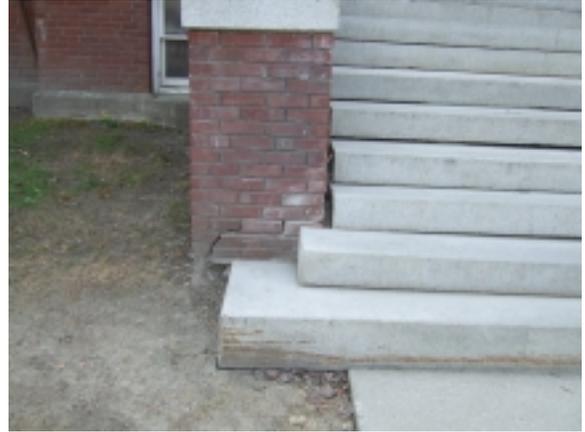
8. View of the front stairways. Both flanking walls exhibit movement. The upper treads are not level.

- An allowance to insert tie rods to stop movement of the stair flanking walls and to reset the upper granite treads.
- Costs to replace the side metal stairway is shown in the near term. The costs reflect installing a compliant ramp to provide a second means of egress.

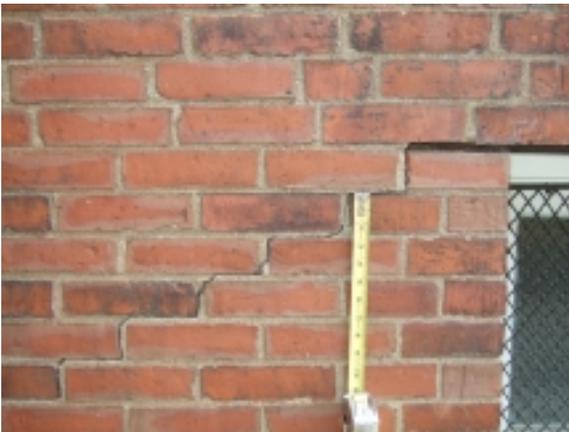
9. View of step cracking on north side of development.

- We have included costs twice in the plan for exterior repairs. The first cycle is to repoint the crack and to replace the cap stone. The second cycle is for miscellaneous repairs.

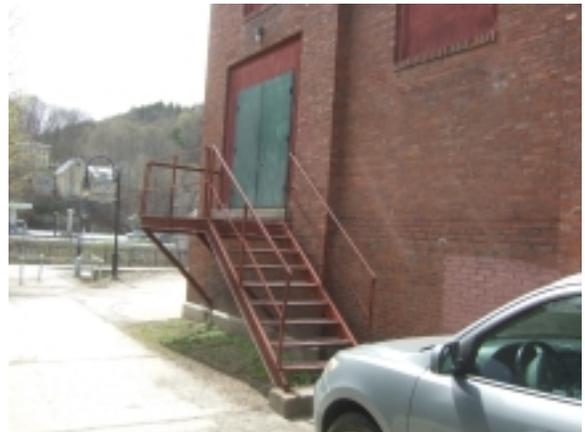
10. Side access stairs and doors to Gymnasium. It appears there is sufficient room to install an access ramp for secondary means of egress.

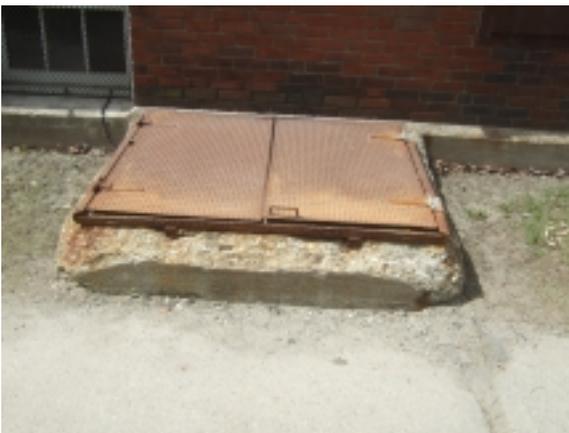
11. View of the side bulkhead door. The doors are in fair condition, but the base has significantly deteriorated.

- We have included costs to reset the concrete pad and to re-use the heavy duty storm doors.
- We have included costs in the near term to replace the secondary egress doors concurrent with the installation of a ramp. The doors should conform to all UFAS requirements.

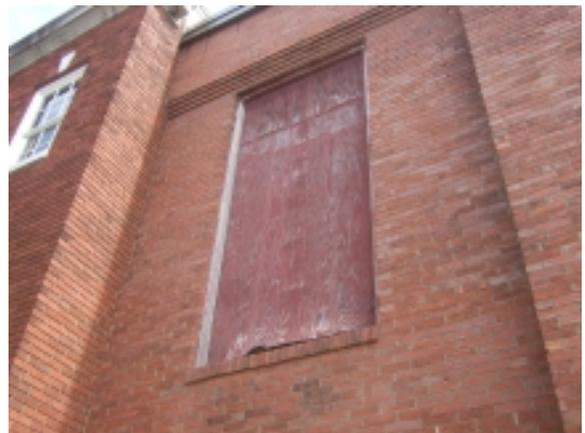
12. View of a large window to the Gymnasium area. Management reported the need to install windows to provide natural lighting.

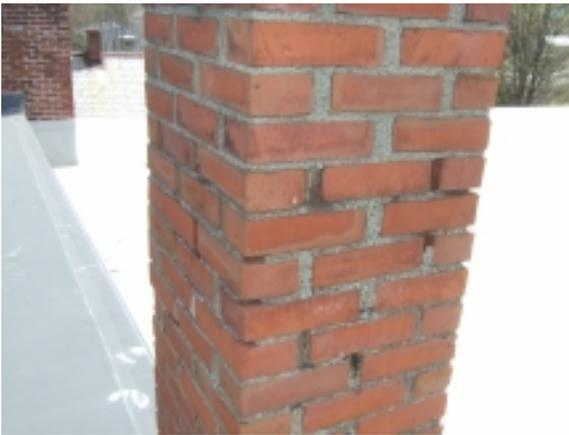
17. View of one of the brick chimneys. Note the mortar loss.

- We have included costs in the second half of the plan to replace the roof coverings.
- Allowances to repoint the chimneys and caps are shown in the near term.

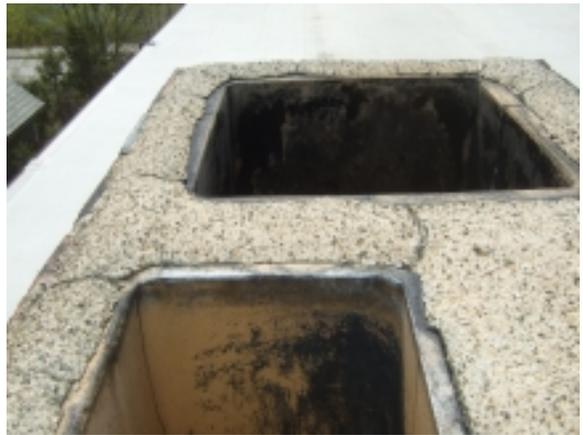
18. View of the cracked mortar at the chimney caps.

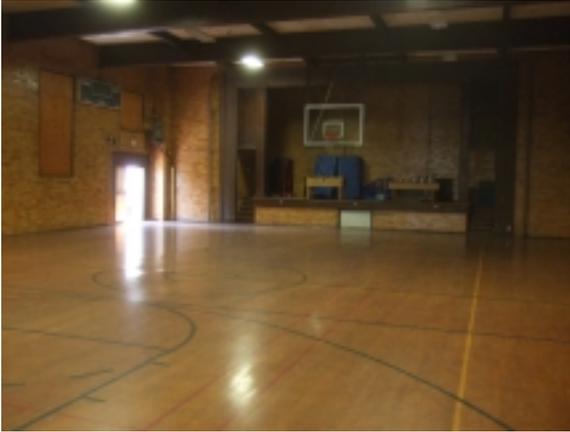
19. View of the Gymnasium finishes. The floor has the original finish.

- We have included costs in the near term to replace all of the flooring with the exception of the gymnasium floor.
- Costs to refinish the gymnasium floor have been included.

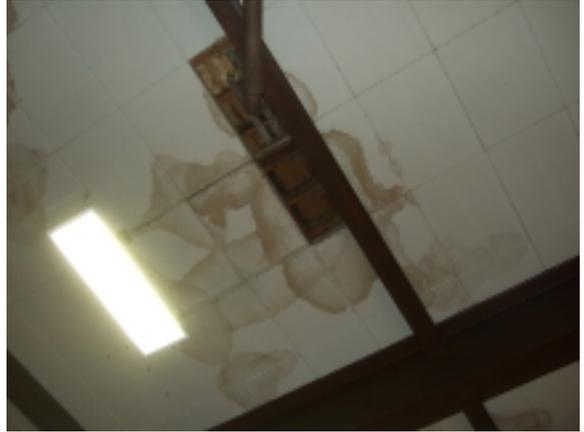
20. View of the Gymnasium ceiling. Many of the ceiling tiles are water damaged.

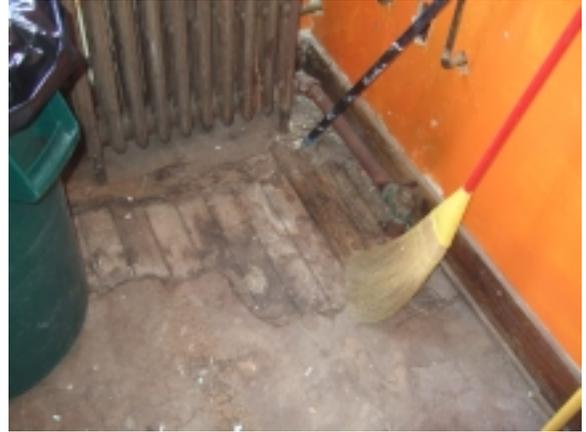
26. Some areas of the floor have worn.

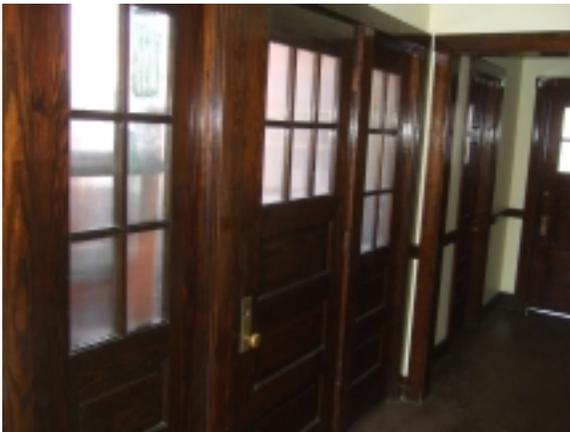
Interior common doors are solid core wood. The doors are original and have a stained finish and feature the original vintage hardware. The staining has worn somewhat at the door edges. All of the door openings have a 32-inch or more clear opening. The door hardware is typically the turn style door knob type.

27. View of the original doors on the second floor.

- The doors should be re-stained as needed. Costs are included with the walls to perform this.
- Management should install lever hardware to meet UFAS requirements.

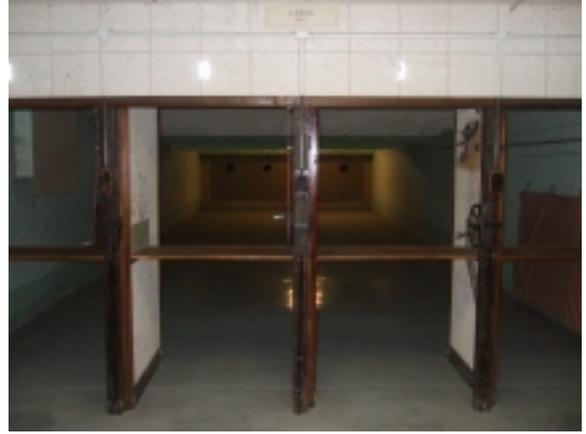
32. View of the shooting gallery. This space is not on an accessible route.

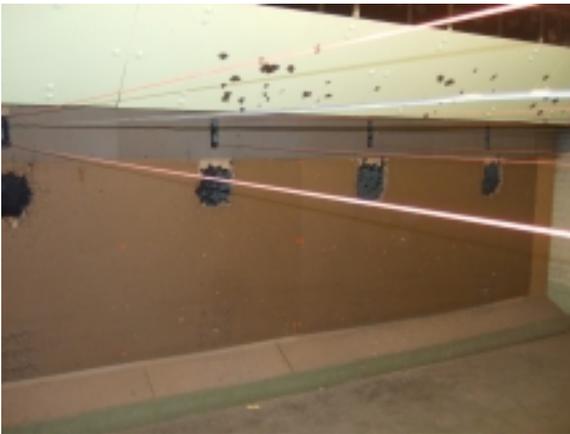
33. View of the shooting range back board.

- Replace the gallery backboard (GWB) as needed through the operating budget.

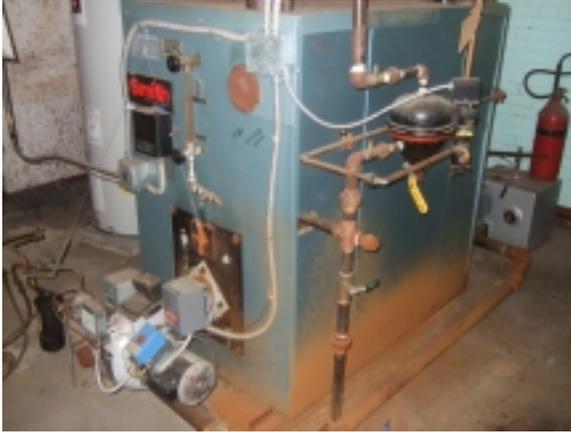
There is a central mechanical room that houses all of the heating and hot water generating equipment. Heating steam is generated by an oil-fired SMITH cast-iron boiler (model# 19A-S/W-08 serial# FA2003-736). The boiler has a SAFGARD low water cut off switch and a CARLIN (6-13 gph) burner. The boiler and peripheral equipment were installed in 2003. The original HB SMITH cast iron water tube boiler is abandoned in place.

37. View of the main boiler in the basement.

- We have included costs approximately halfway through the plan to replace the boiler. These costs also include removing the abandoned equipment.

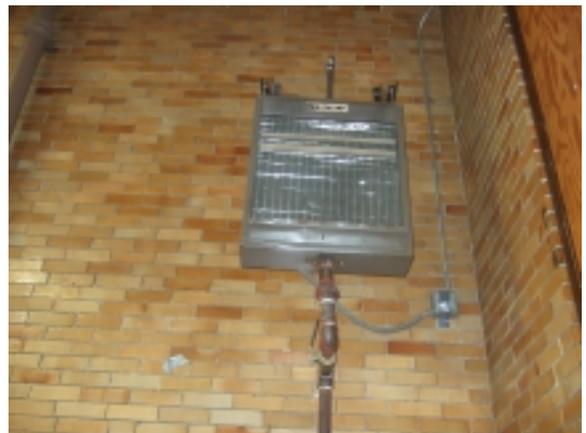
42. View of the heating fan coil units. Two are to be replaced.

- We have included costs in the near term to replace two steam fan coil units.
- The original ceiling hung devices should be removed during the boiler replacement.
