**VERMONT STATE HOSPITAL
WATERBURY, VT**

**EXTERNAL/INTERNAL INSPECTION
TWO RADIAL BRICK CHIMNEYS**

Subject: Internal/External Inspection Report
Two Radial Brick Chimneys
Contract ID 9886

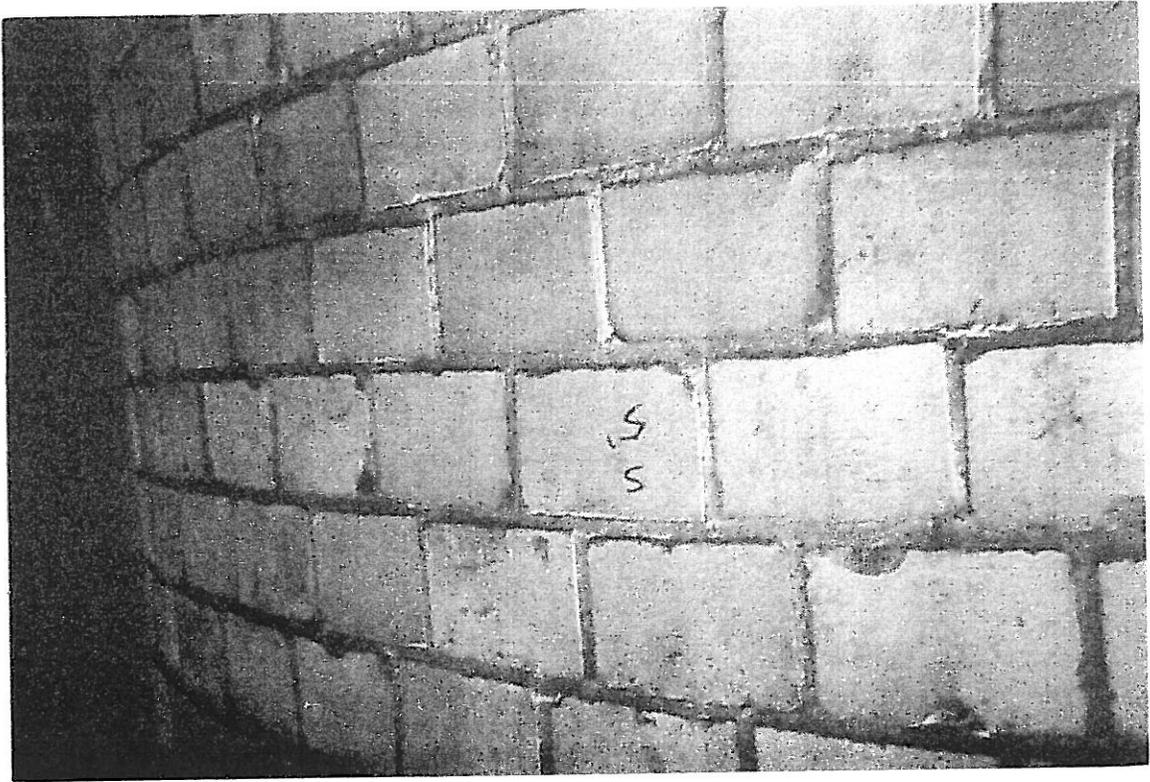
1. Exterior surface - south side - elevation 5' above grade level - good condition.

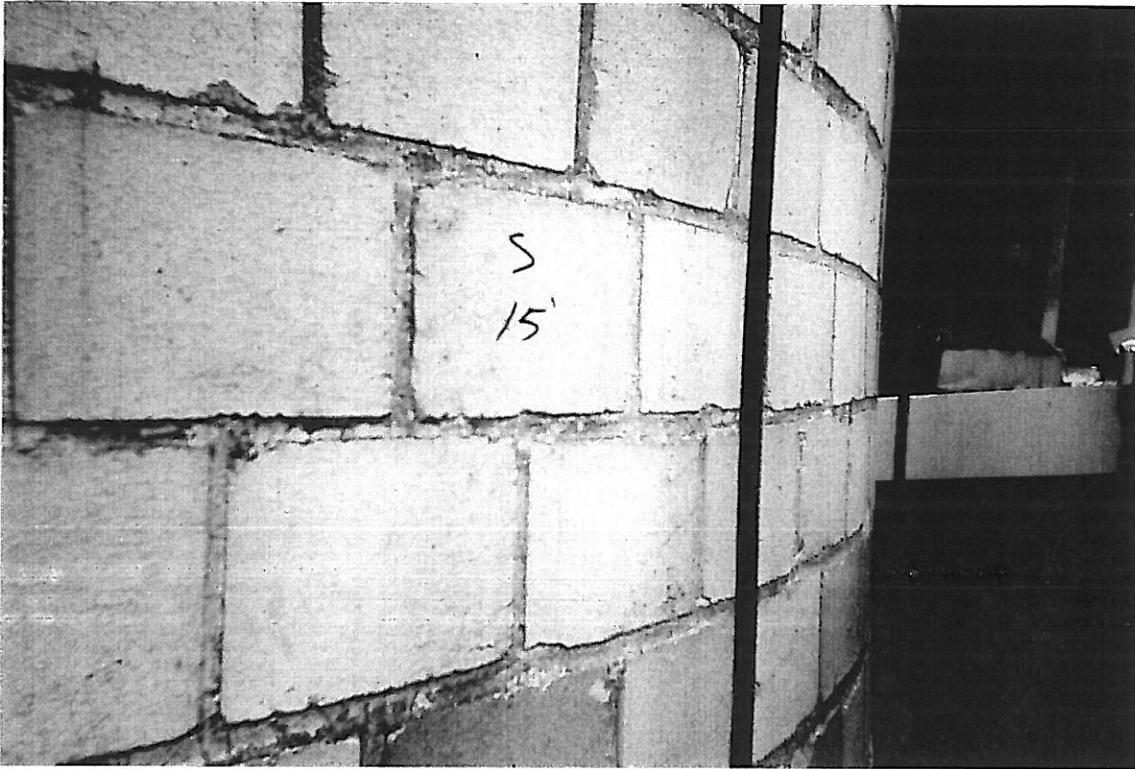
The top encircling cable anchor is loose, as can be seen in Photograph No. 17. The remainder of the lightning protection system is interconnected and properly functioning, as can be seen in Photograph Nos. 2 through 20.

2. Exterior surface and downlead - south side - elevation 15' above ground level - good condition.

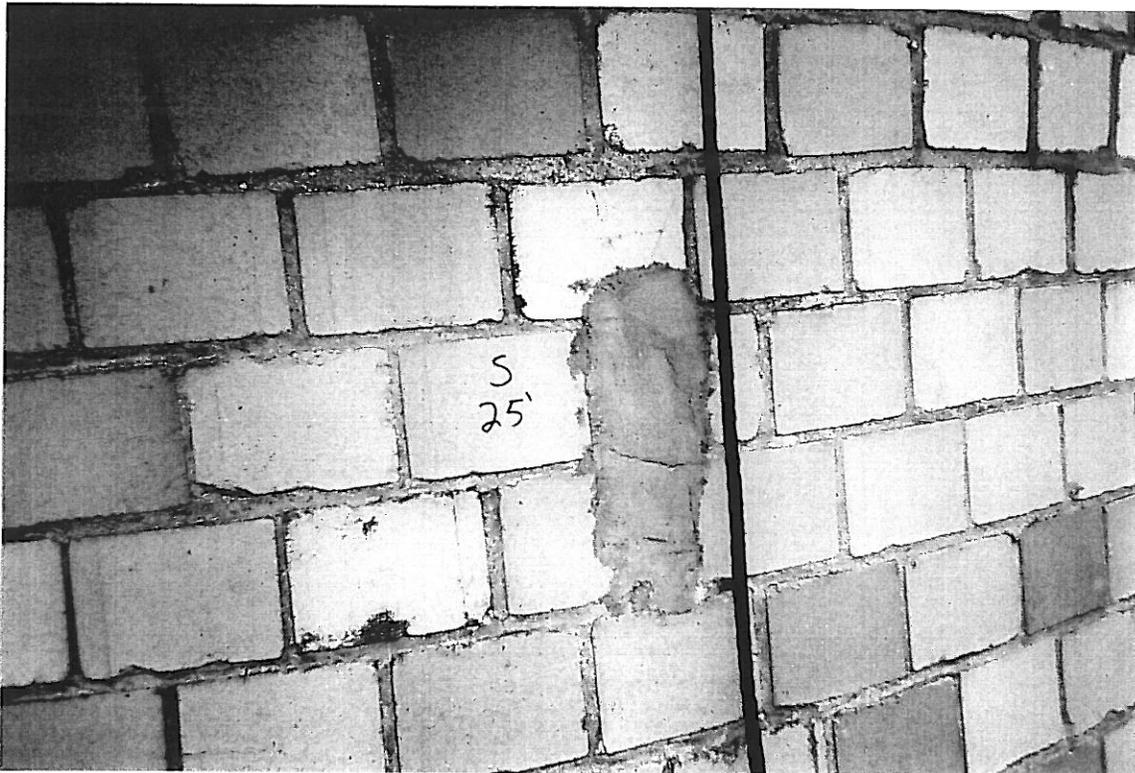
3. Exterior surface and downlead - south side - elevation 25' above ground level - good condition.

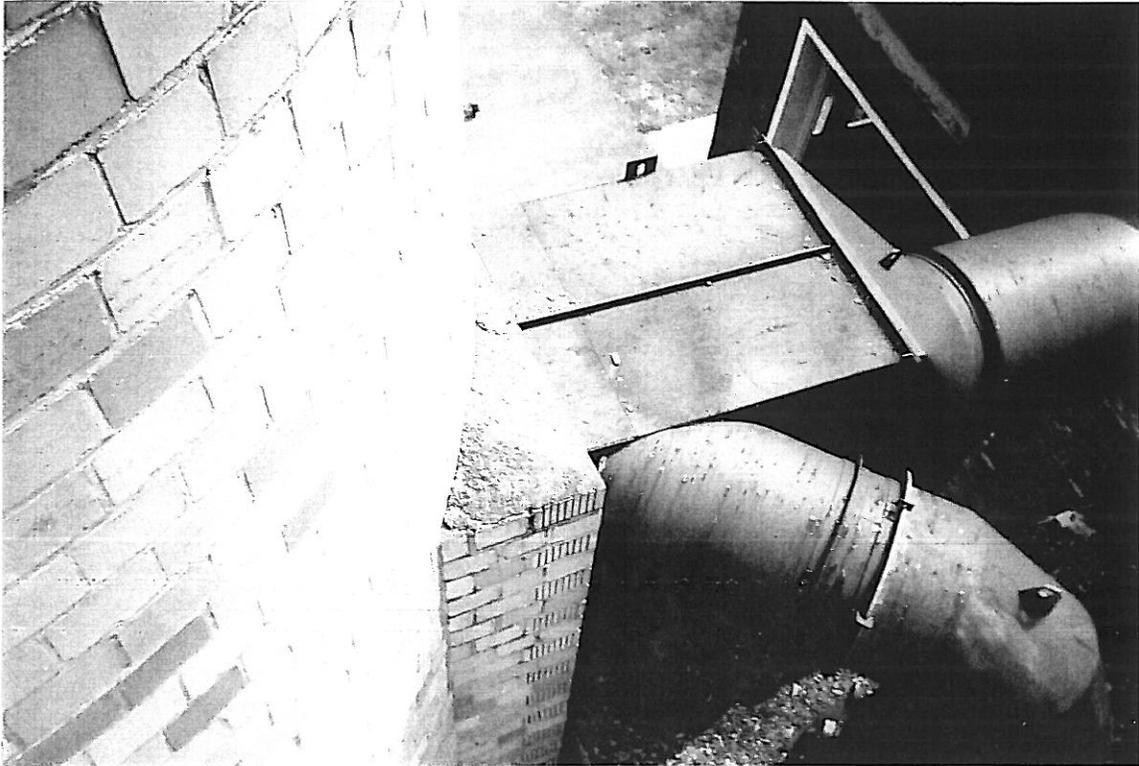
4. Exterior surface and breaching entry - south side - elevation 30' above ground level - shell good condition - breaching rusty.

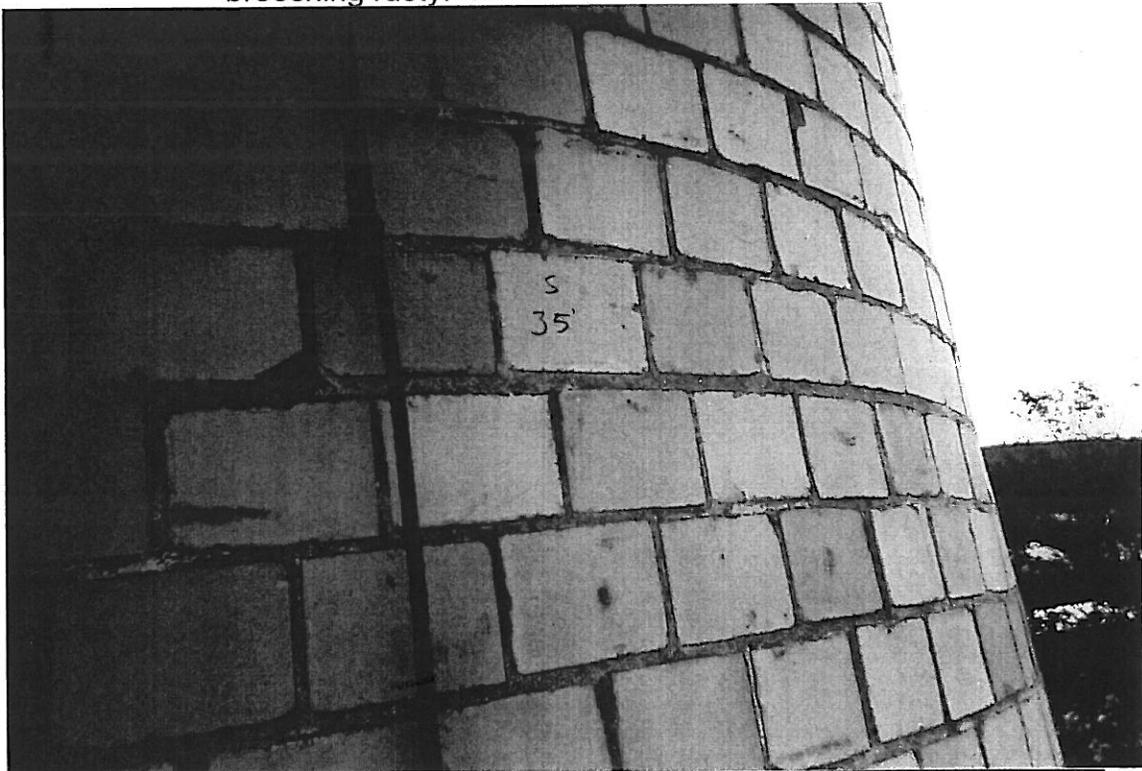
5. Exterior surface and downlead - south side - elevation 35' above ground level - good condition.

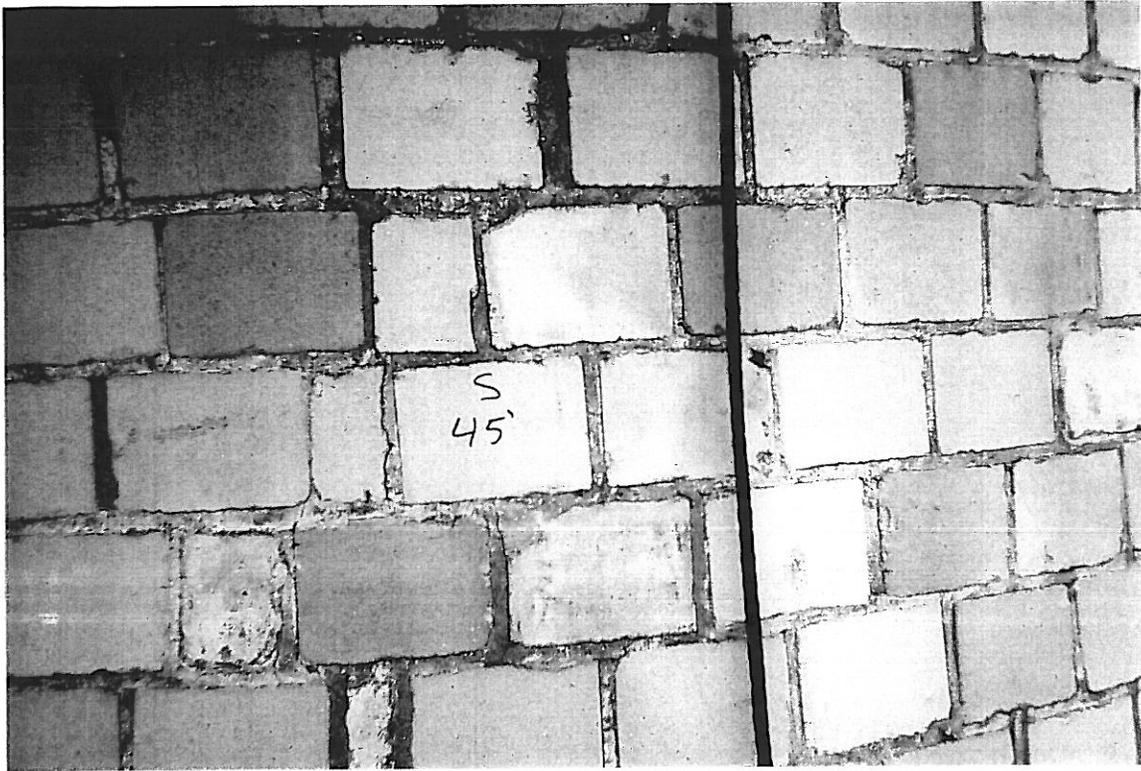
6. Exterior surface and downlead - south side - elevation 45' above ground level - good condition.

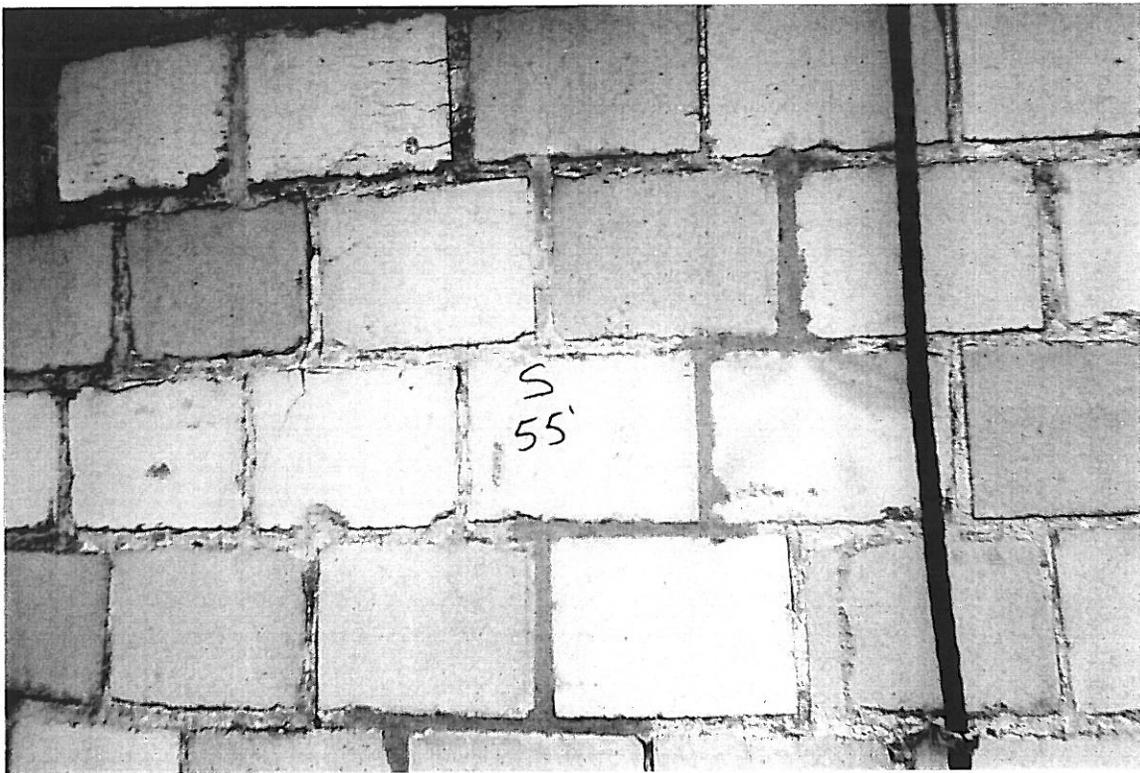
7. Exterior surface and downlead - south side - elevation 55' above ground level - good condition.

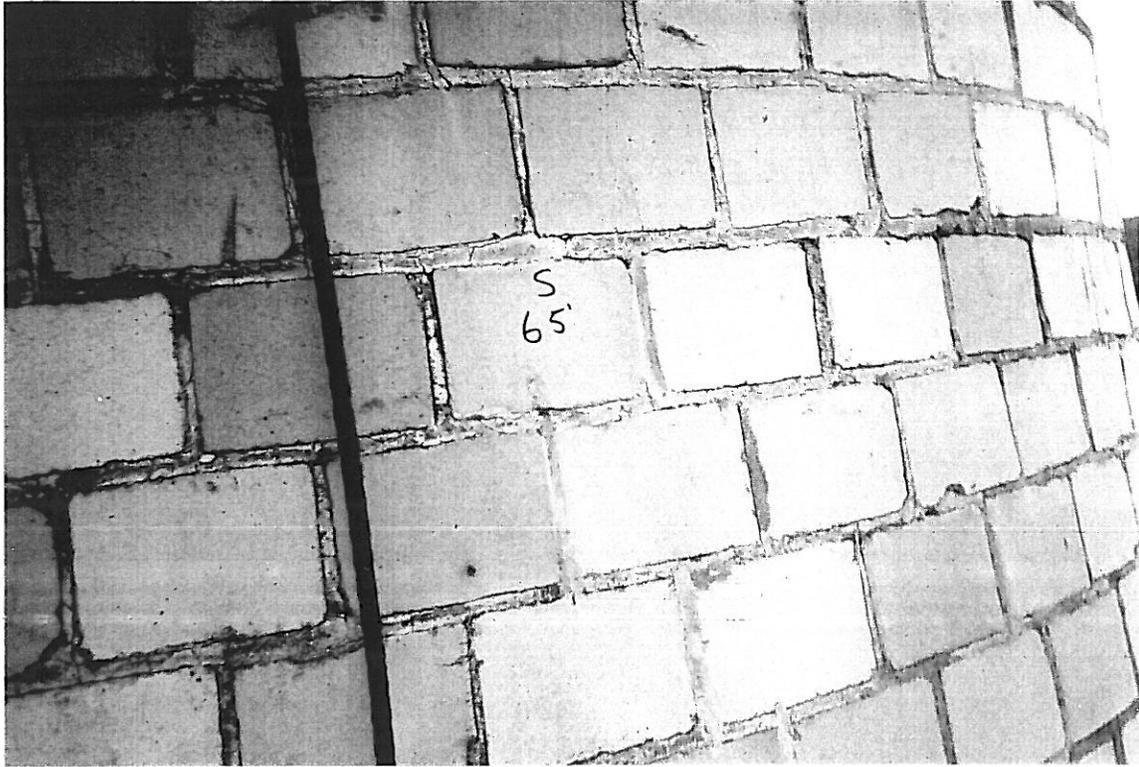
8. Exterior surface and downlead - south side - elevation 65' above ground level - good condition.

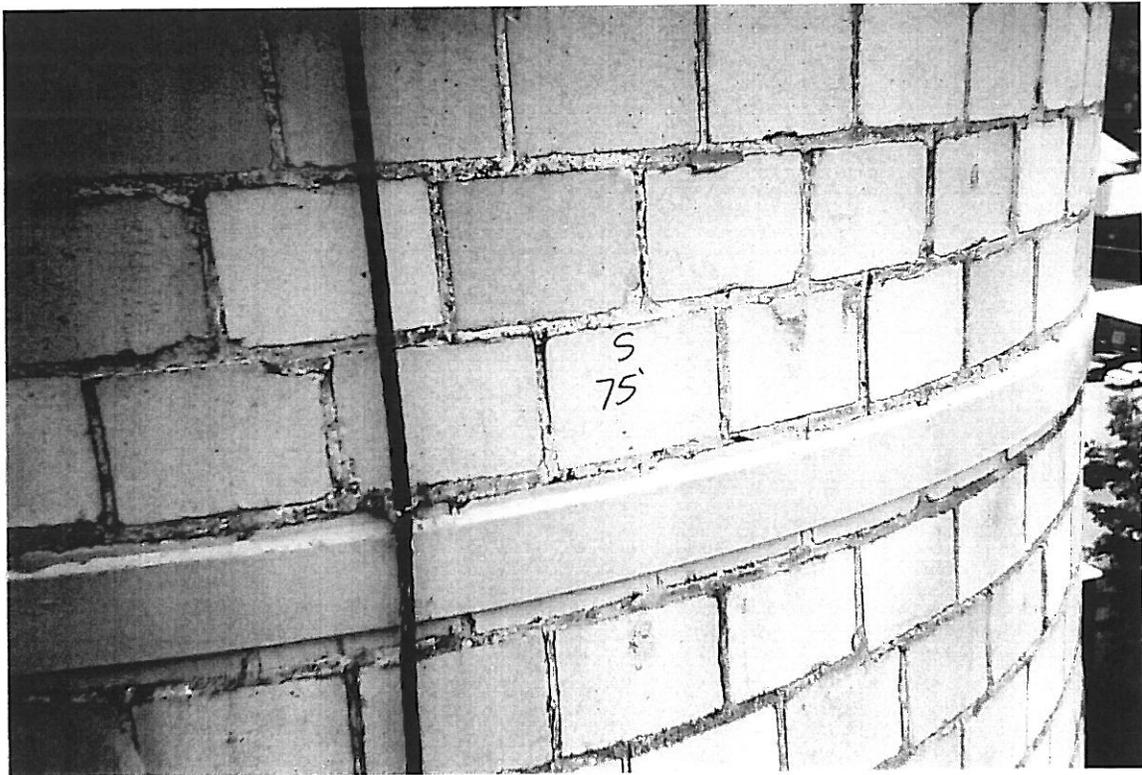
9. Exterior surface, steel tension band, and downlead - south side - elevation 75' above ground level - good condition.

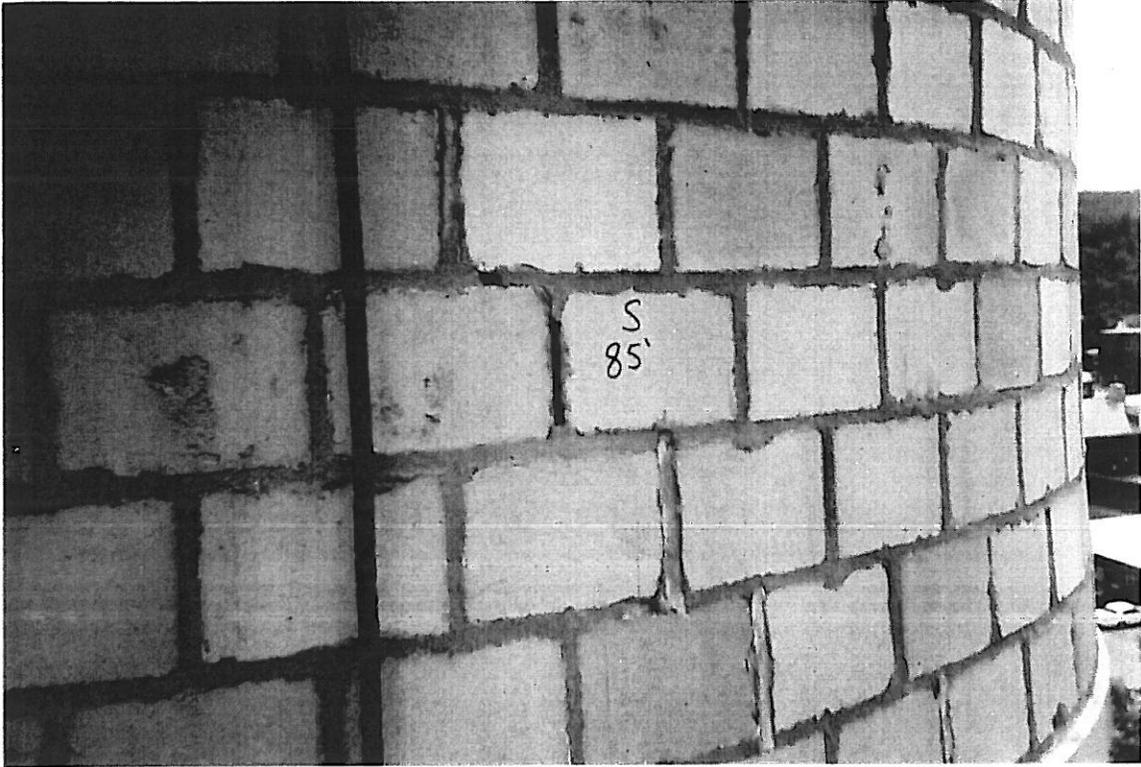
The exterior shell is generally in good condition, however the upper 8' of the column has 30% of the mortar joints worn, weathered, and deteriorated, as can be seen in Photograph Nos. 16, 17, and 19. There are intermittent hairline cracks and missing mortar joints the full height and on all sides of the chimney column, as can be seen in Photograph Nos. 10 through 13, 22, 24, 29, and 33.

10. Exterior surface and downlead - south side - elevation 85' above ground level - mortar joint missing - shell good condition.

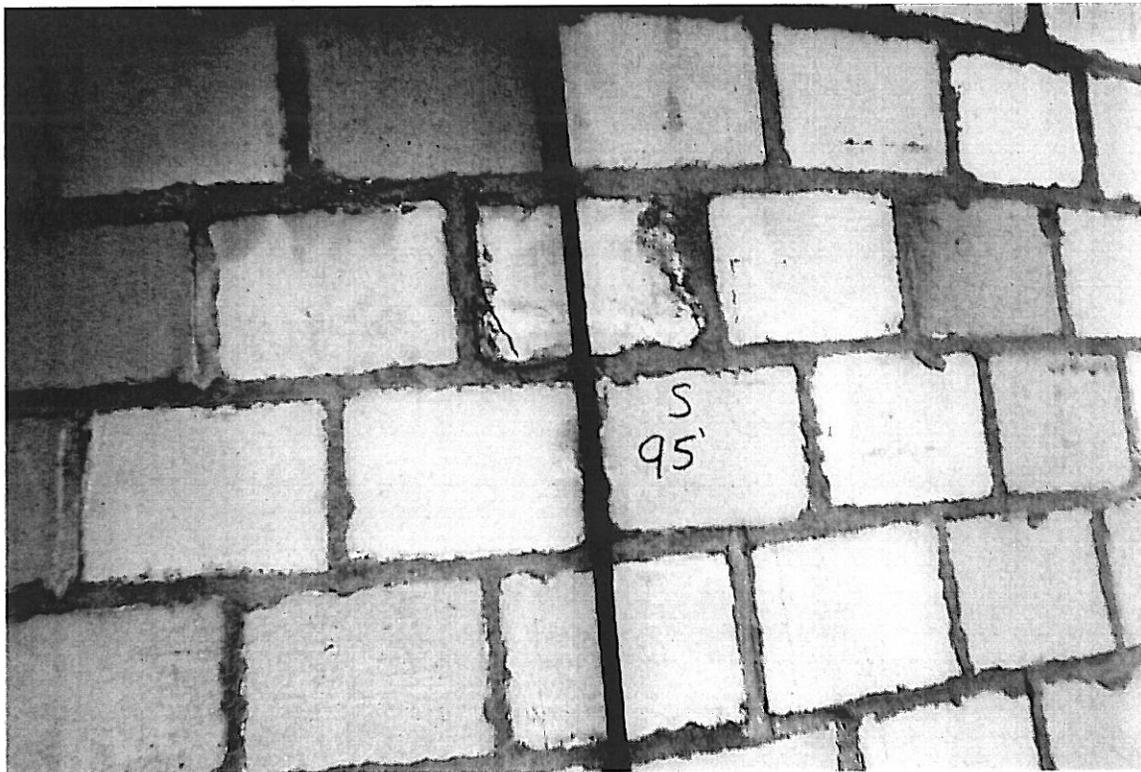
11. Exterior surface and downlead - south side - elevation 95' above ground level - brick face crack - shell good condition.

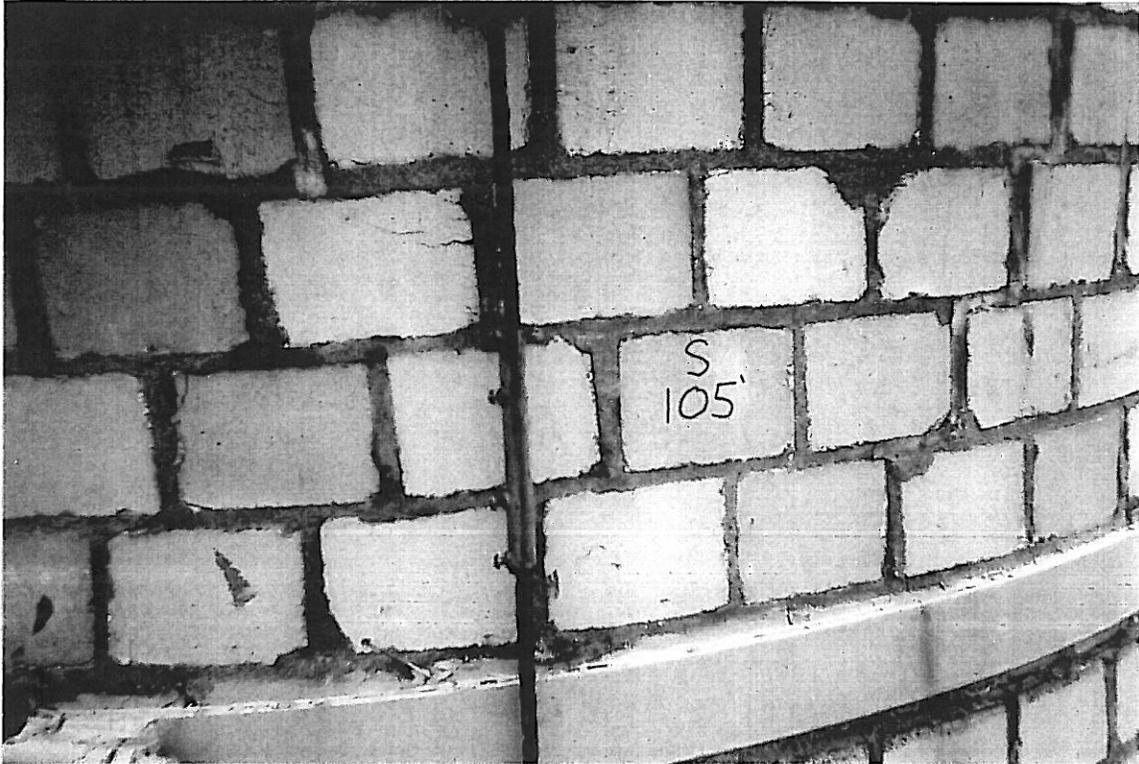
12. Exterior surface, steel tension band, and downlead - south side - elevation 105' above ground level - mortar joint crack - shell good condition.

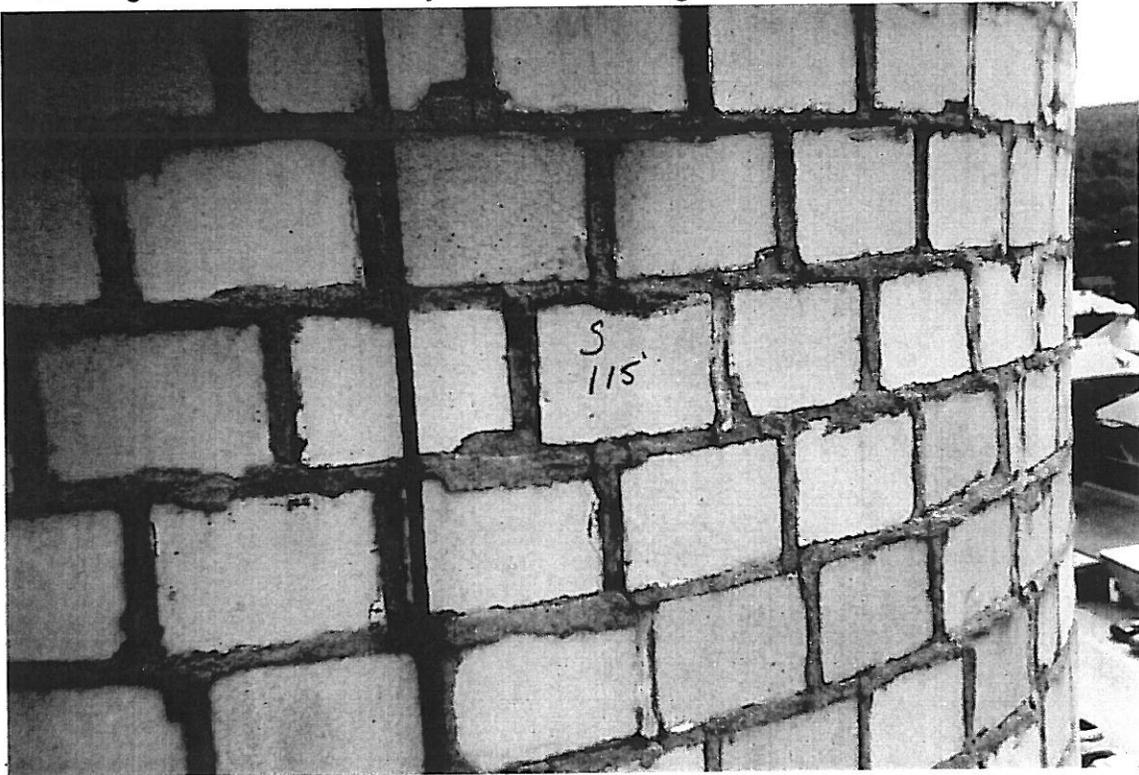
13. Exterior surface and downlead - south side - elevation 115' above ground level - mortar joints crack - shell good condition.

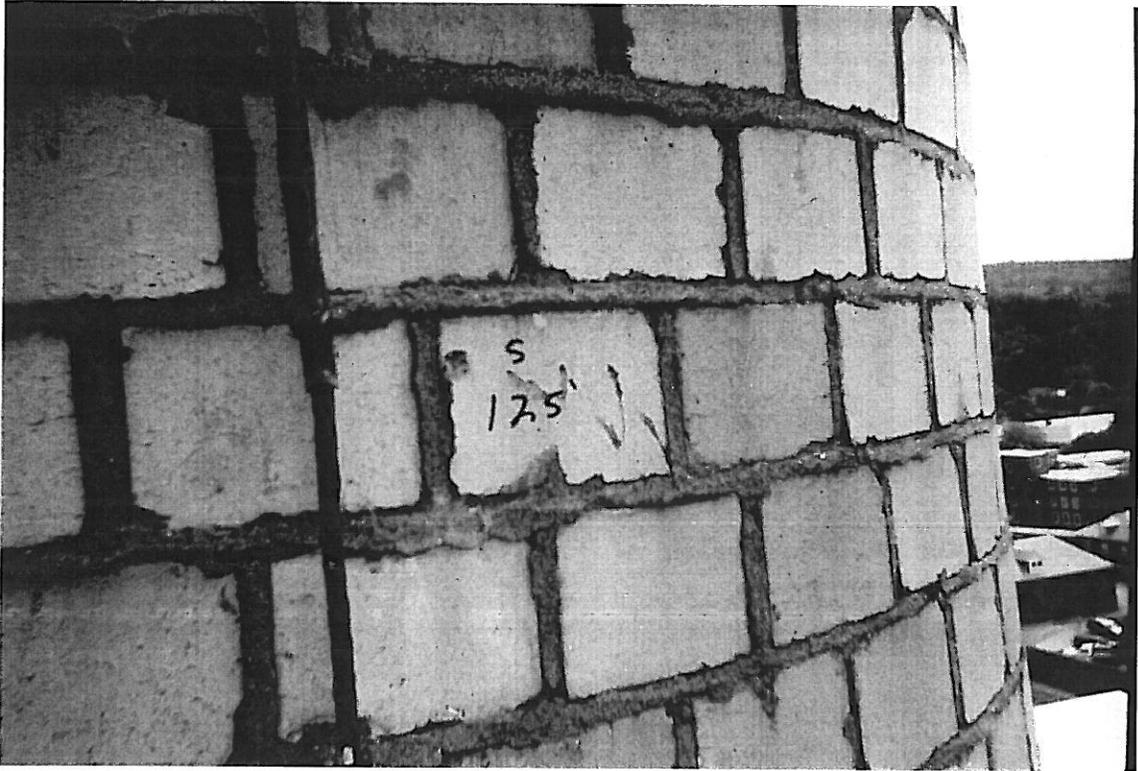
14. Exterior surface and downlead - south side - elevation 125' above ground level - good condition.

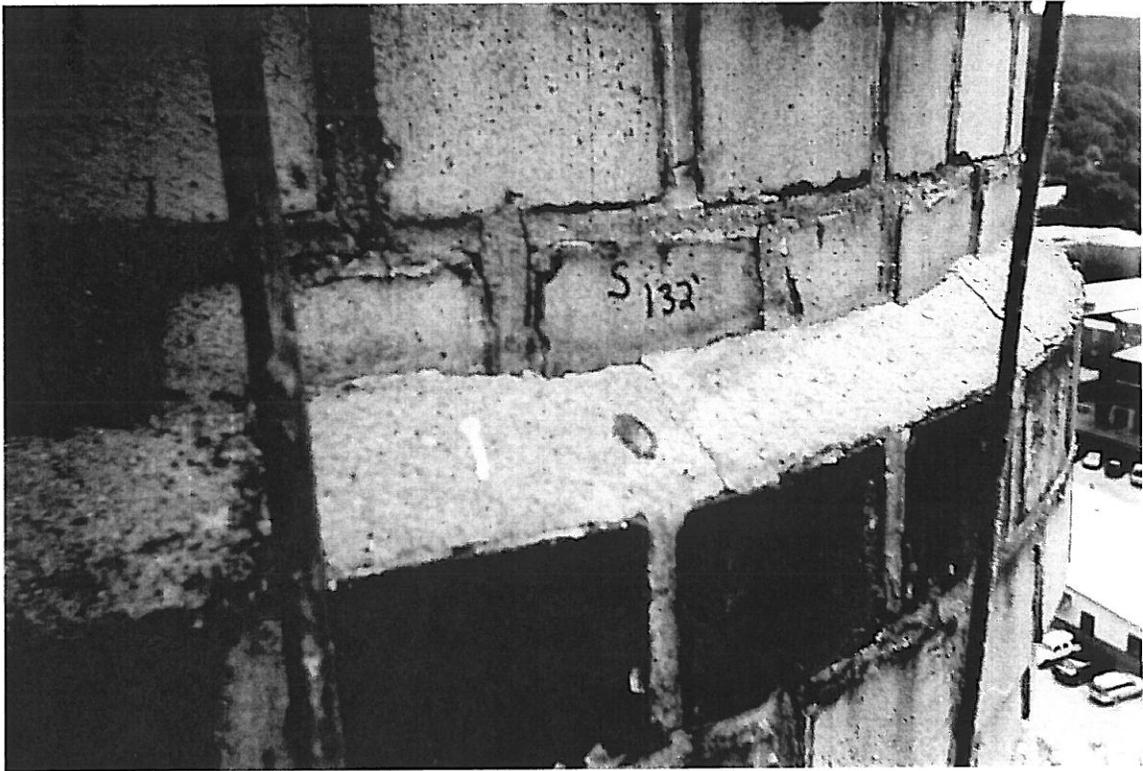
15. Exterior surface, watertable, and downlead - south side - elevation 132' above ground level - hairline cracks in watertable - shell good condition.

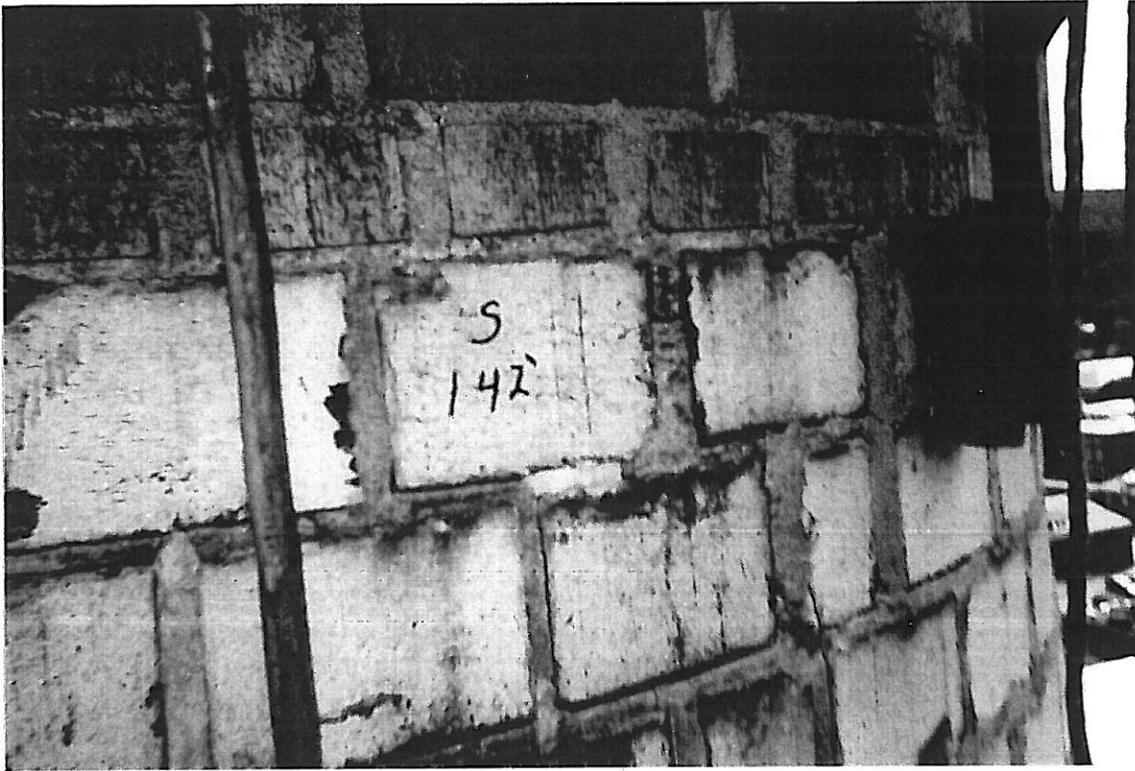
16. Exterior surface and downlead - south side - elevation 142' above ground level - good condition.

- Tuckpoint and crack repair upper 8'
- Lightning protection system inspected and re-anchored as needed
- Internal washdown
- Breeching interior crack repair and re-clad
- Internal inspection

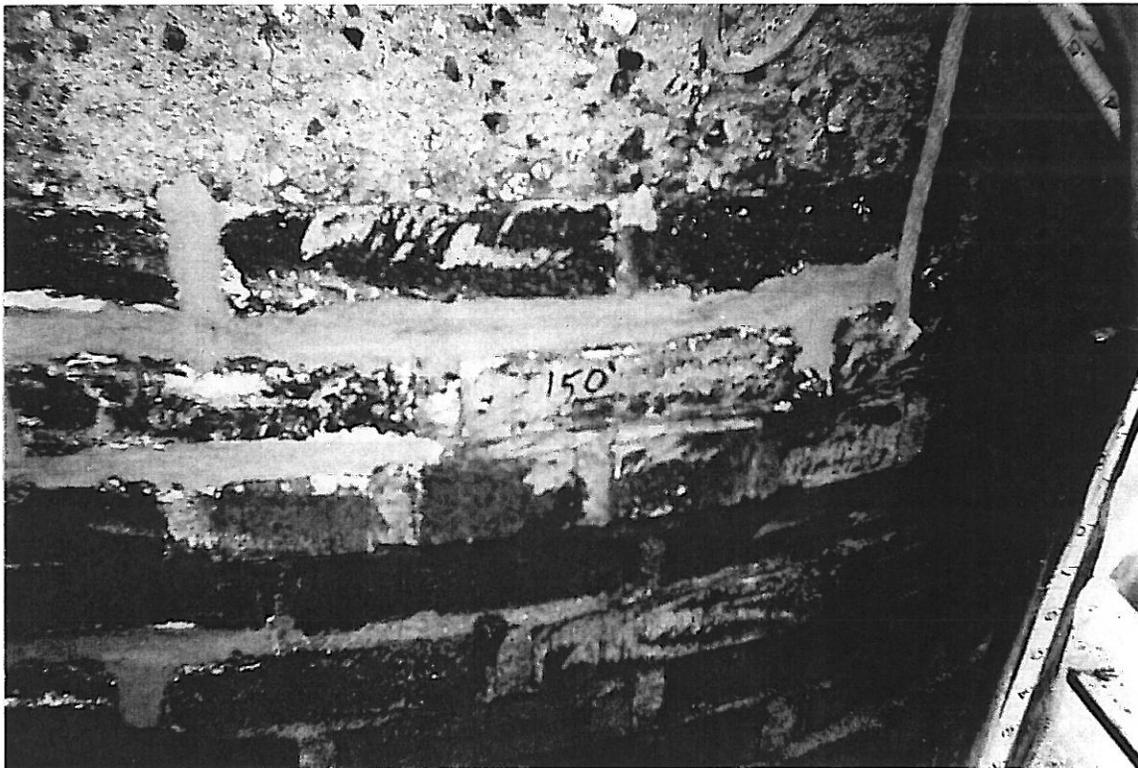
The formed concrete cap atop the chimney column is worn and weathered, as can be seen in Photograph Nos. 17, 18, 36, 37, and 38.

17. Exterior surface, air terminal, and cap - south side - elevation 150' above ground level - cap worn - shell good condition.

- Remove upper 12' of gunite liner
- Sandblast upper 12' and 4' wide area at elevation 43'
- Install new liner upper 12'
- Install flashcoat liner at elevation 43' above ground level
- Remove old cap
- Install new formed concrete cap

The remaining deteriorated cap will be removed, dropping the pieces to the inside of the chimney. A new reinforced concrete cap of monolithic design will be formed and poured to seal the top of the chimney from moisture and the discharge of chemical gases. The cap will be reinforced with steel bars, which will be anchored or wired to the upper chimney wall.
