GERARD CHIMNEY COMPANY

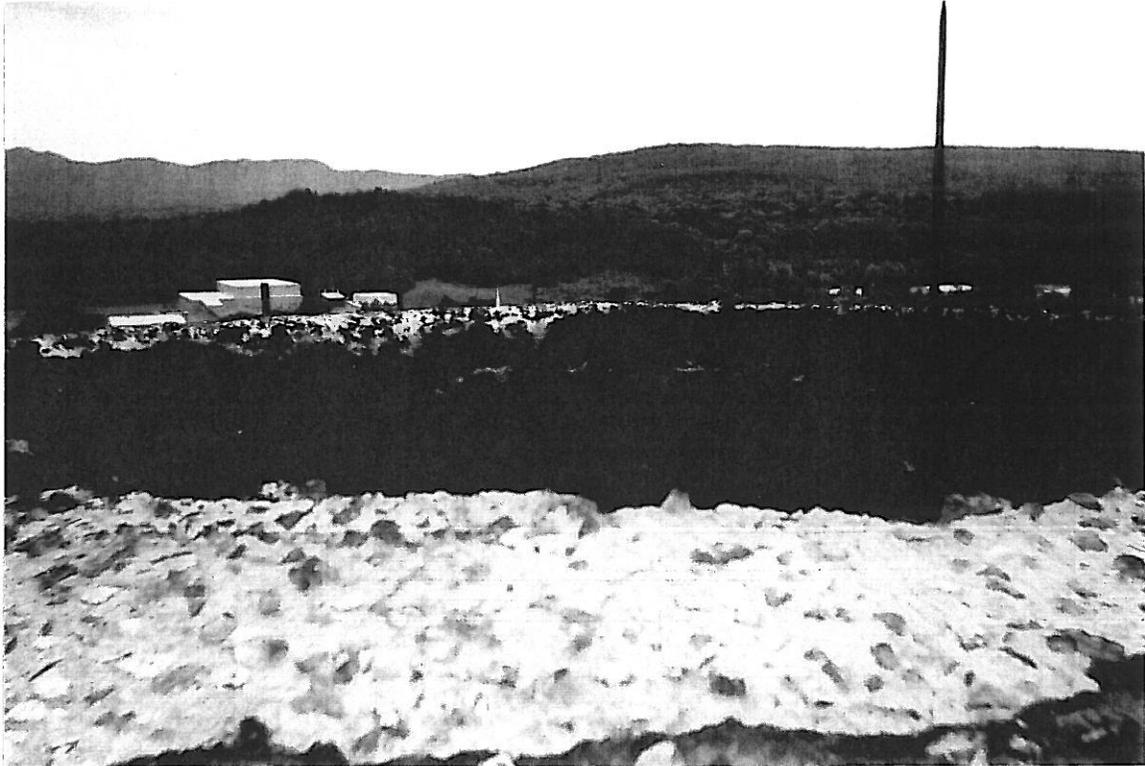
18. Formed concrete cap and air terminal - top of chimney - concrete cap worn and weathered.

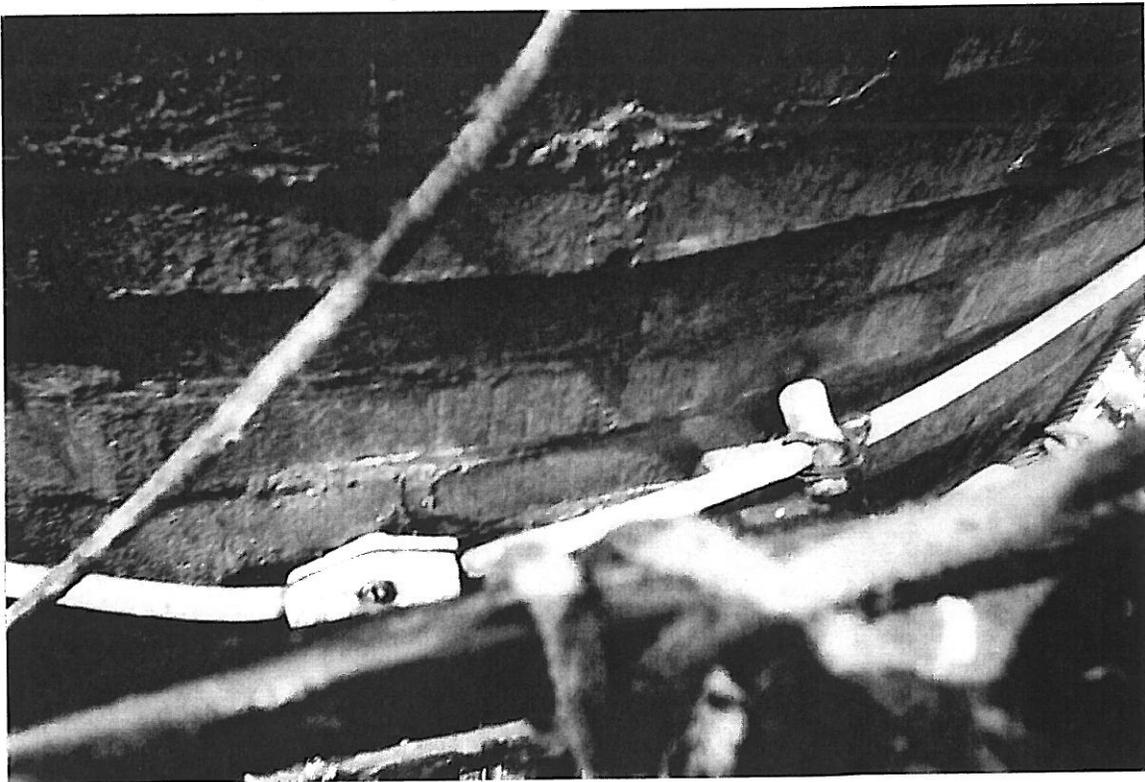
19. Exterior surface and top encircling cable - north side - elevation 147' above ground level - loose anchor on cable - shell good condition.

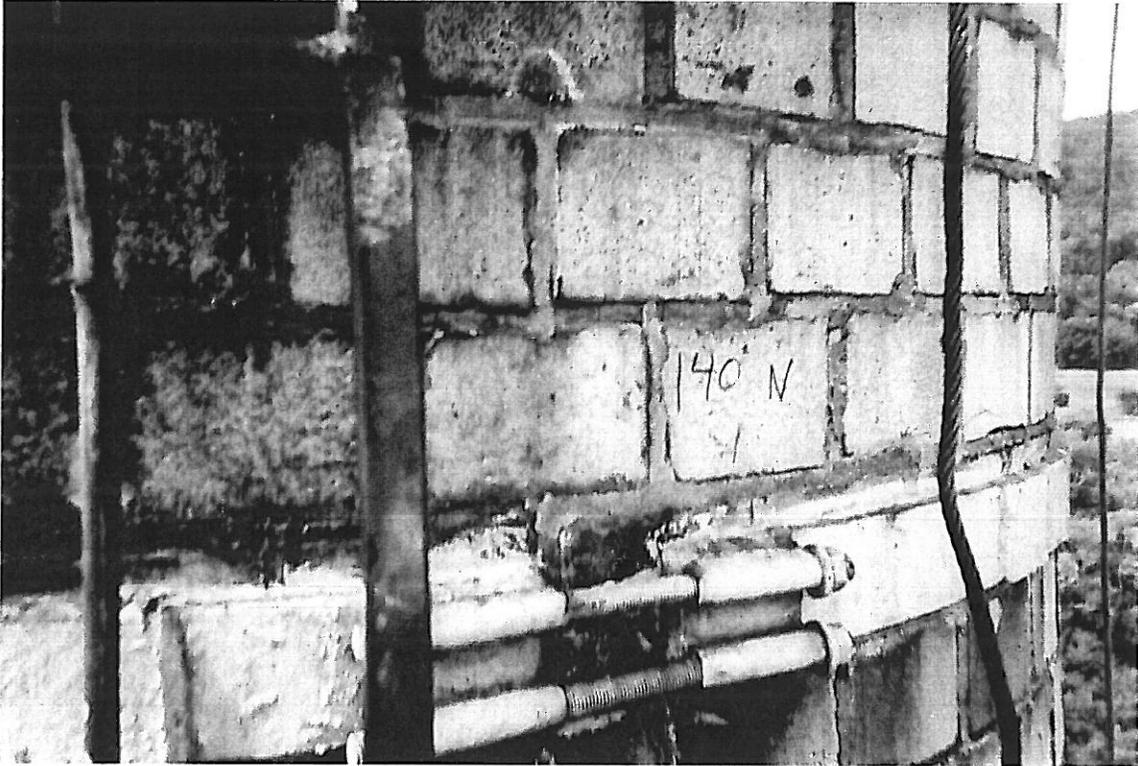
20. Exterior surface, steel tension band, and downlead - north side - elevation 140' above ground level - good condition.

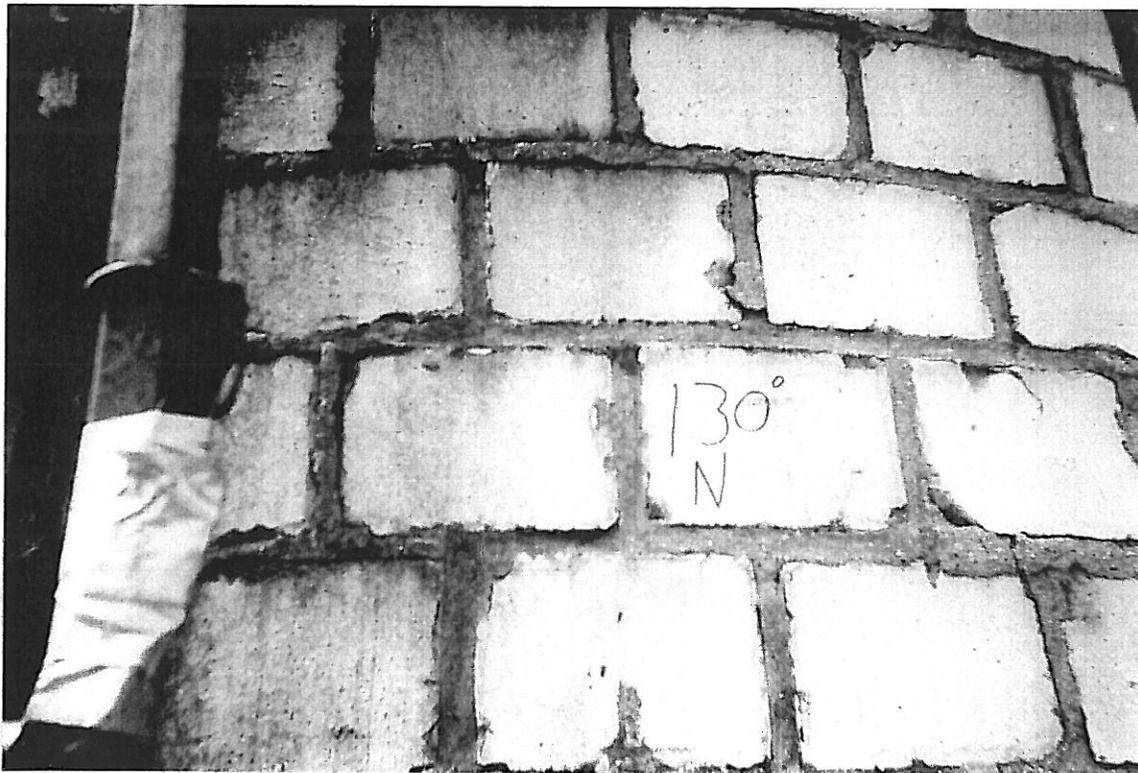
21. Exterior surface - north side - elevation 130' above ground level - good condition.

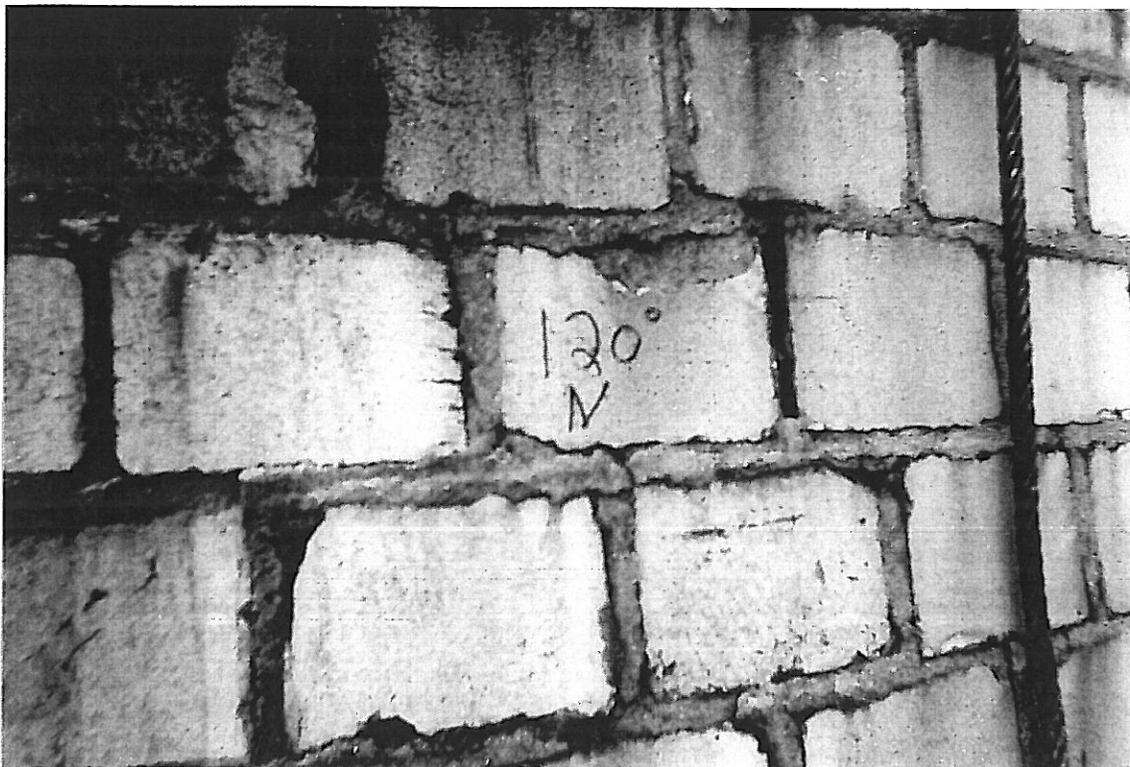
22. Exterior surface and downlead - north side - elevation 120' above ground level - mortar joint crack and missing - shell good condition.

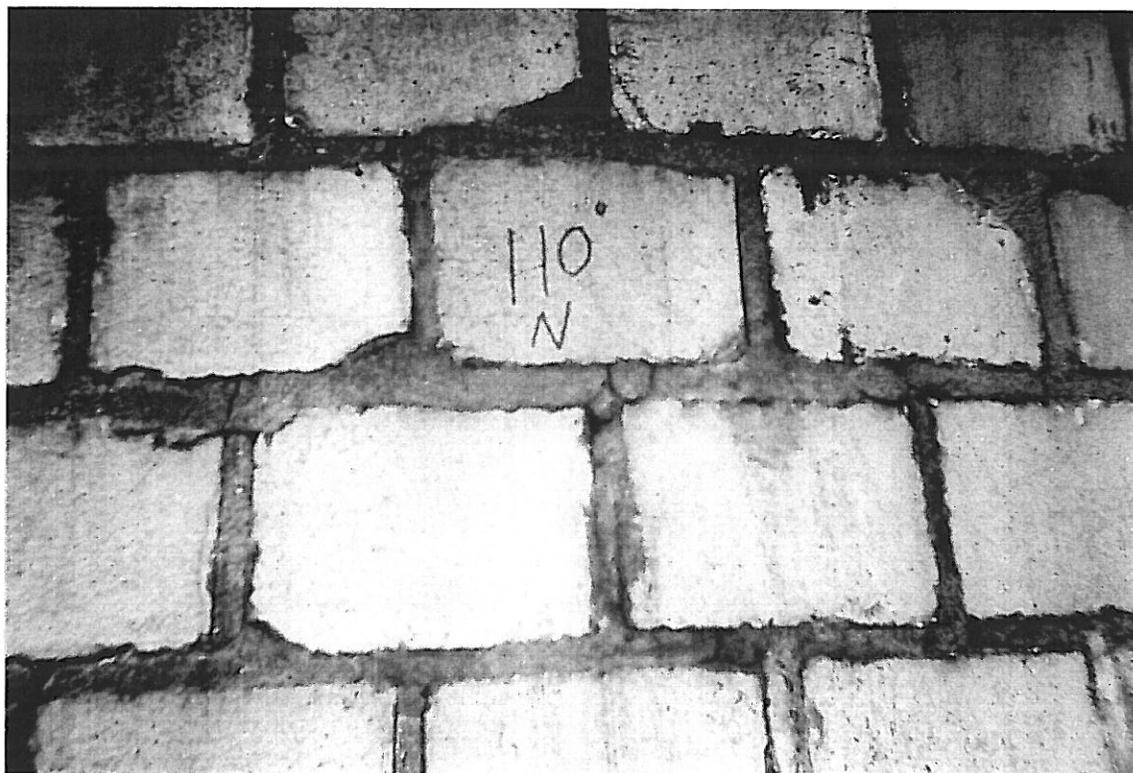
23. Exterior surface - north side - elevation 110' above ground level - good condition.

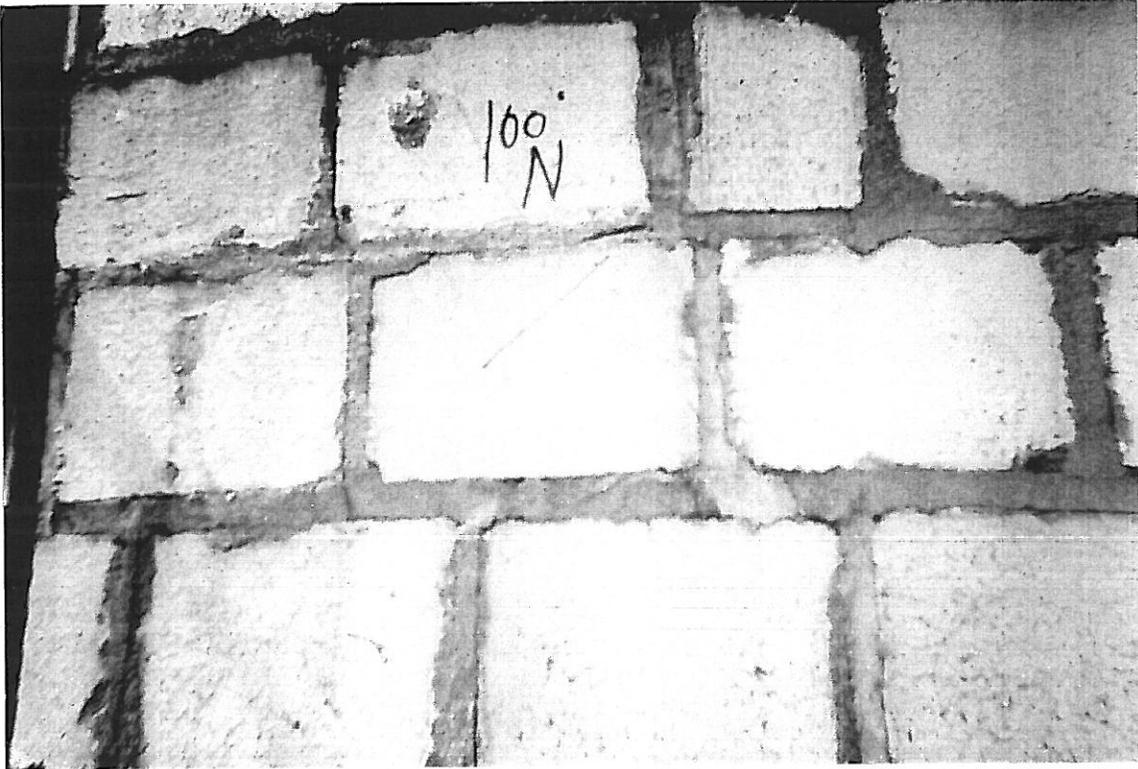
24. Exterior surface - north side - elevation 100' above ground level - mortar joint crack - shell good condition.

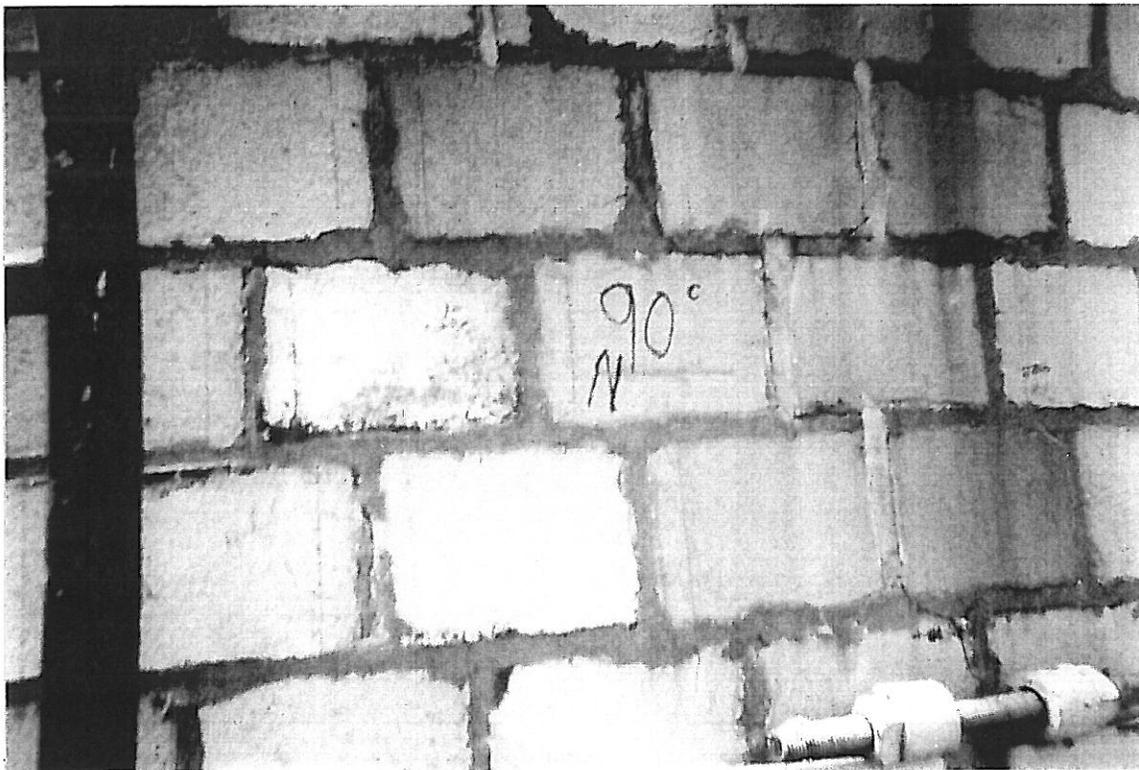
25. Exterior surface and steel tension band connector bolt - north side - elevation 90' above ground level - stain on surface - shell good condition.

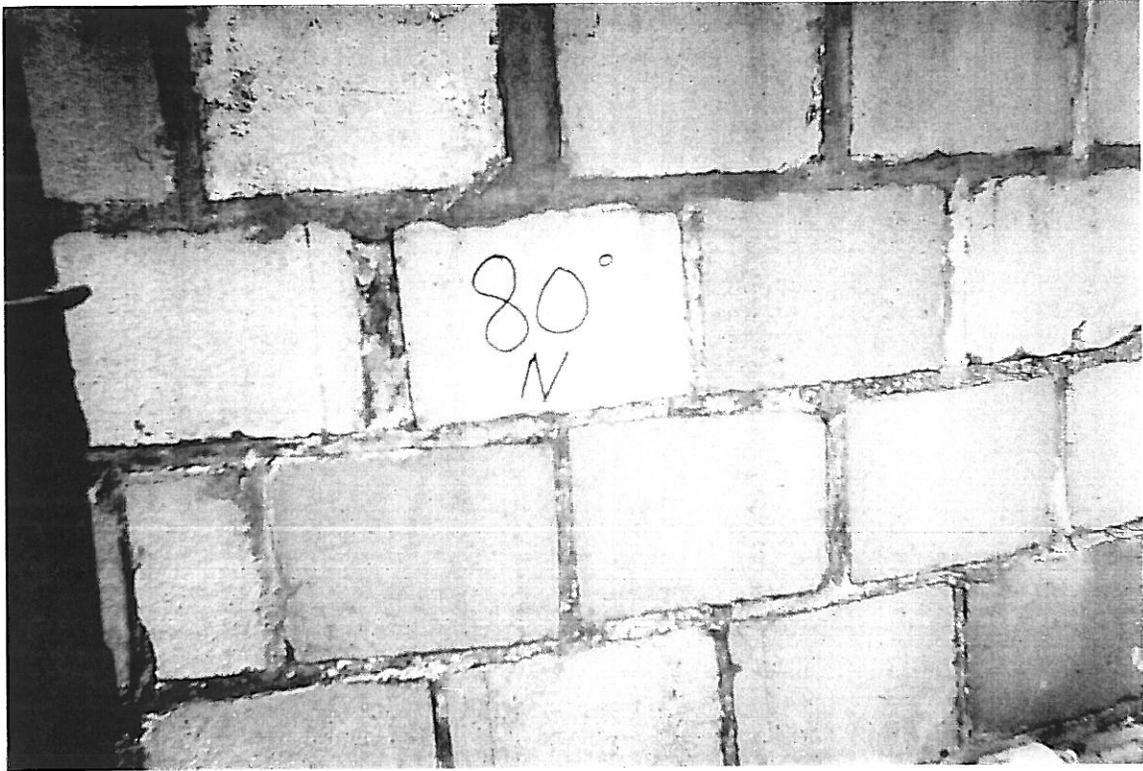
26. Exterior surface - north side - elevation 80' above ground level - good condition.

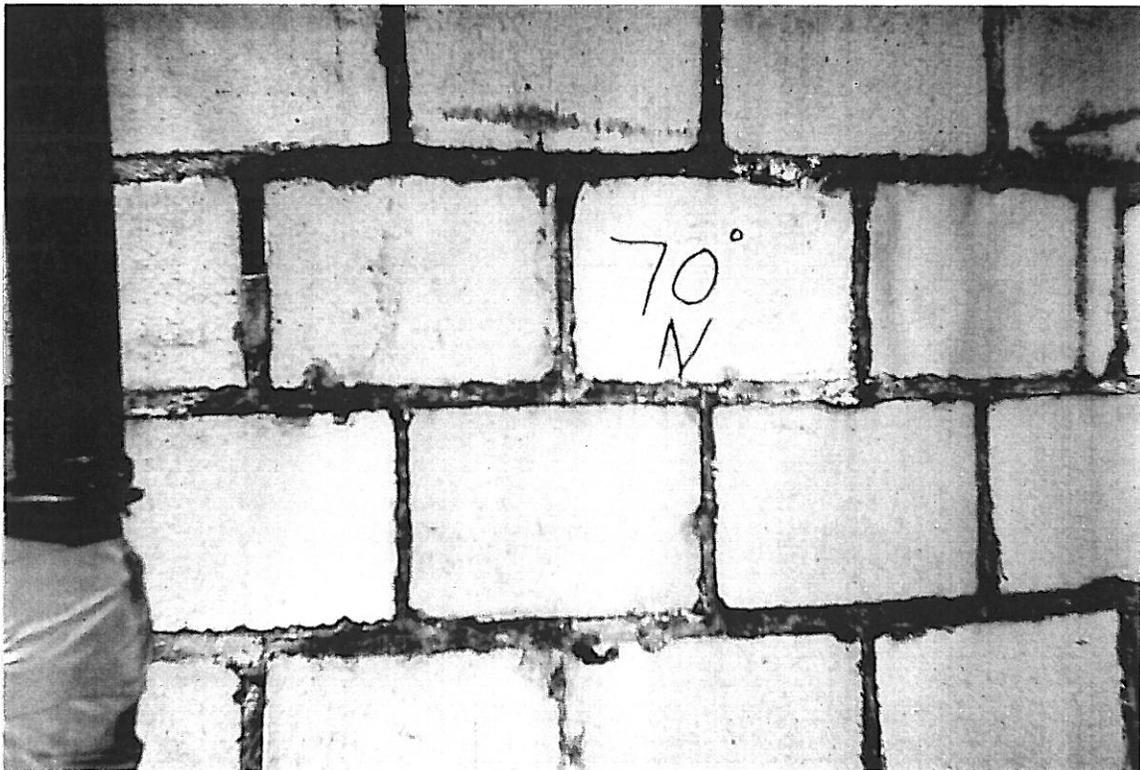
27. Exterior surface - north side - elevation 70' above ground level - good condition.

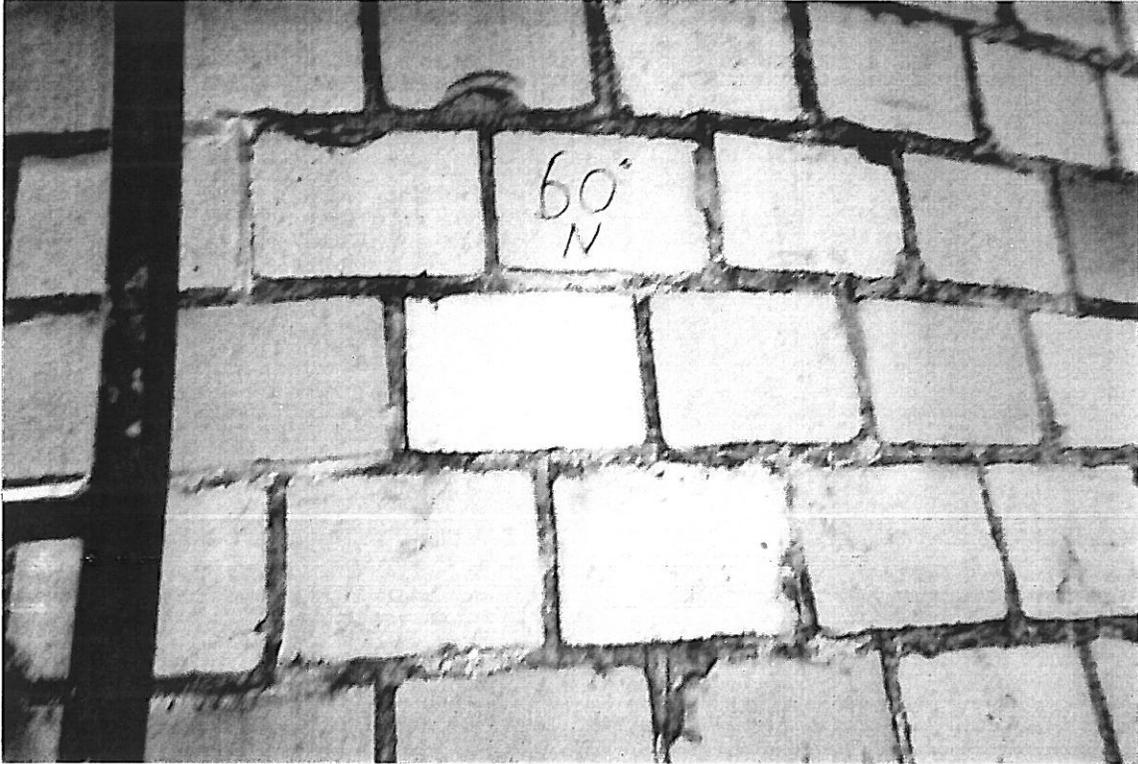
28. Exterior surface - north side - elevation 60' above ground level - good condition.

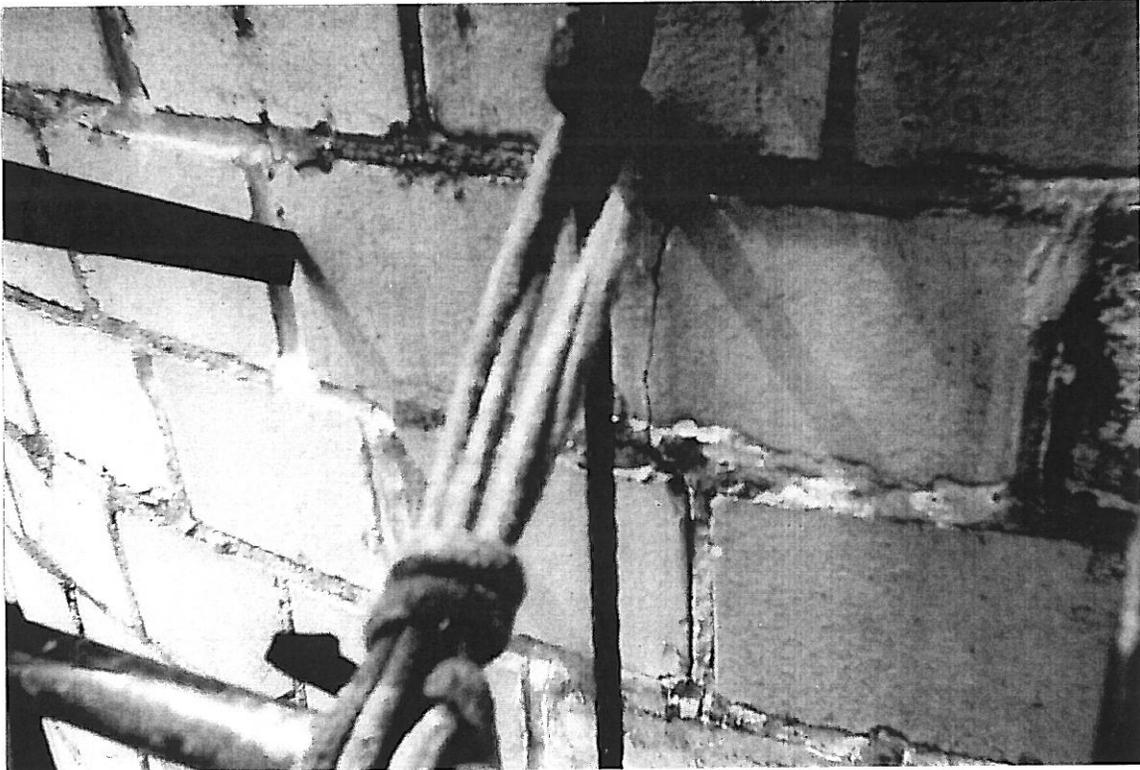
29. Exterior surface - north side - elevation 55' above ground level - mortar crack - shell good condition.

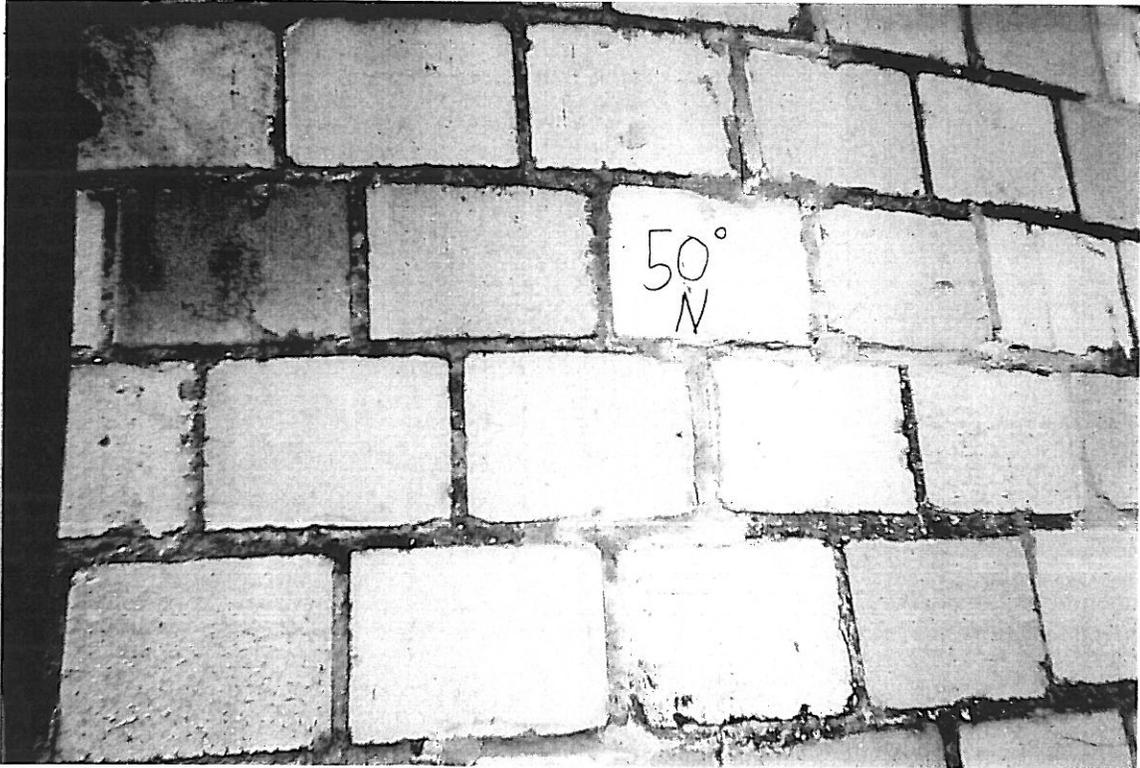
30. Exterior surface - north side - elevation 50' above ground level - good condition.

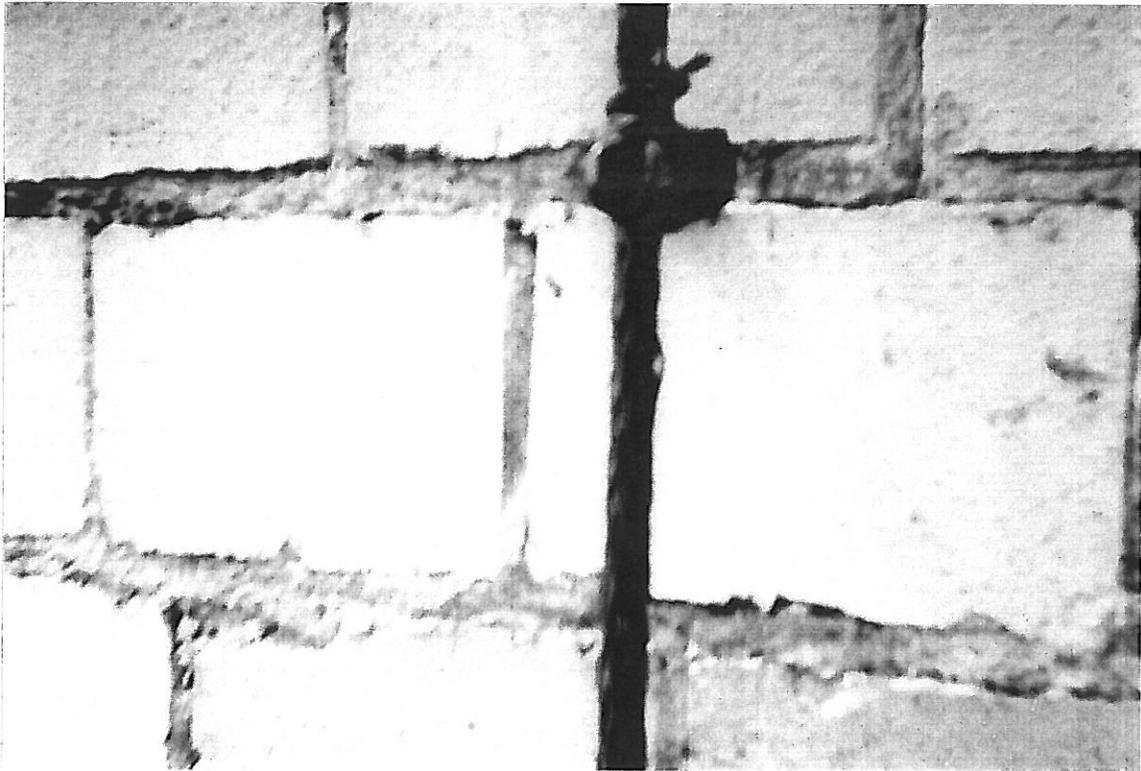
31. Exterior surface - north side - elevation 45' above ground level - good condition.

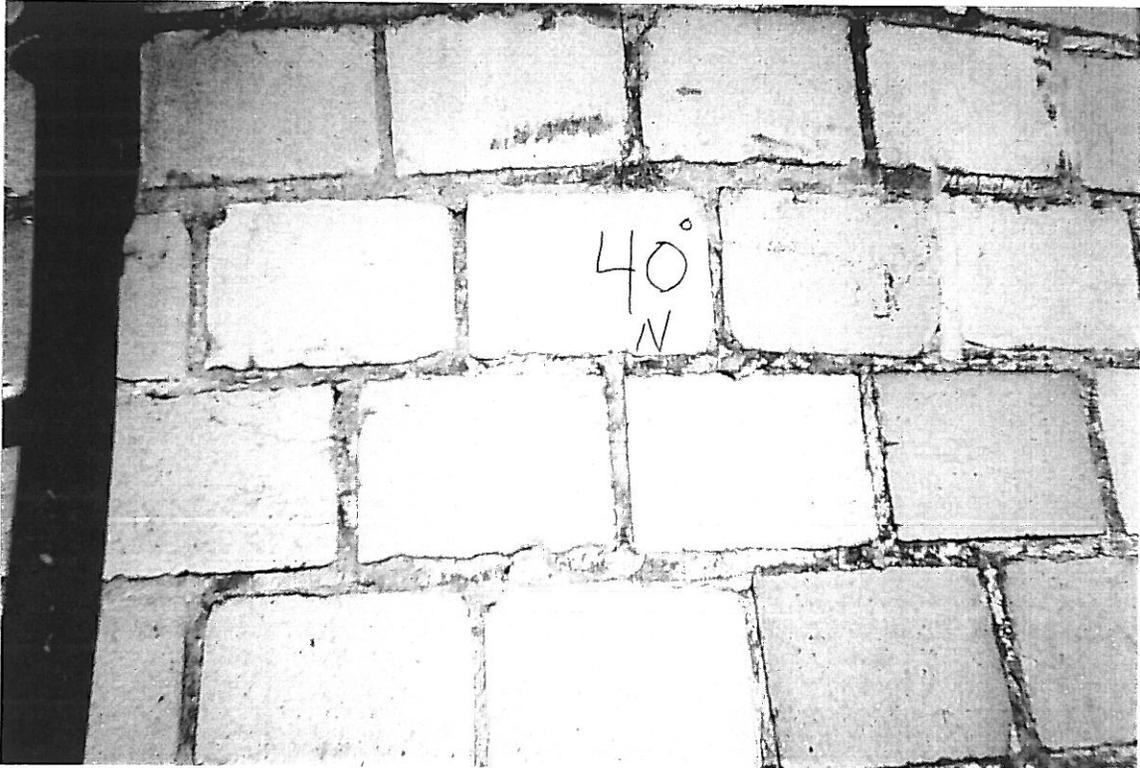
32. Exterior surface - north side - elevation 40' above ground level - good condition.

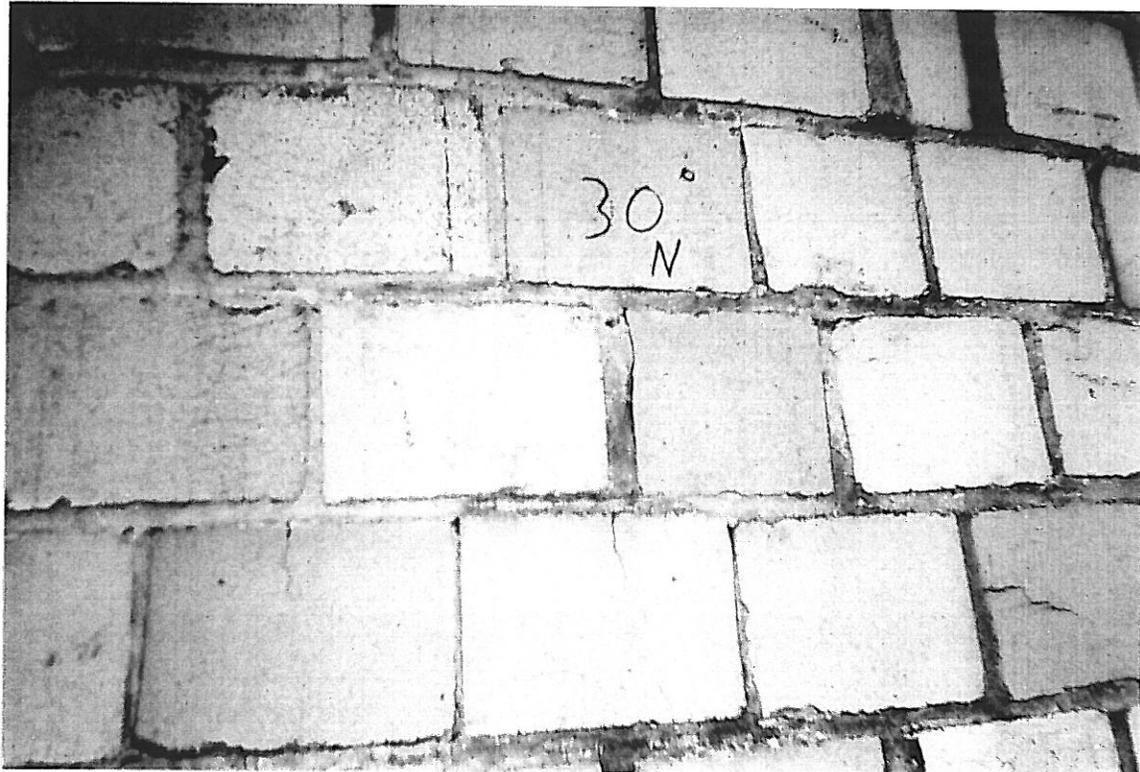
33. Exterior surface - north side - elevation 30' above ground level - hairline crack in brick face - shell good condition.

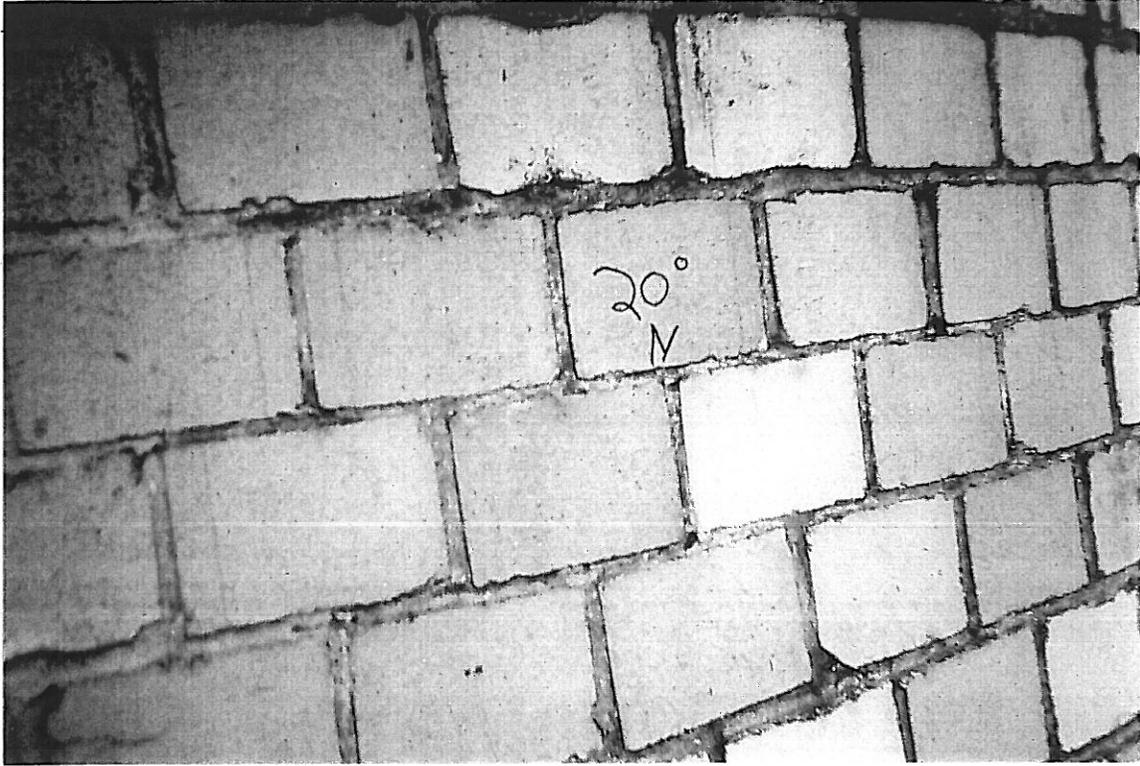
34. Exterior surface - north side - elevation 20' above ground level - good condition.

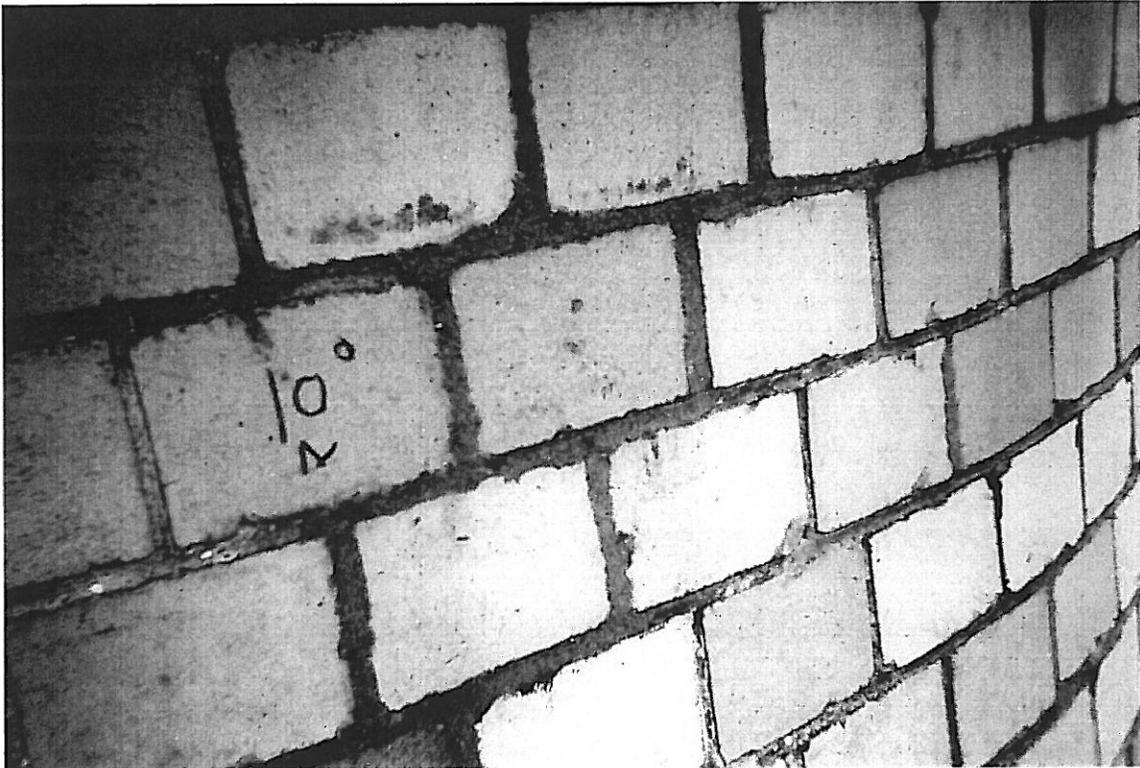
35. Exterior surface - north side - elevation 10' above ground level - good condition.

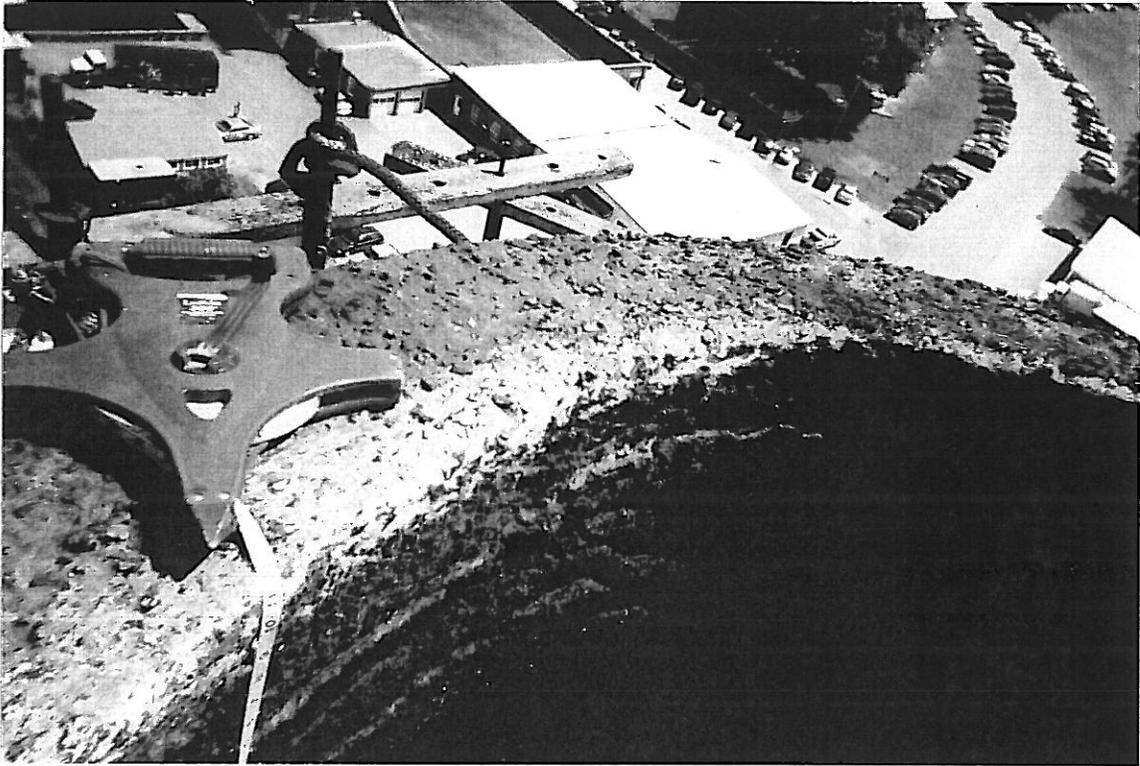
36. Interior surface and formed concrete cap - north side -top of chimney - cap worn and weathered.

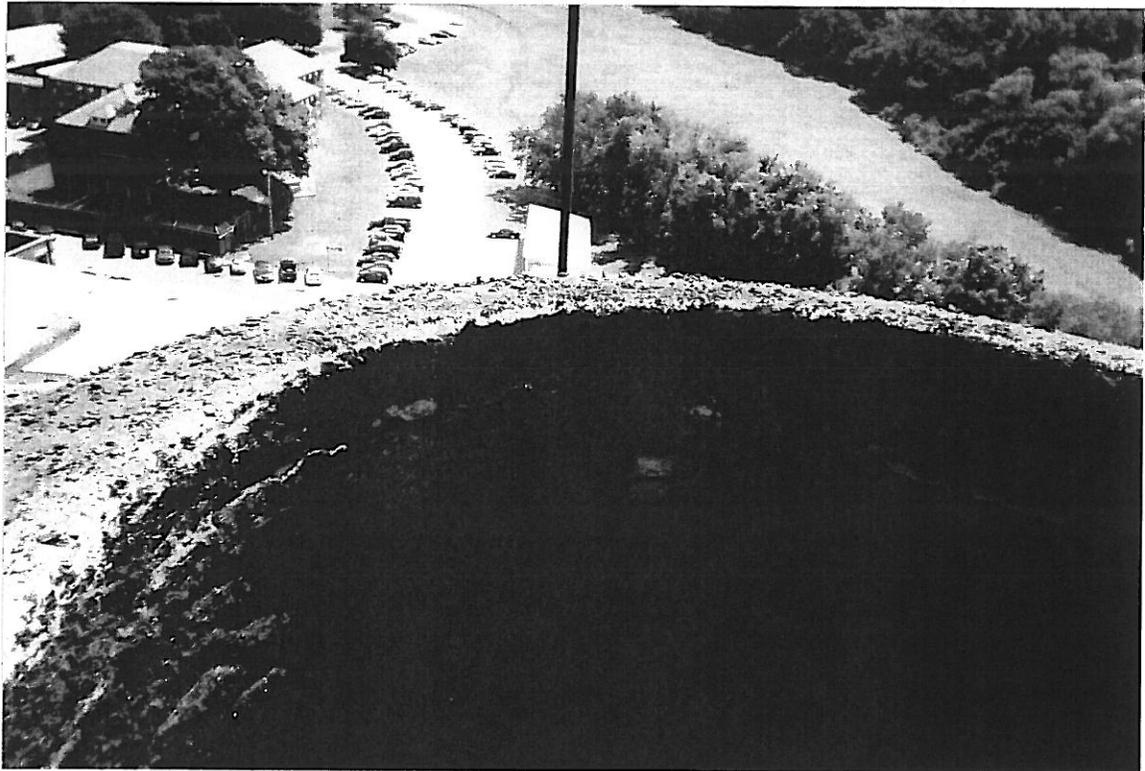
37. Interior surface, formed concrete cap and air terminals - west side - top of chimney - interior gunite spalled and cracked - cap worn and weathered.

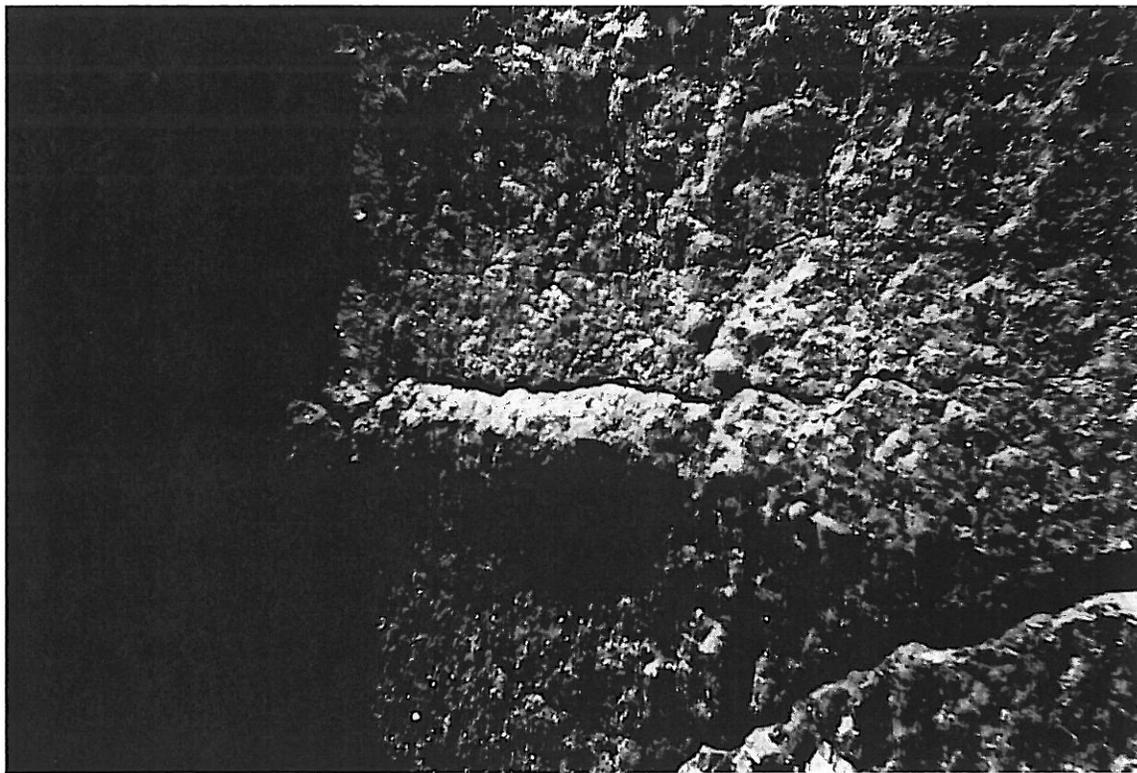
39. Interior surface - east side - elevation 150' above ground level - 1/8" to 1" wide cracks in gunite liner.

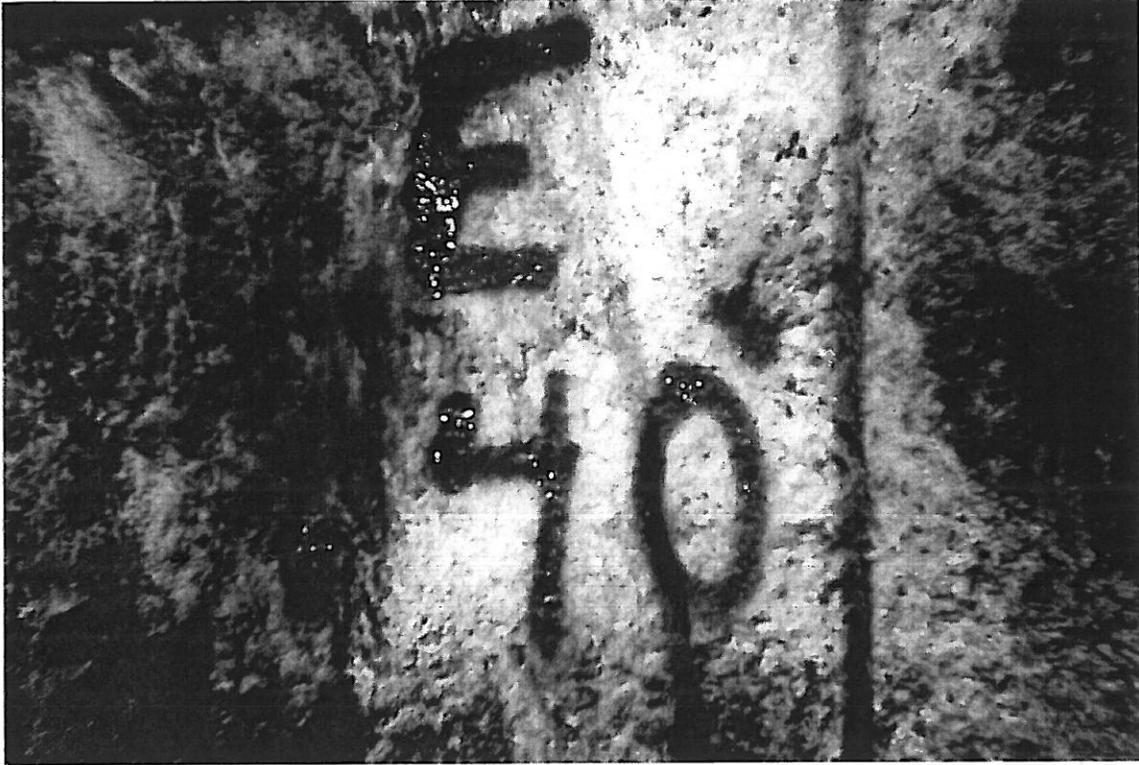
40. Interior surface - east side - elevation 140' above ground level - two spalled areas in gunite liner.

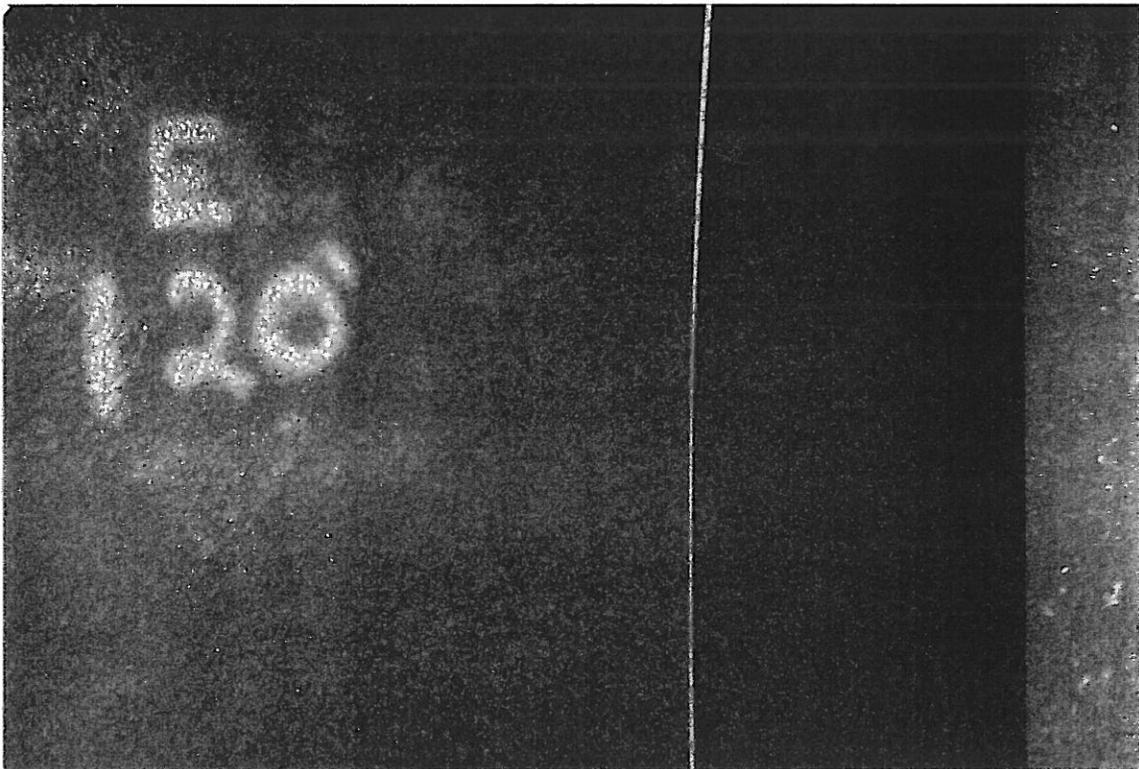
41. Interior surface - east side - elevation 120' above ground level - good condition.

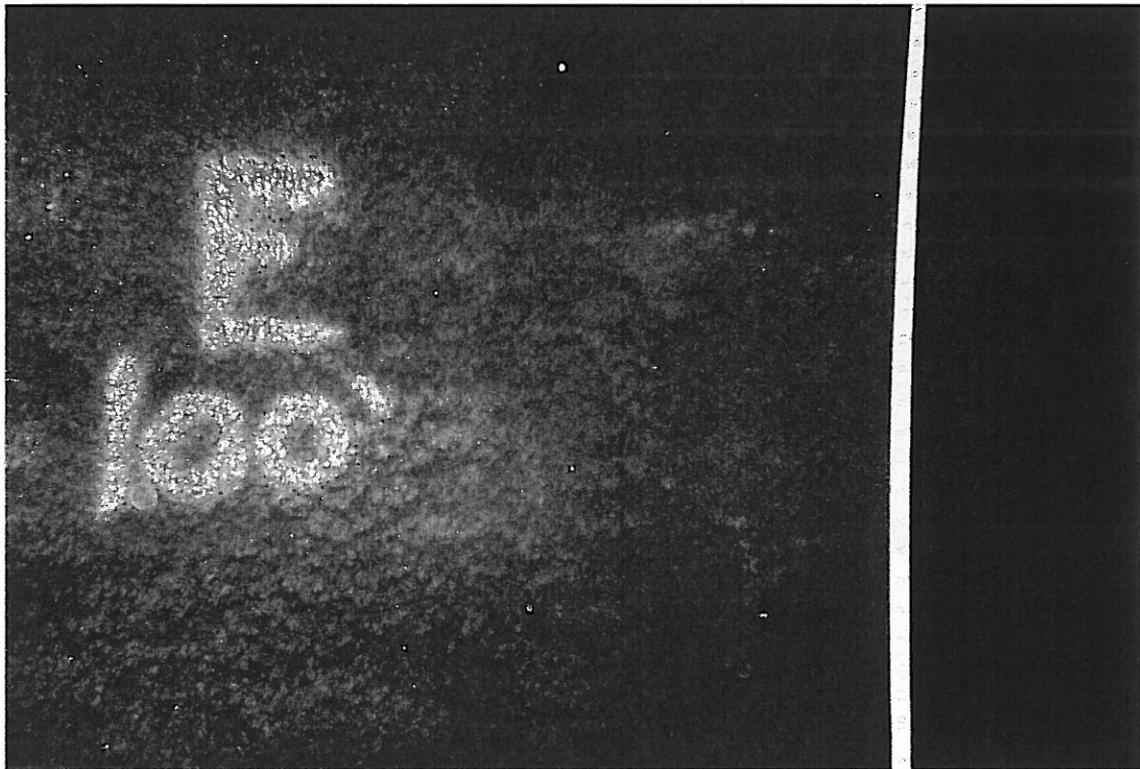
43. Interior surface - east side - elevation 100' above ground level - good condition.

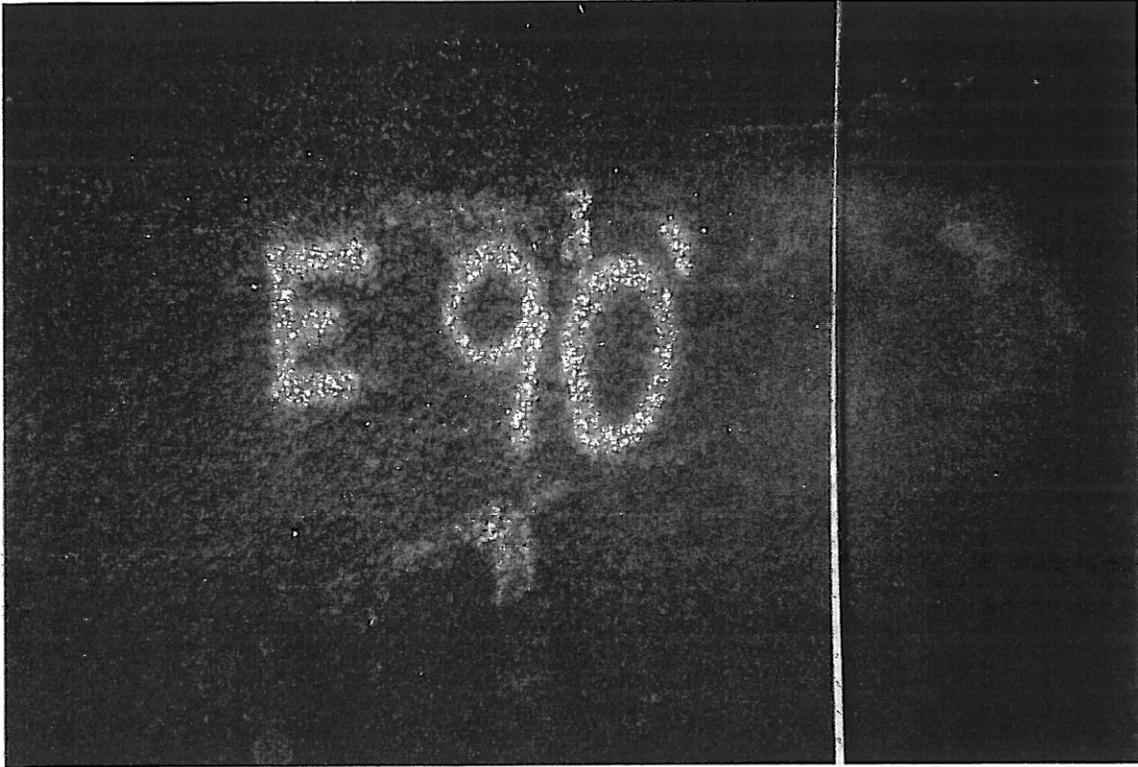
44. Interior surface - east side - elevation 90' above ground level - good condition.
