GERARD CHIMNEY COMPANY

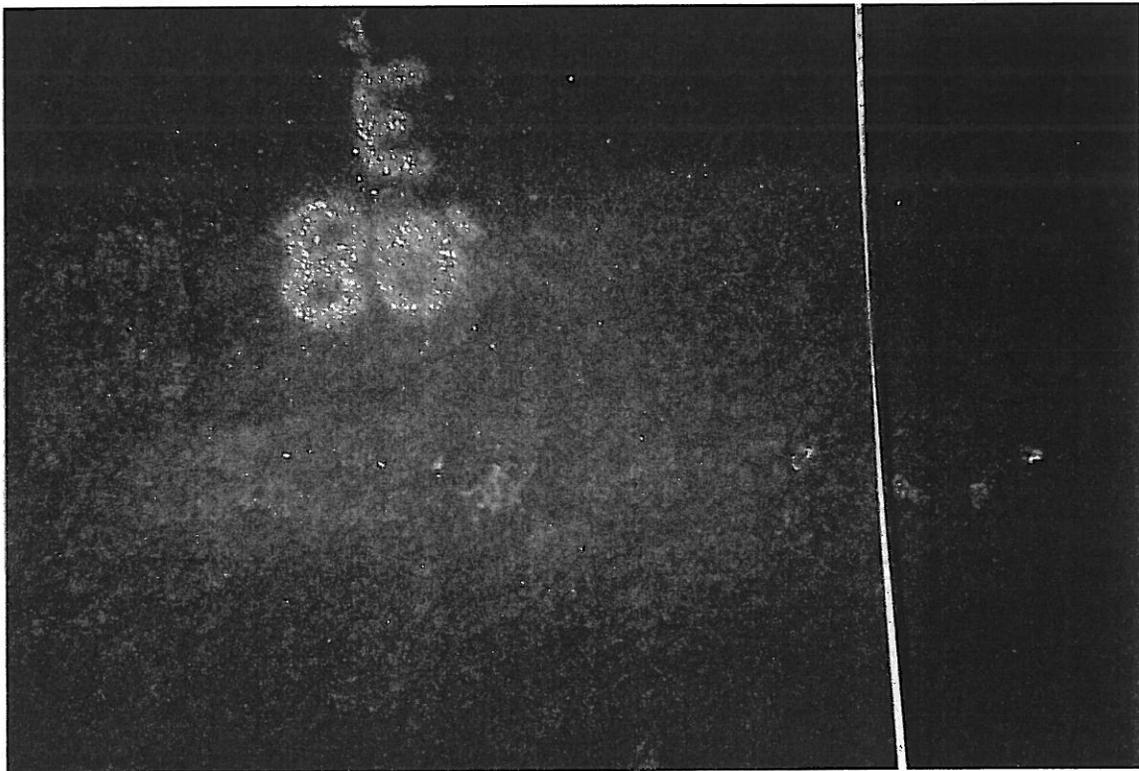
45. Interior surface - east side - elevation 80' above ground level - good condition.

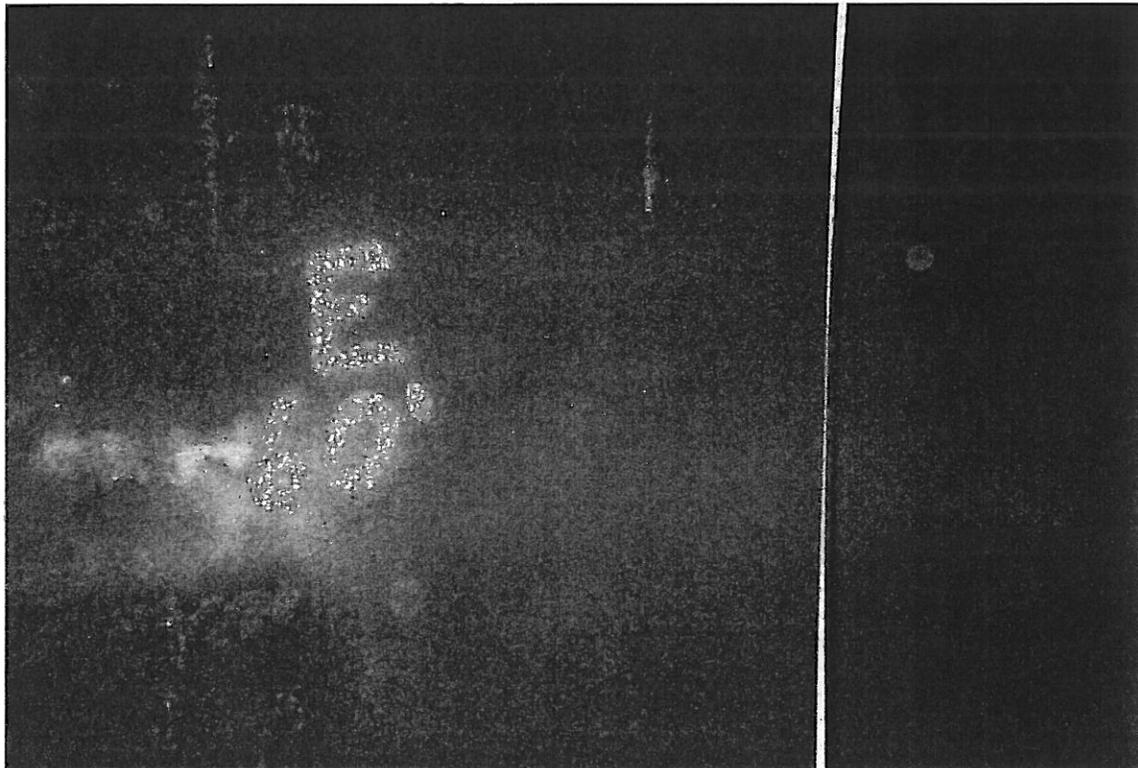
47. Interior surface - east side - elevation 60' above ground level - good condition.

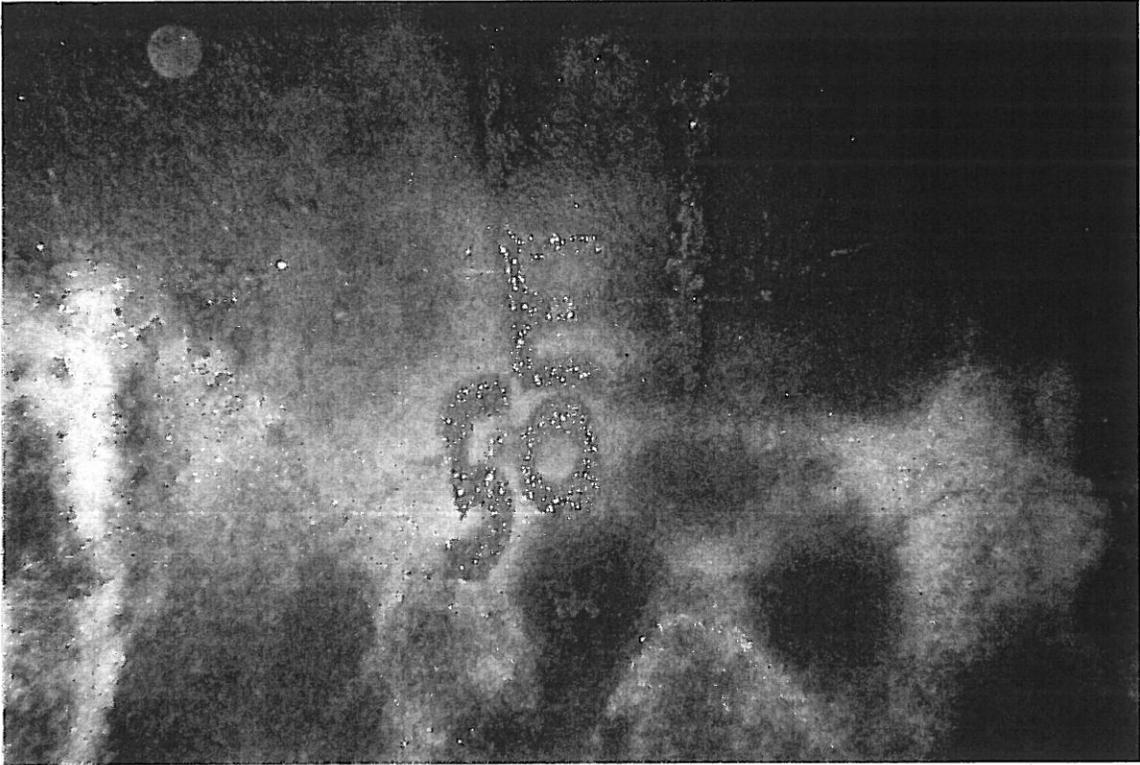
48. Interior surface - east side - elevation 50' above ground level - good condition.

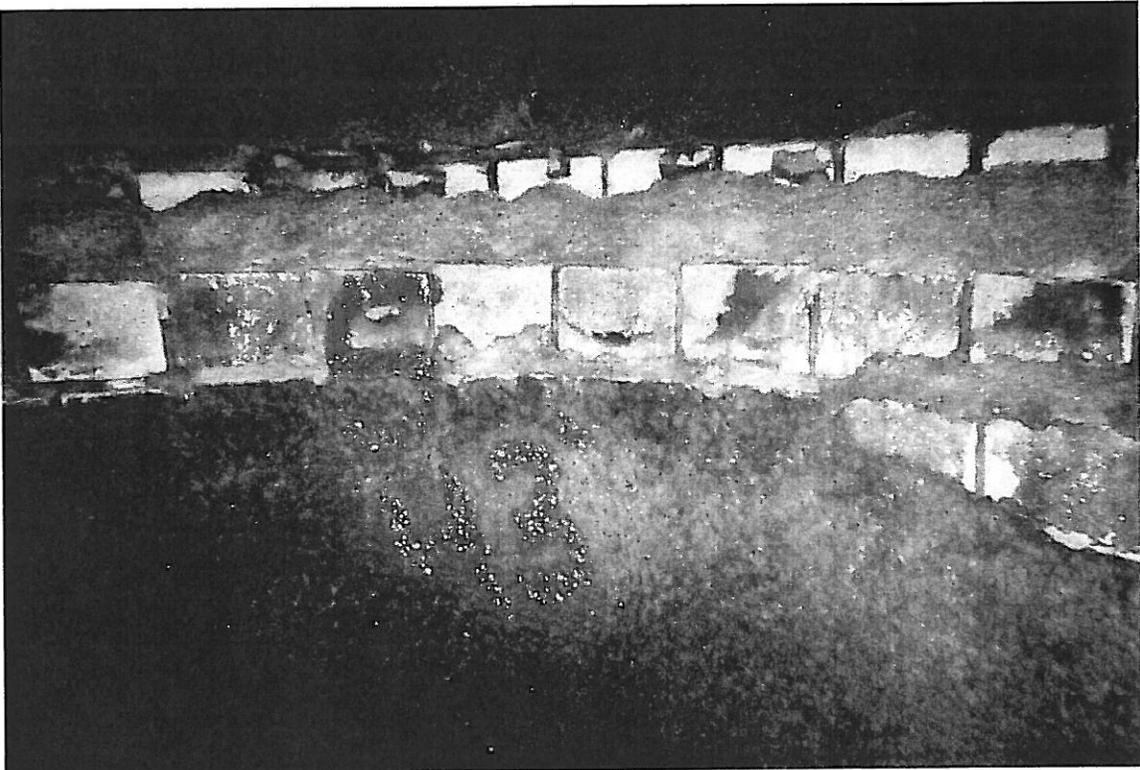
49. Interior surface - south side - elevation 43' above ground level - gunite thin - brick exposed.

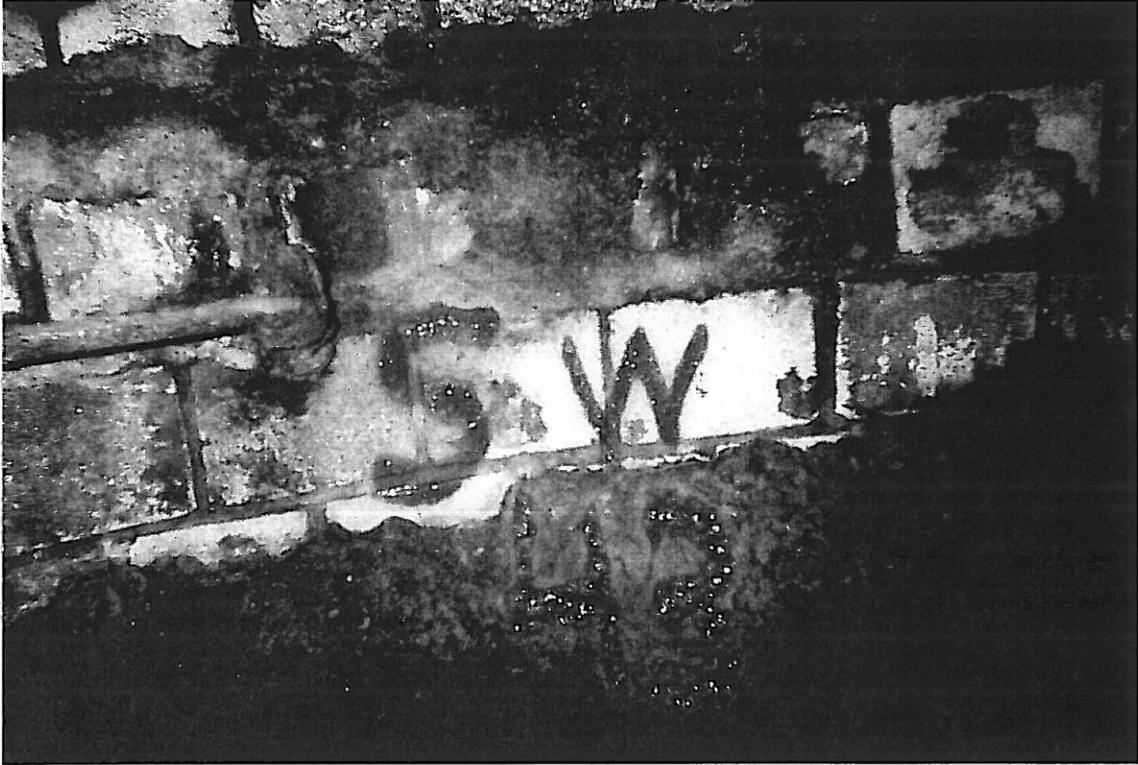
50. Interior surface - southwest side - elevation 43' above ground level - mortar joint crack - gunite thin - brick exposed.

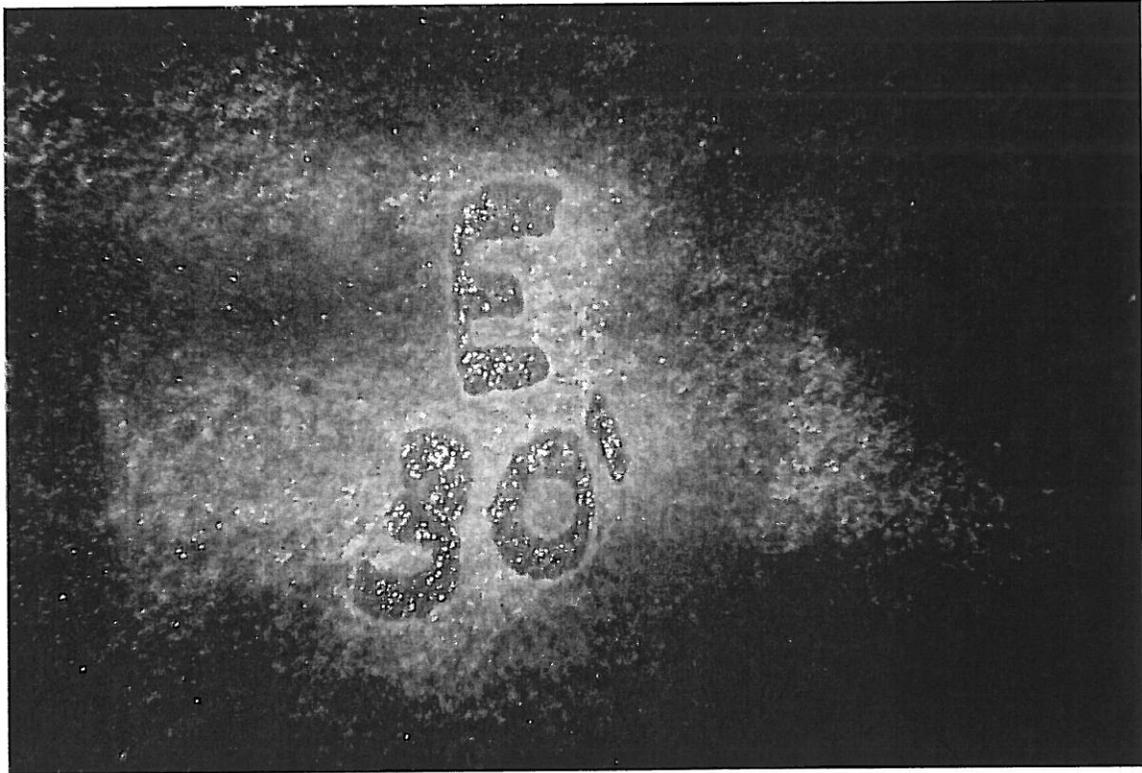
51. Interior surface - east side - elevation 30' above ground level - good condition.

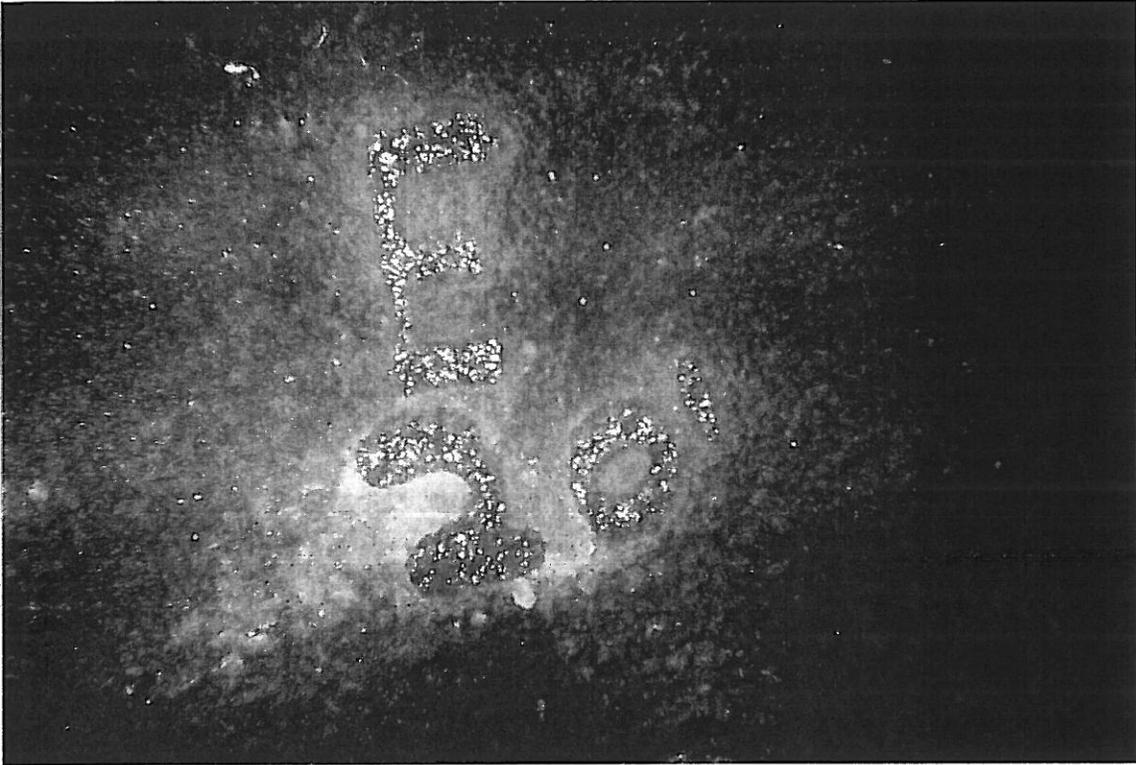
52. Interior surface - east side - elevation 20' above ground level - good condition.

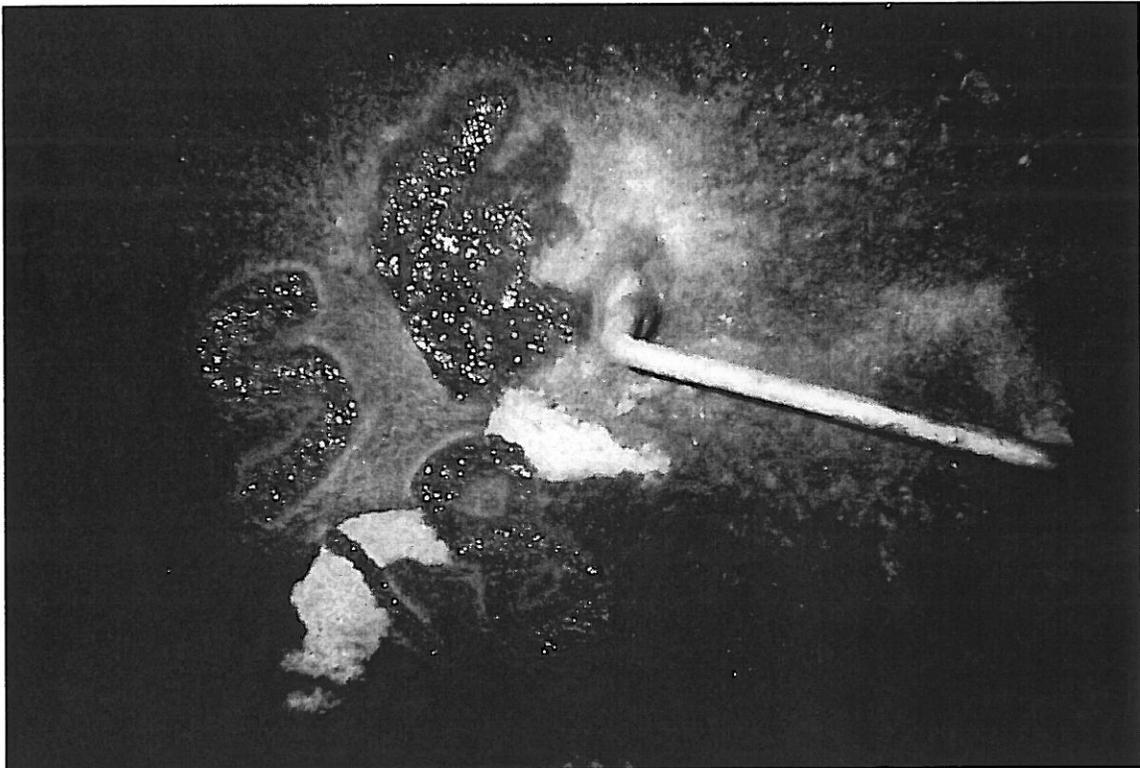
53. Interior surface and step iron - southwest side - elevation 18' above ground level - spalled area in gunite liner.

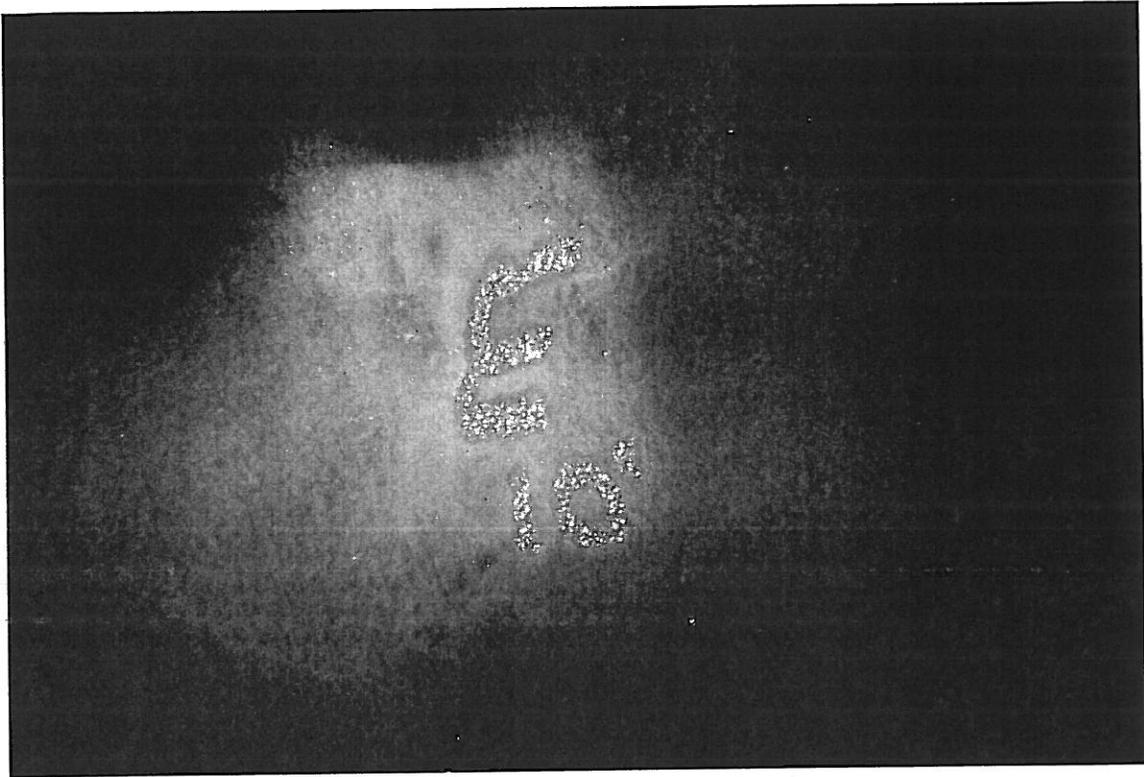
54. Interior surface - east side - elevation 10' above ground level - good condition.

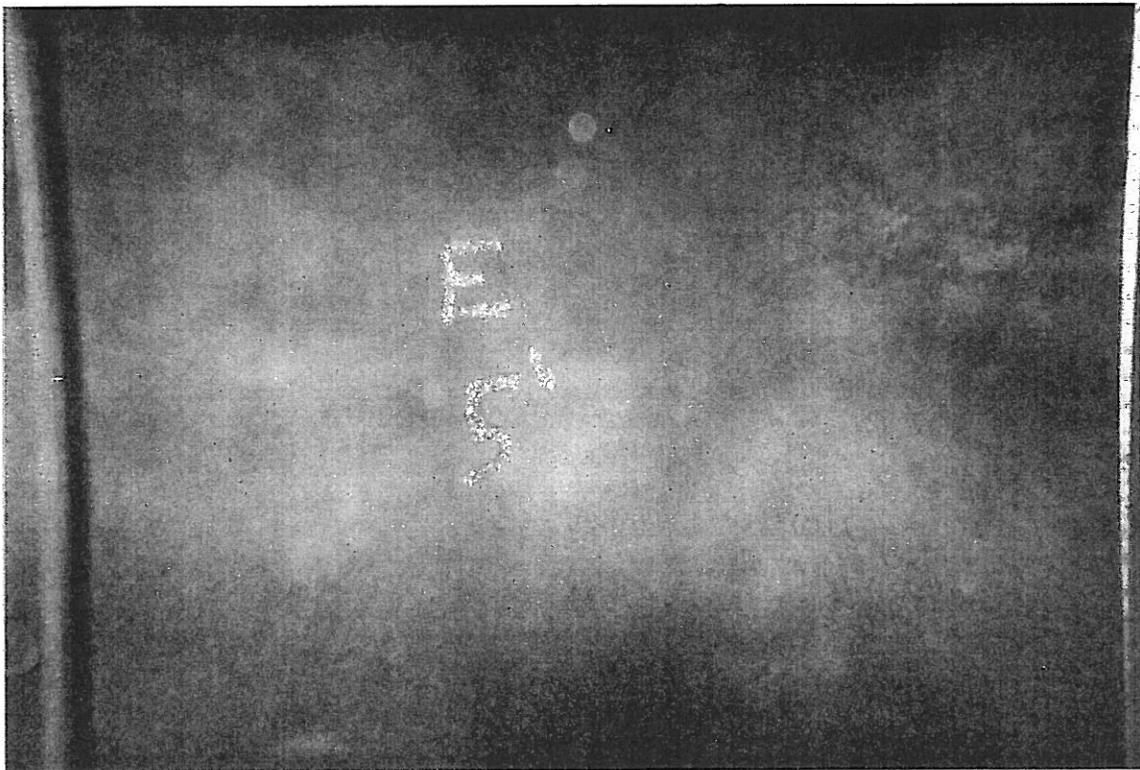
55. Interior surface - east side - elevation 5' above ground level - good condition.

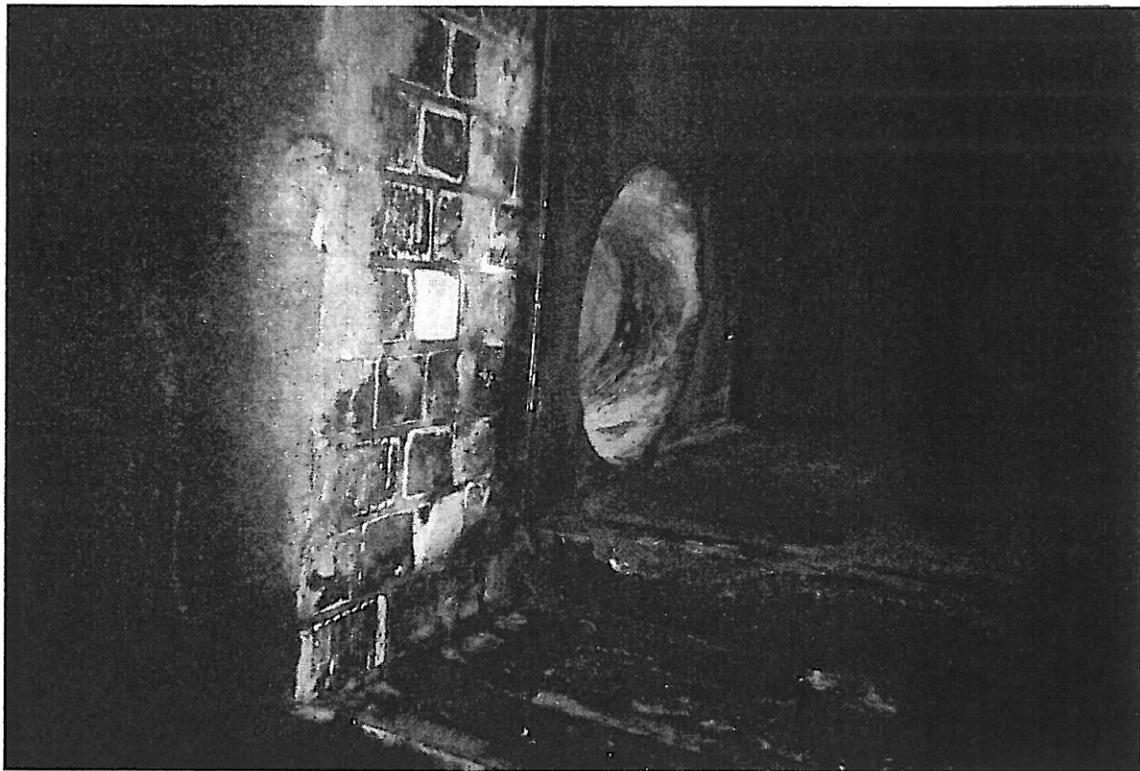
59. Breaching interior and incinerator access east side - elevation 18' above ground level - breaching rusted.
