GERARD CHIMNEY COMPANY

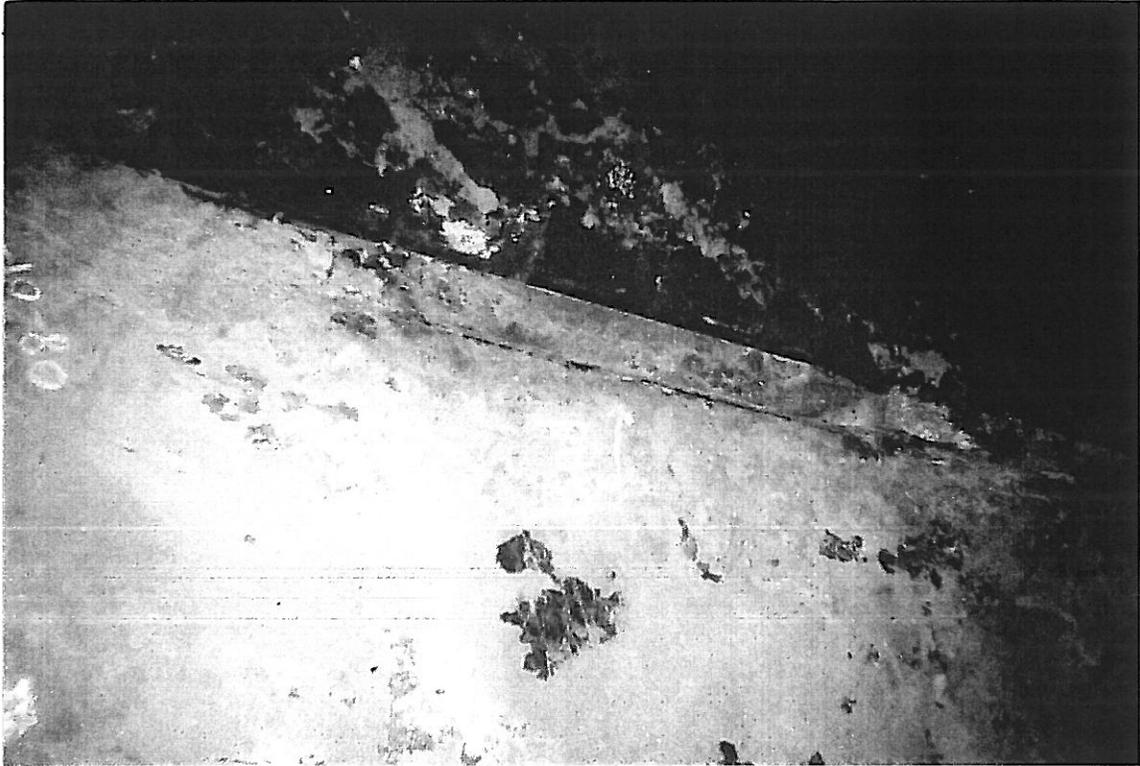
62. Interior surface metal breaching - elevation 18' above ground level - heavy rust.

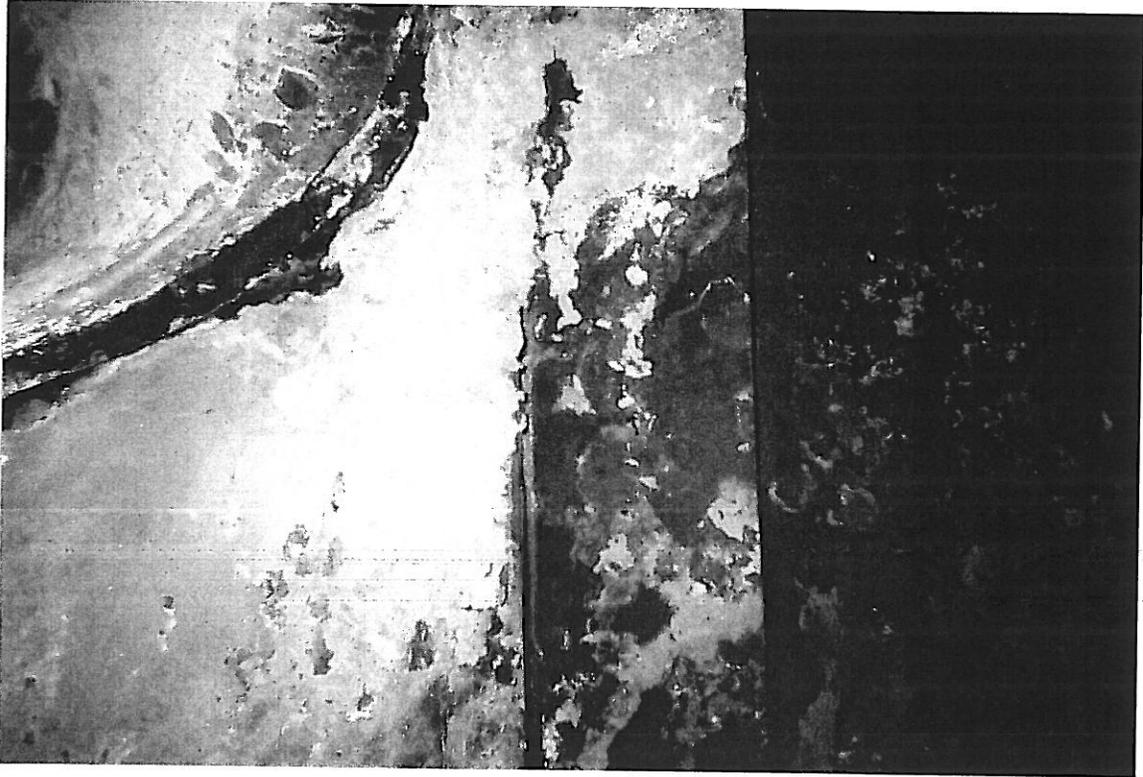
64. Interior surface metal breaching - elevation 18' above ground level - heavy rust.

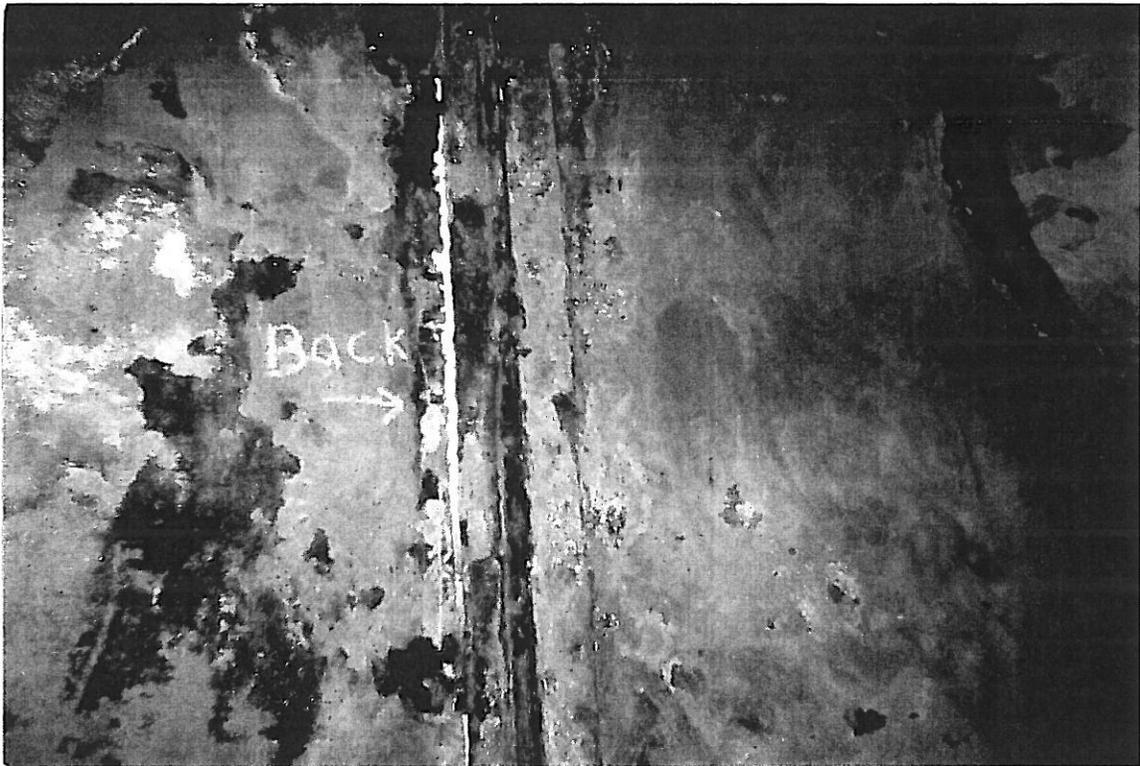
66. Interior surface metal breaching - elevation 18' above ground level - heavy rust - weld seam cracked.

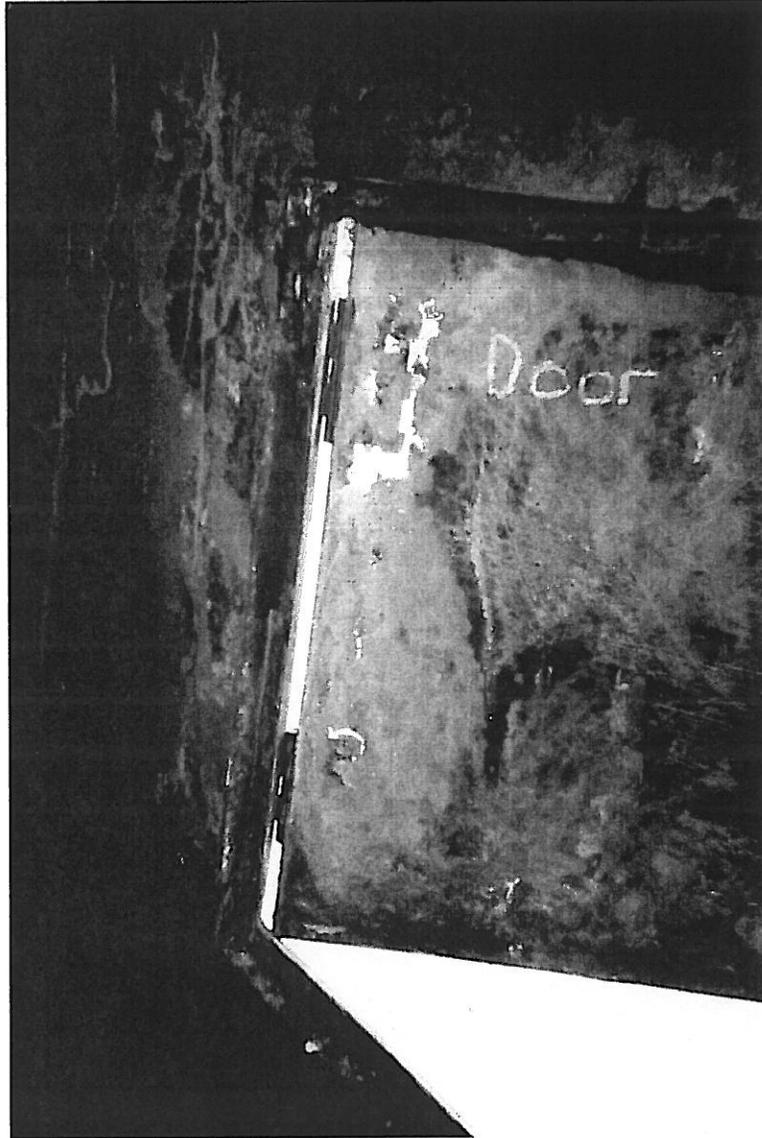
67. Interior surface metal breaching and access door - north side - elevation 18' above ground level - heavy rust.

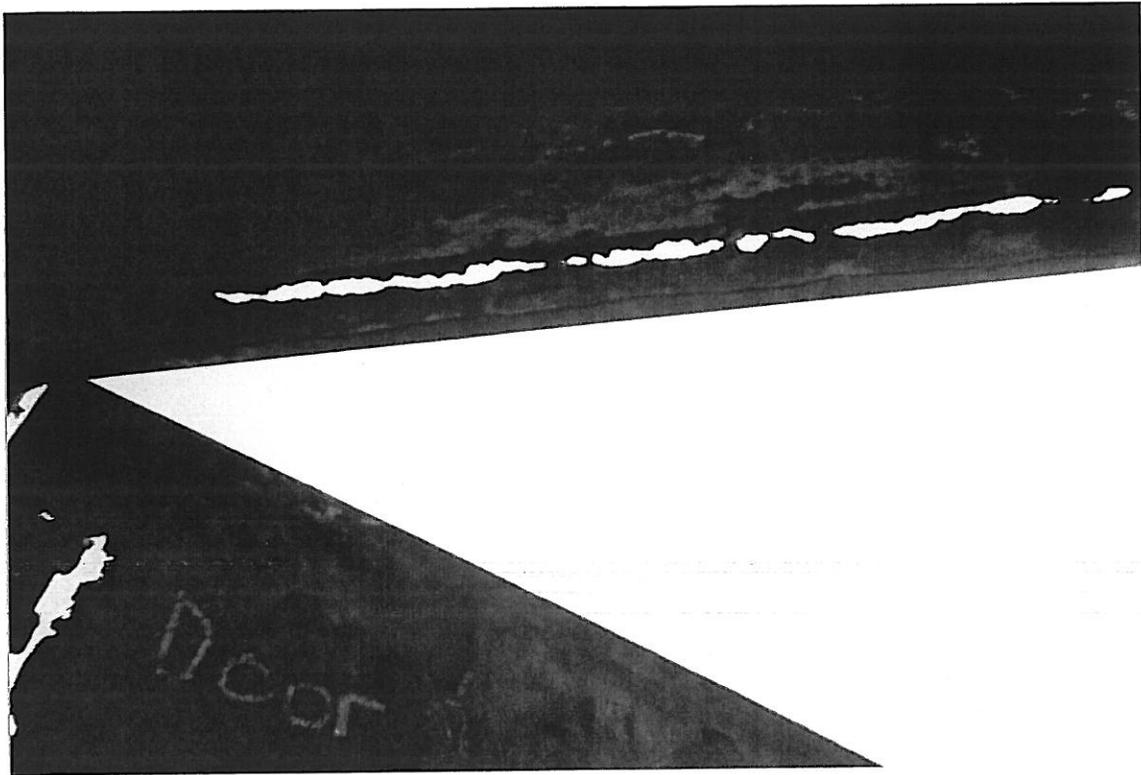
68. Interior surface, metal breaching and access door - north side - elevation 18' above ground level - heavy rust - weld seam rusted through.

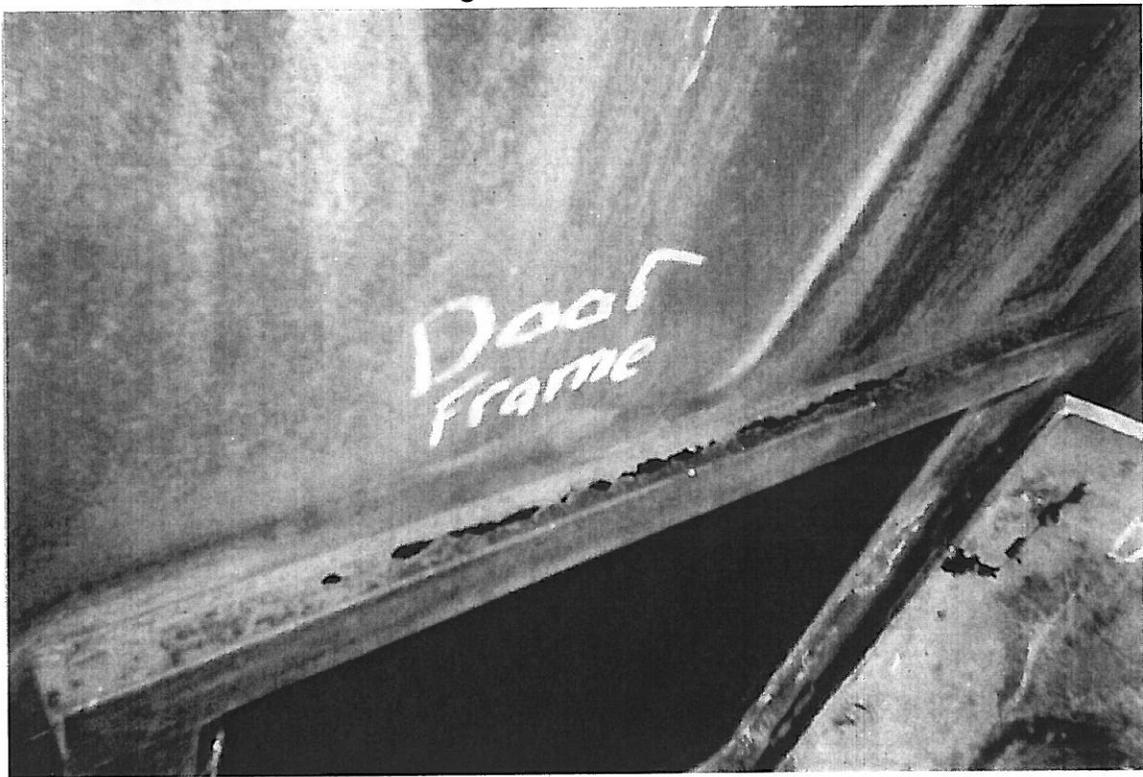
69. Exterior surface metal breaching and access door - north side - elevation 18' above ground level - weld seam rusted through - heavy rust.

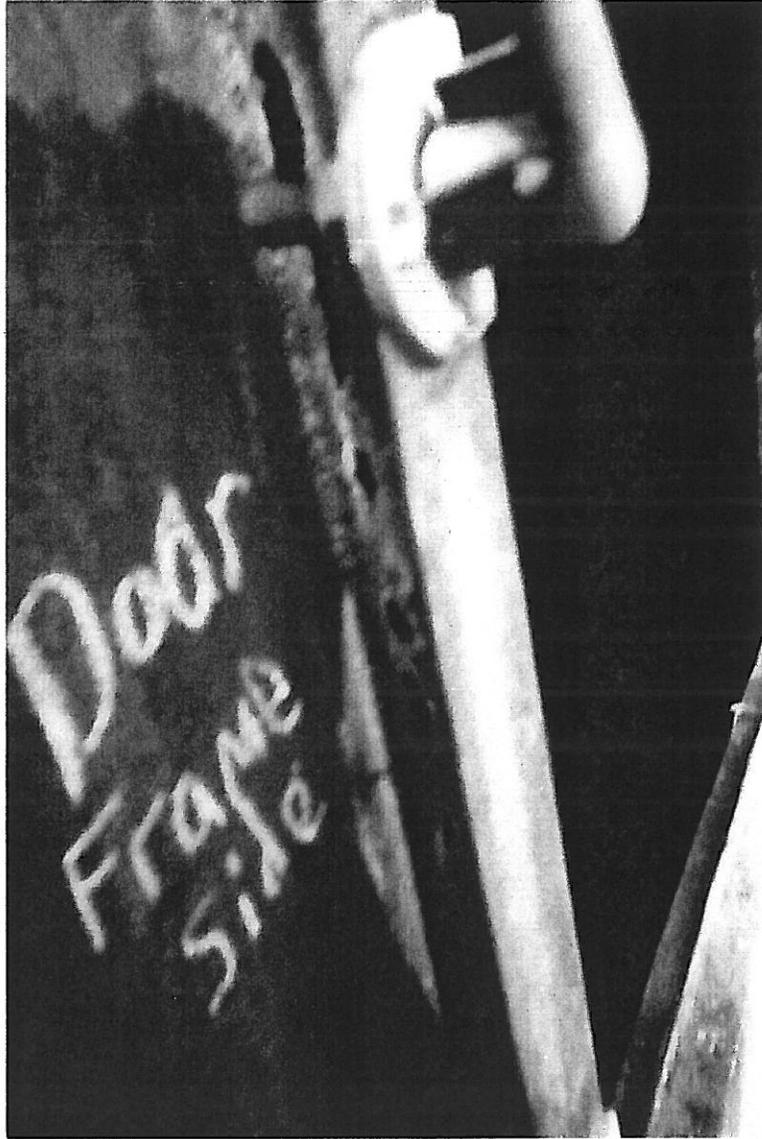
70. Breaching access door - north side - elevation 18' above ground level - heavy rust - frame rusted through

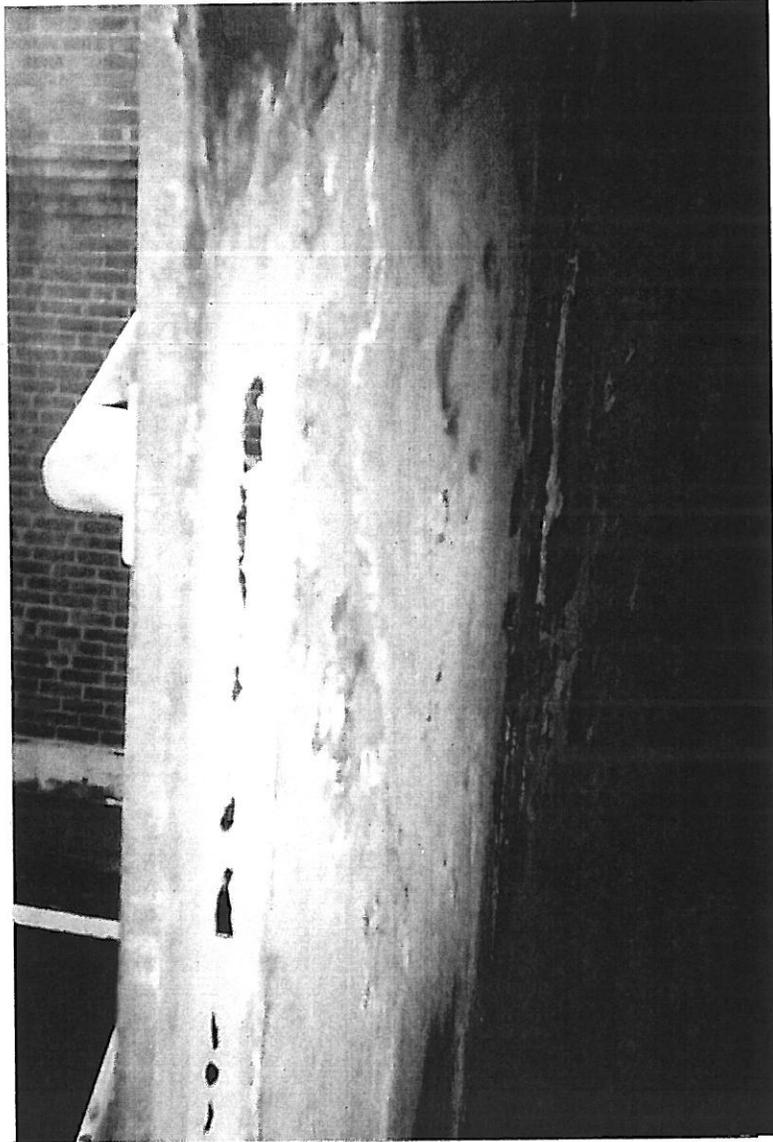
71. Breaching access door - north side -
elevation 18' above ground level -
heavy rust - frame rusted through

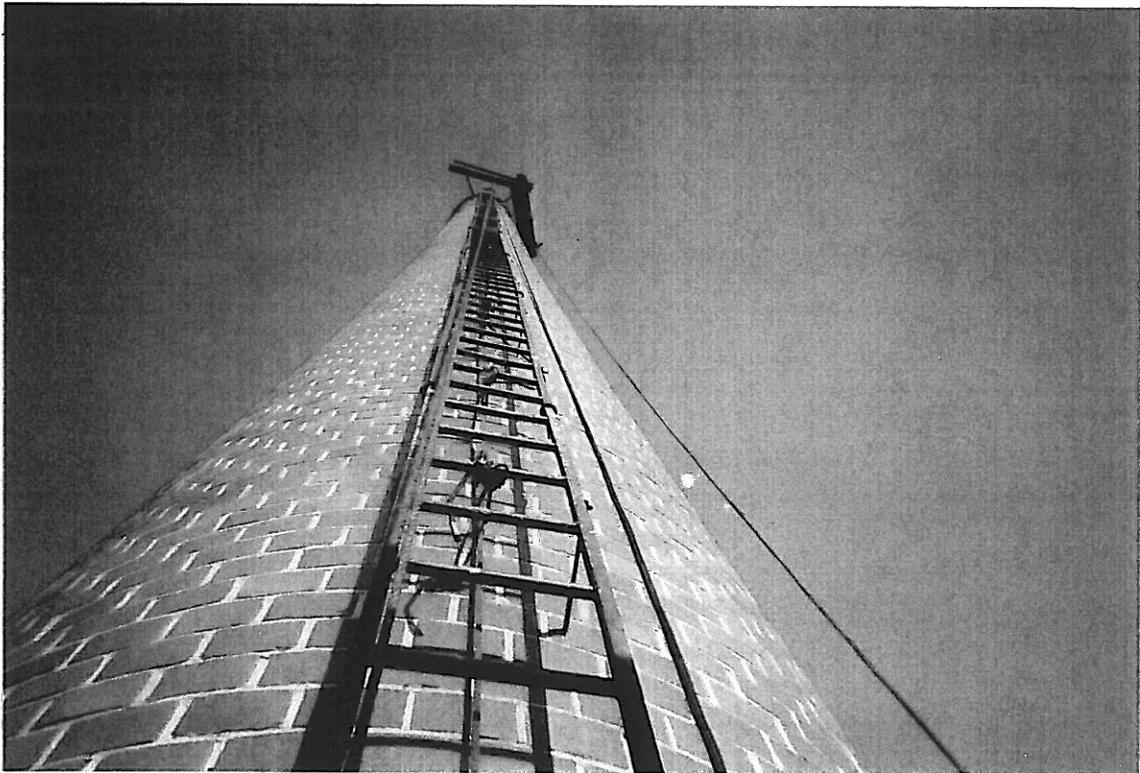
73. Exterior surface - full view from base - good condition.

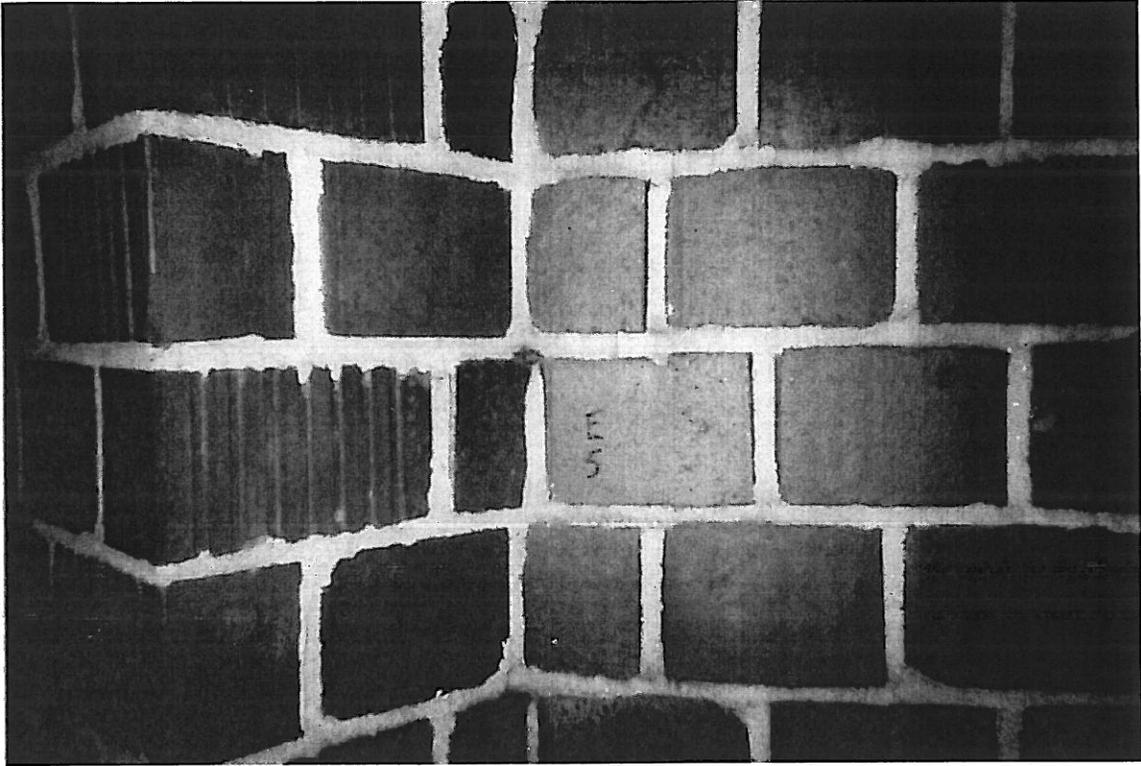
74. Exterior surface - east side - elevation 5' above ground level - good condition.

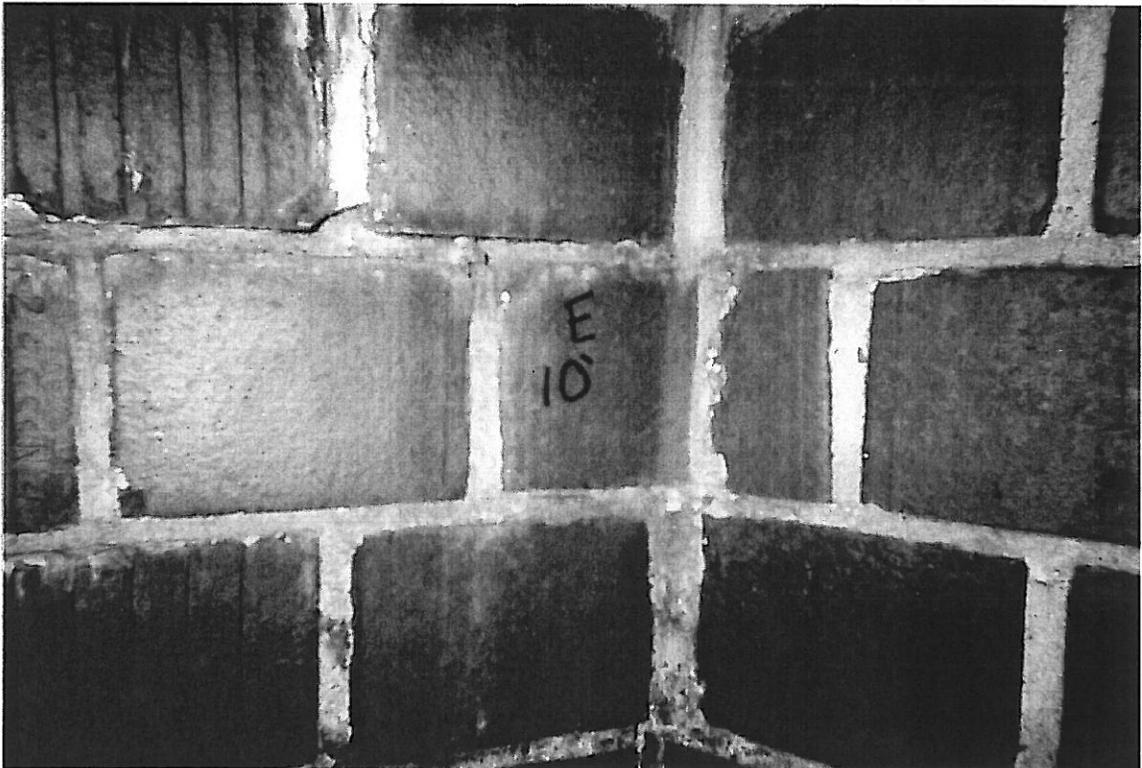
75. Exterior surface - east side - elevation 10' above ground level - good condition.

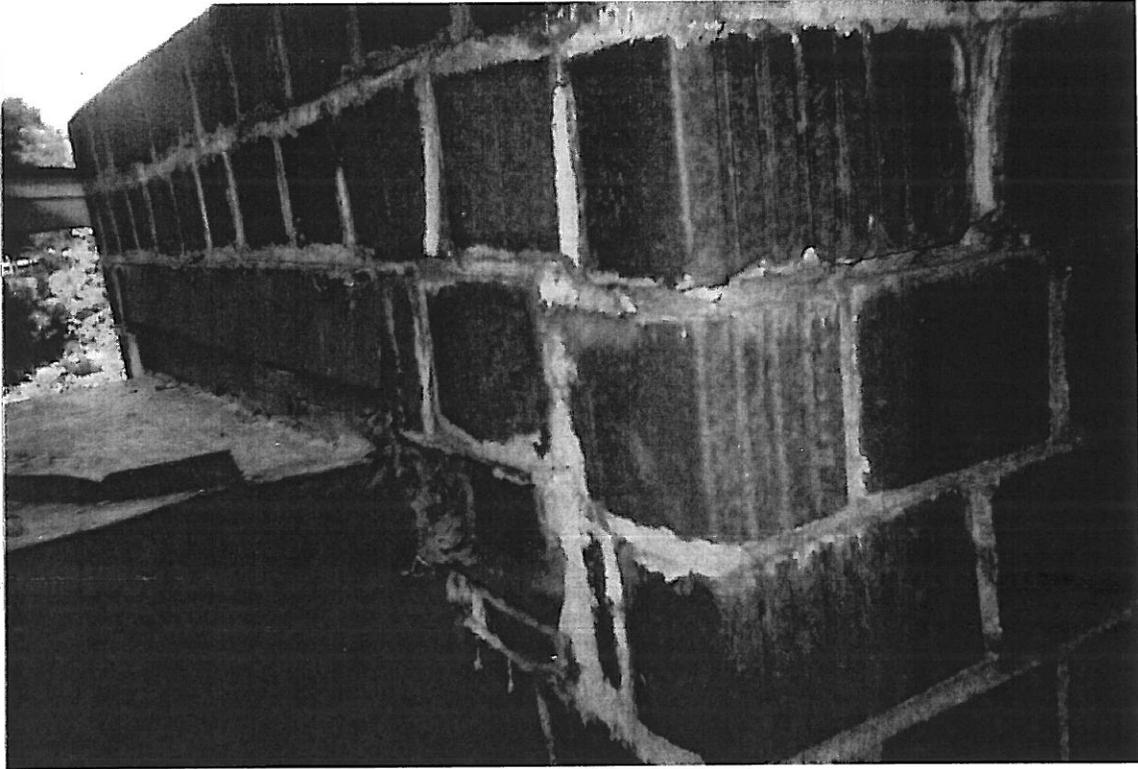
76. Exterior surface and breeching entry - east side - elevation 15' above ground level - good condition.

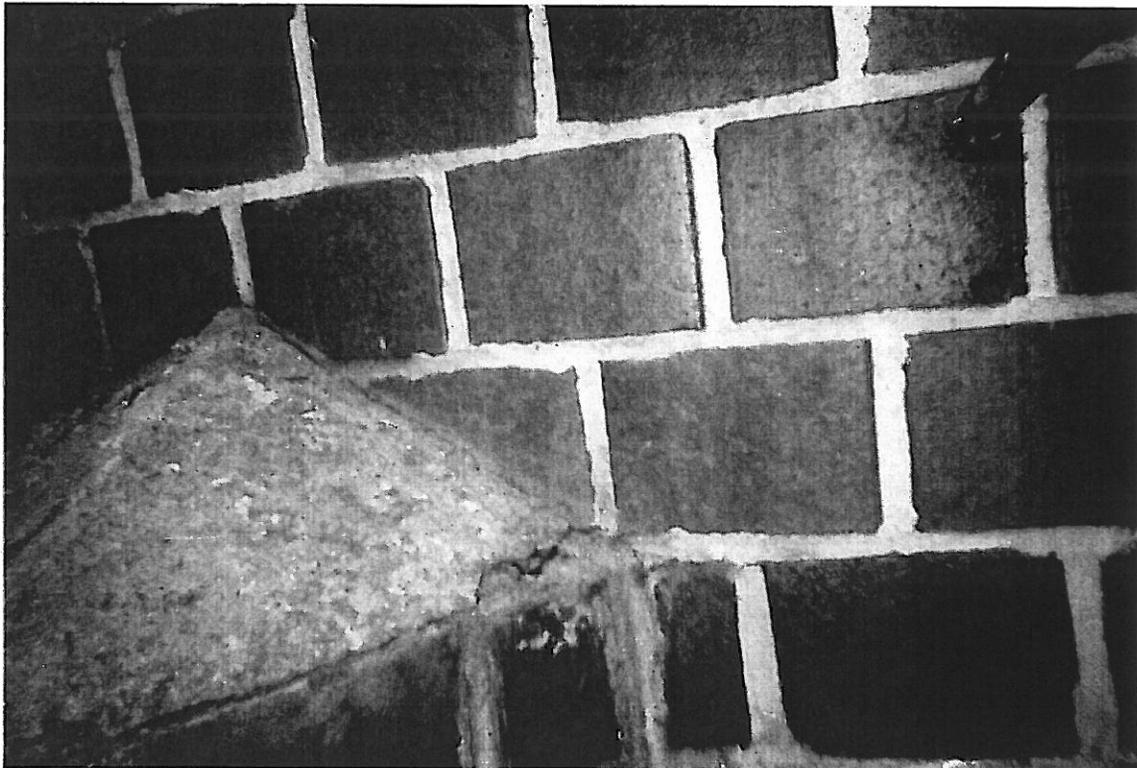
77. Exterior surface and watertable - east side - elevation 20' above ground level - good condition.

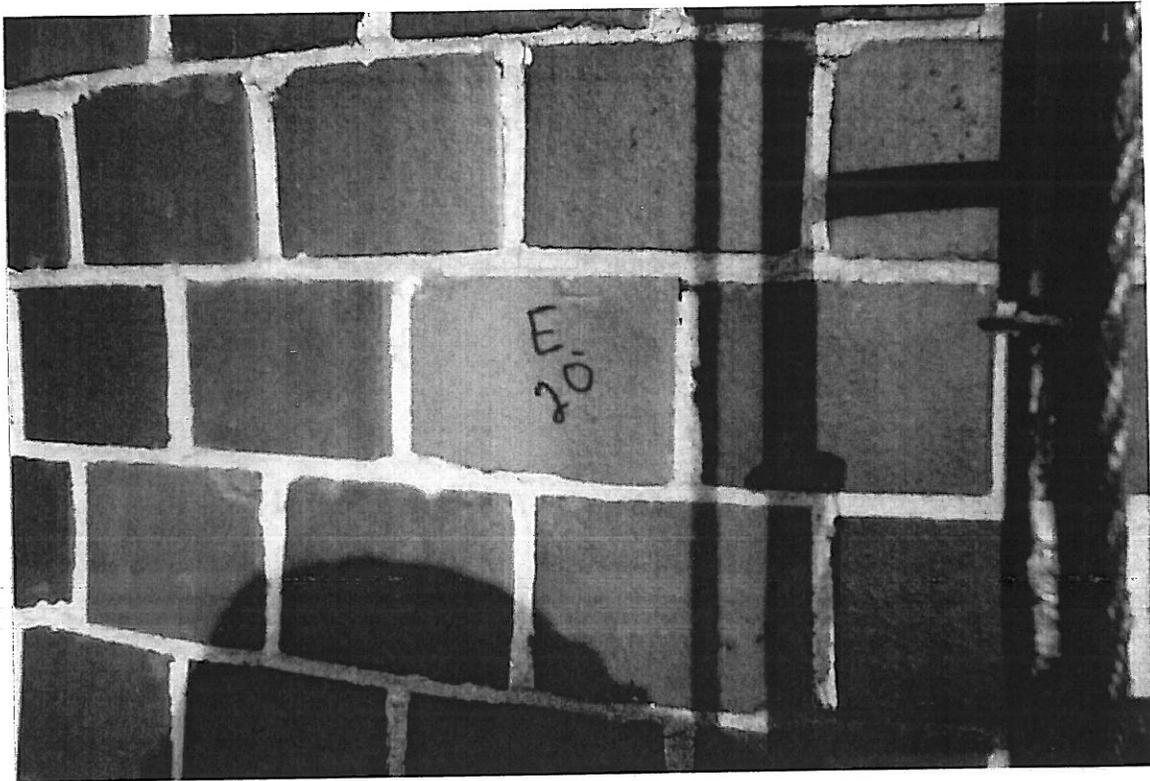
78. Exterior surface - east side - elevation 20' above ground level - good condition.

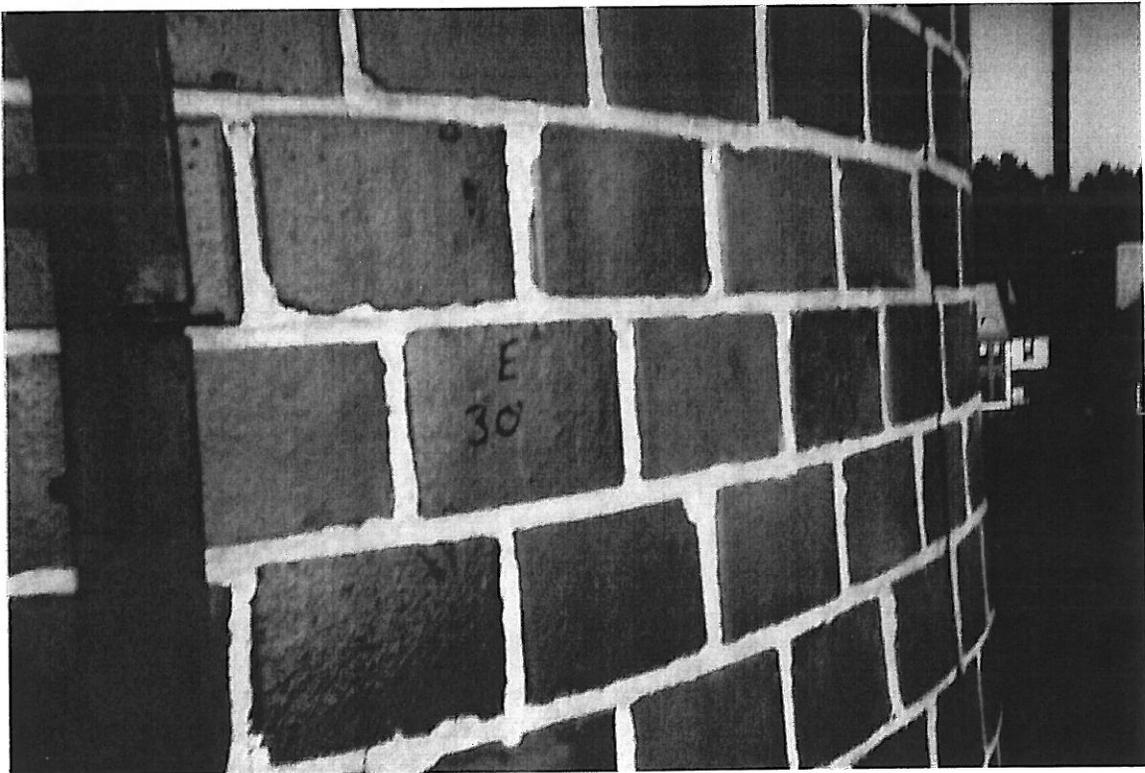
79. Exterior surface - east side - elevation 30' above ground level - good condition.

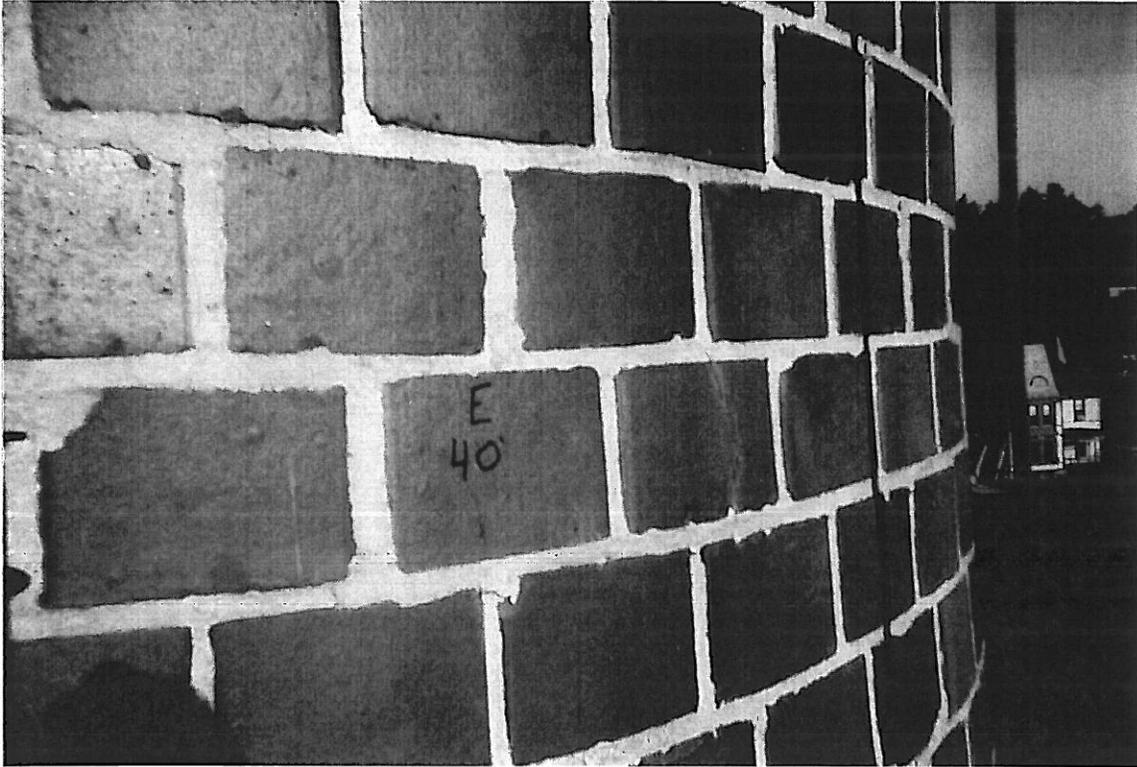
80. Exterior surface - east side - elevation 40' above ground level - good condition.

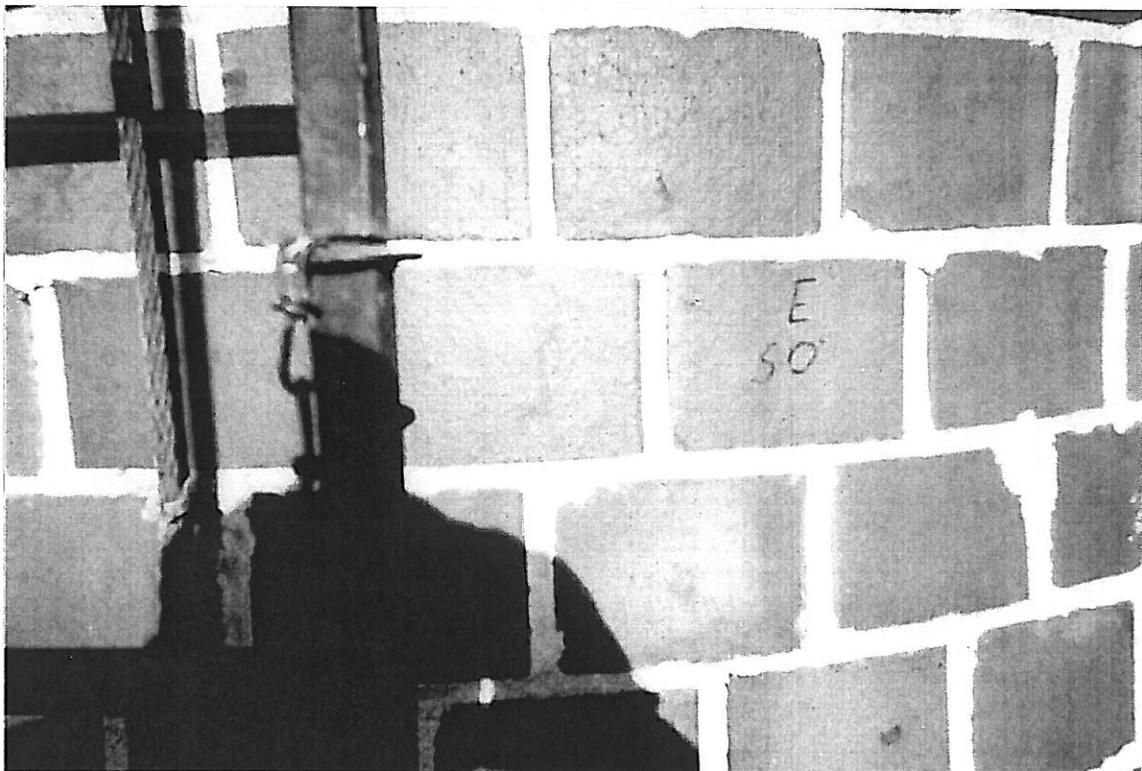
81. Exterior surface and downlead - east side - elevation 50' above ground level - good condition.

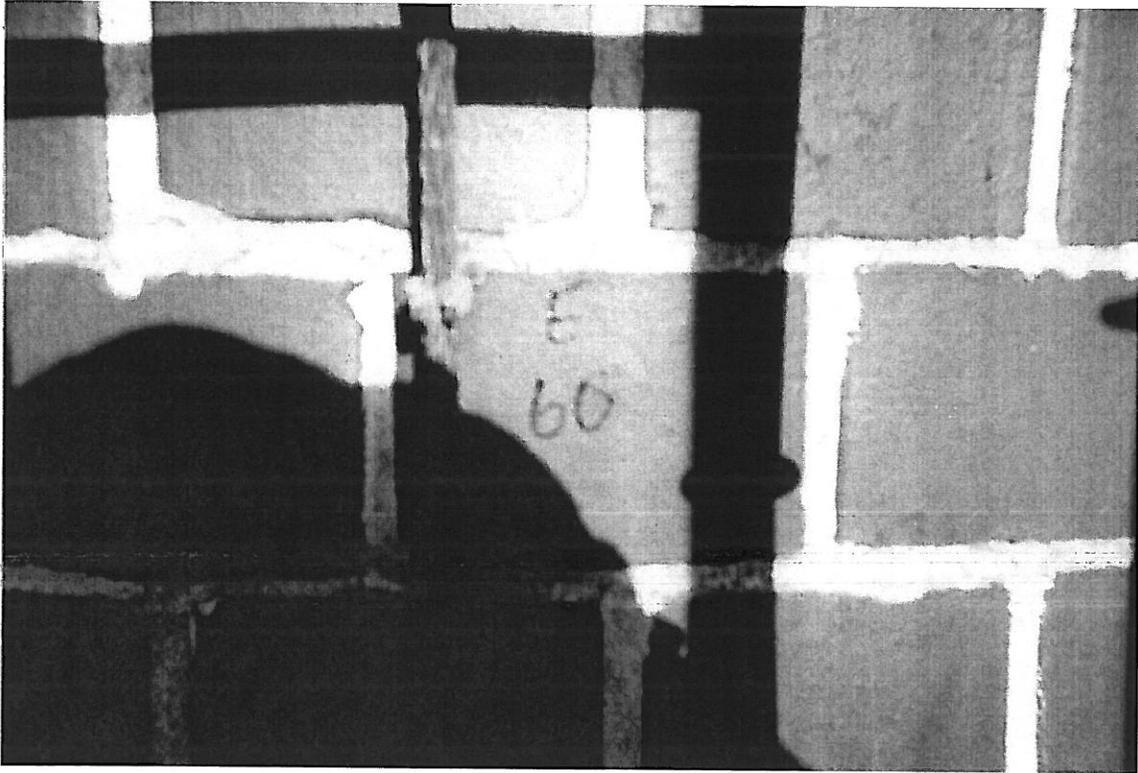
82. Exterior surface and downlead - east side - elevation 60' above ground level - good condition.

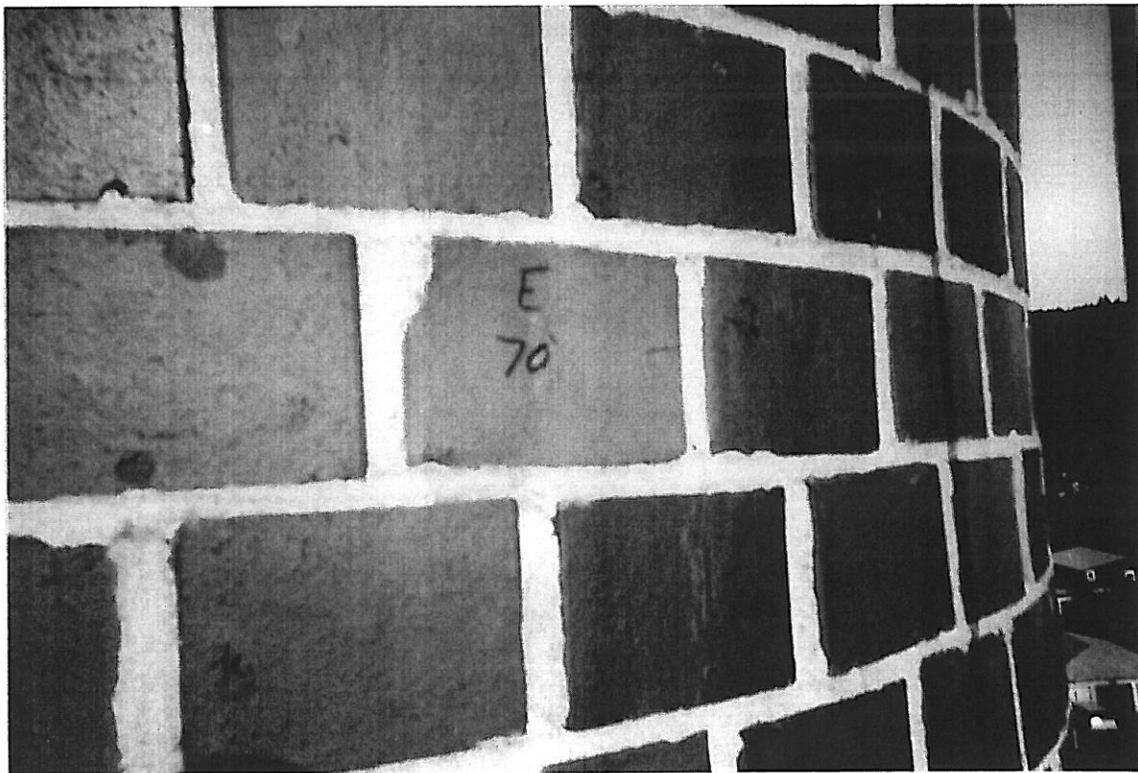
83. Exterior surface - east side - elevation 70' above ground level - good condition.

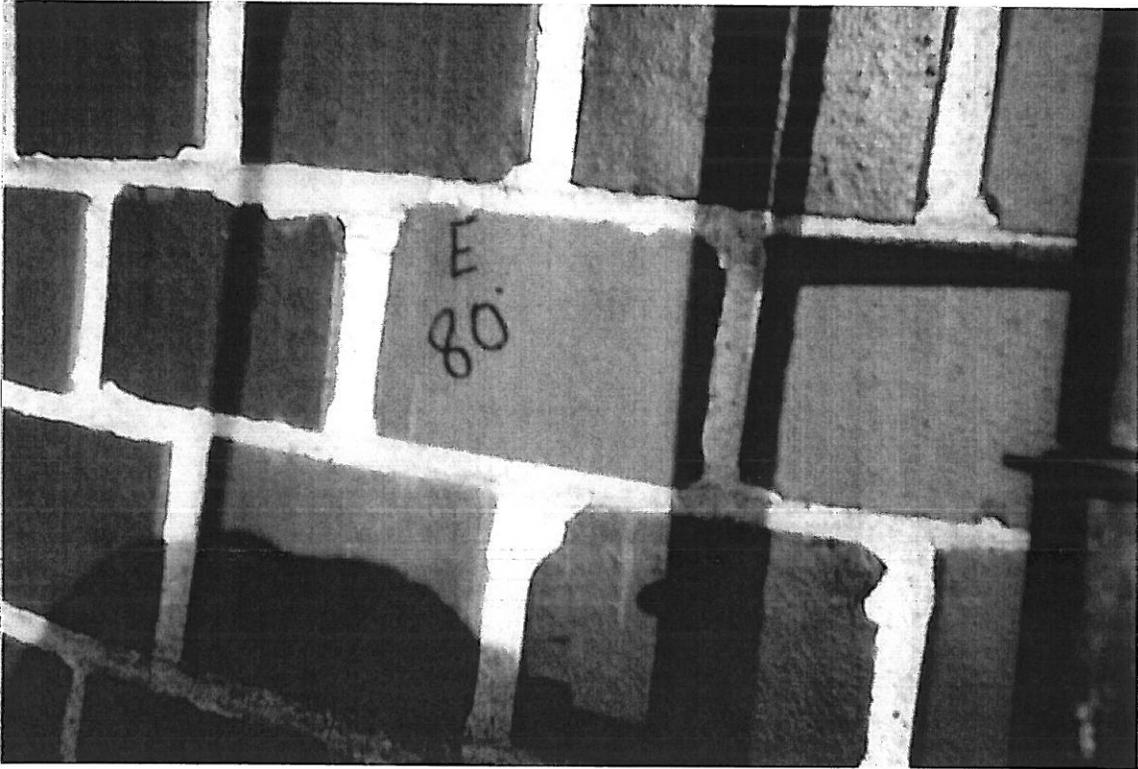
84. Exterior surface - east side - elevation 80' above ground level - good condition.

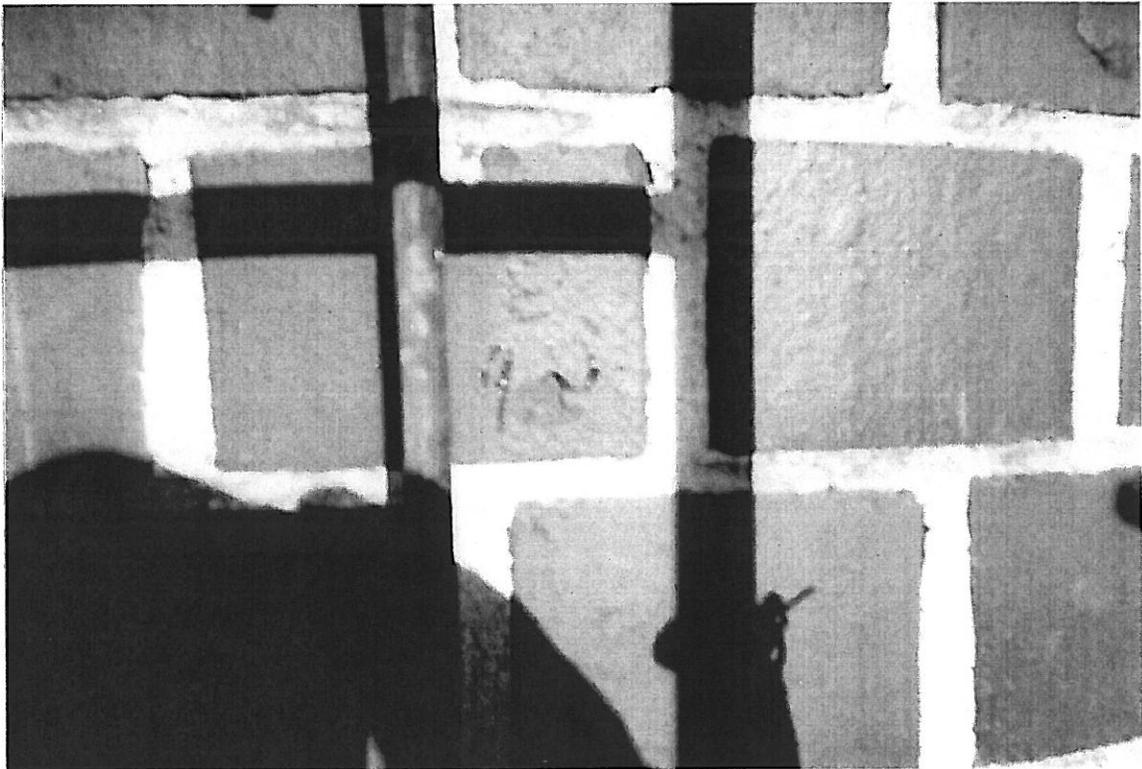
85. Exterior surface and downlead - east side - elevation 90' above ground level - good condition.
