GERARD CHIMNEY COMPANY

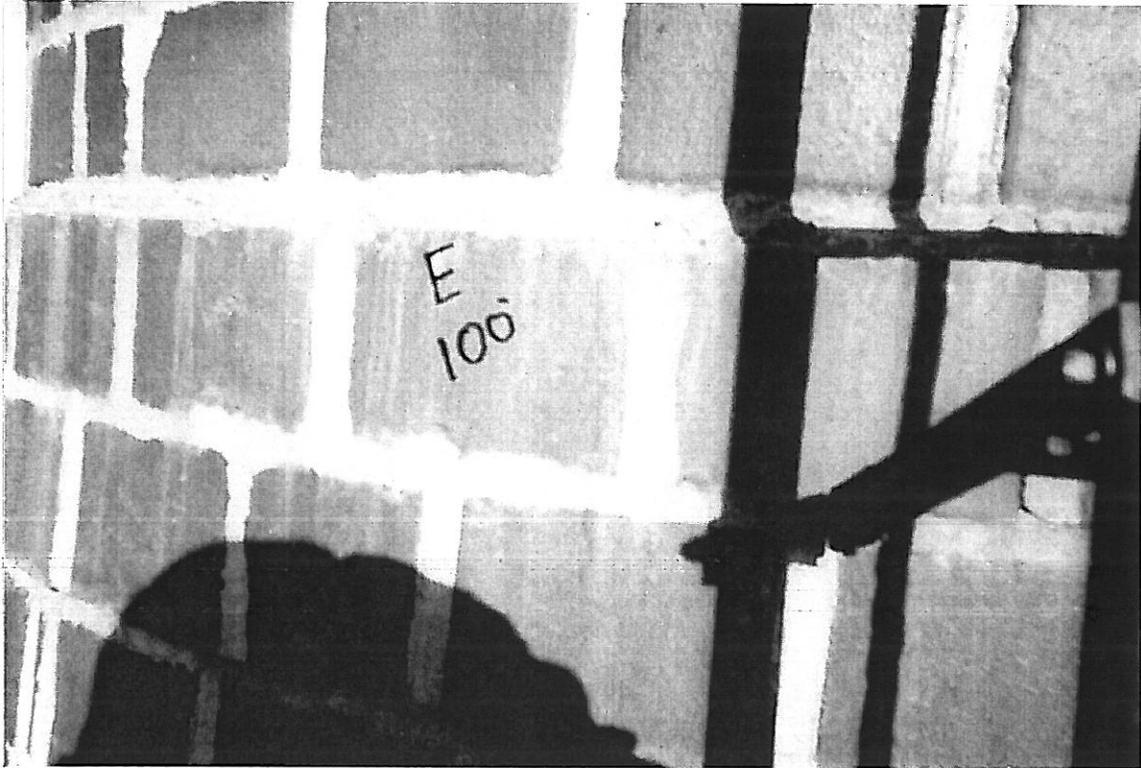
86. Exterior surface - east side - elevation 100' above ground level - good condition.

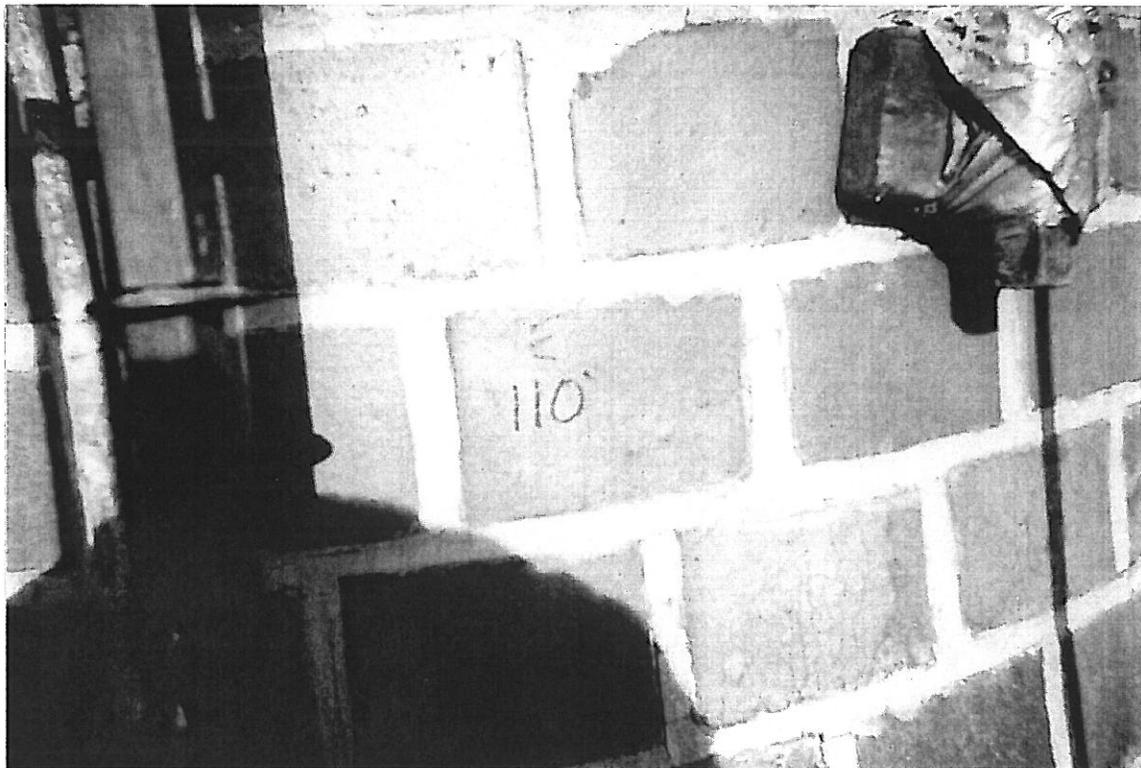
87. Exterior surface - east side - elevation 110' above ground level - good condition.

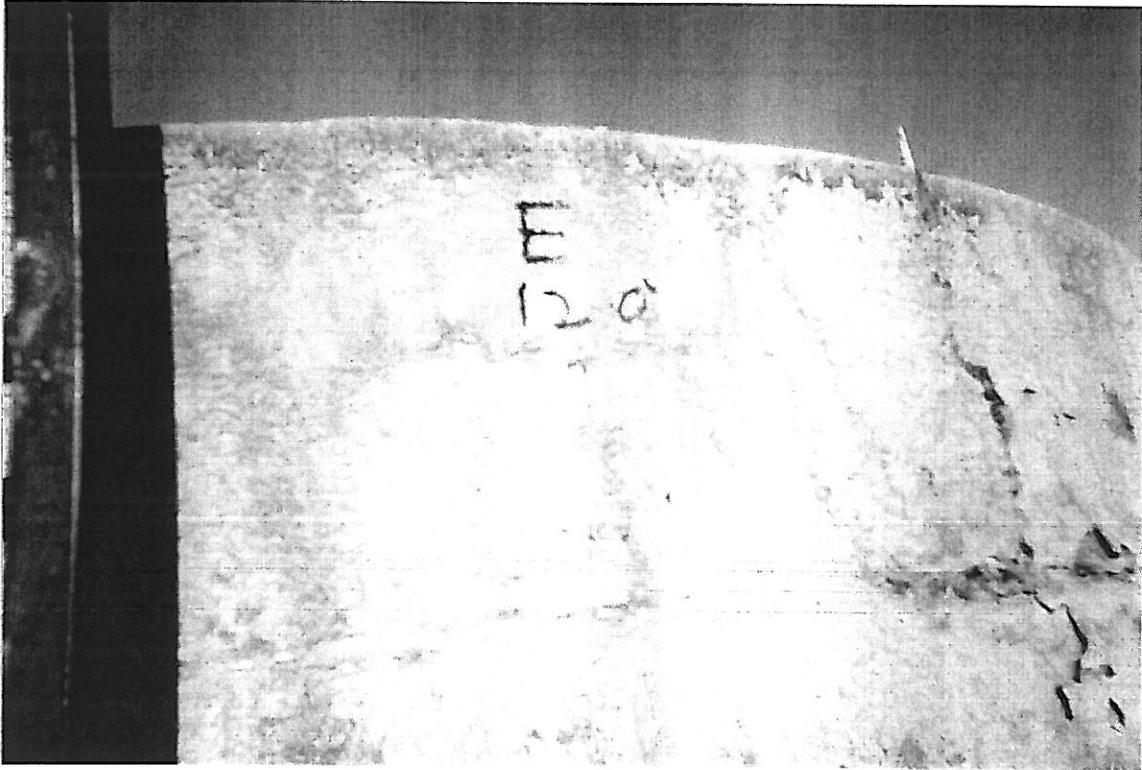
88. Exterior surface and formed concrete cap - east side - elevation 120' above ground level - good condition.

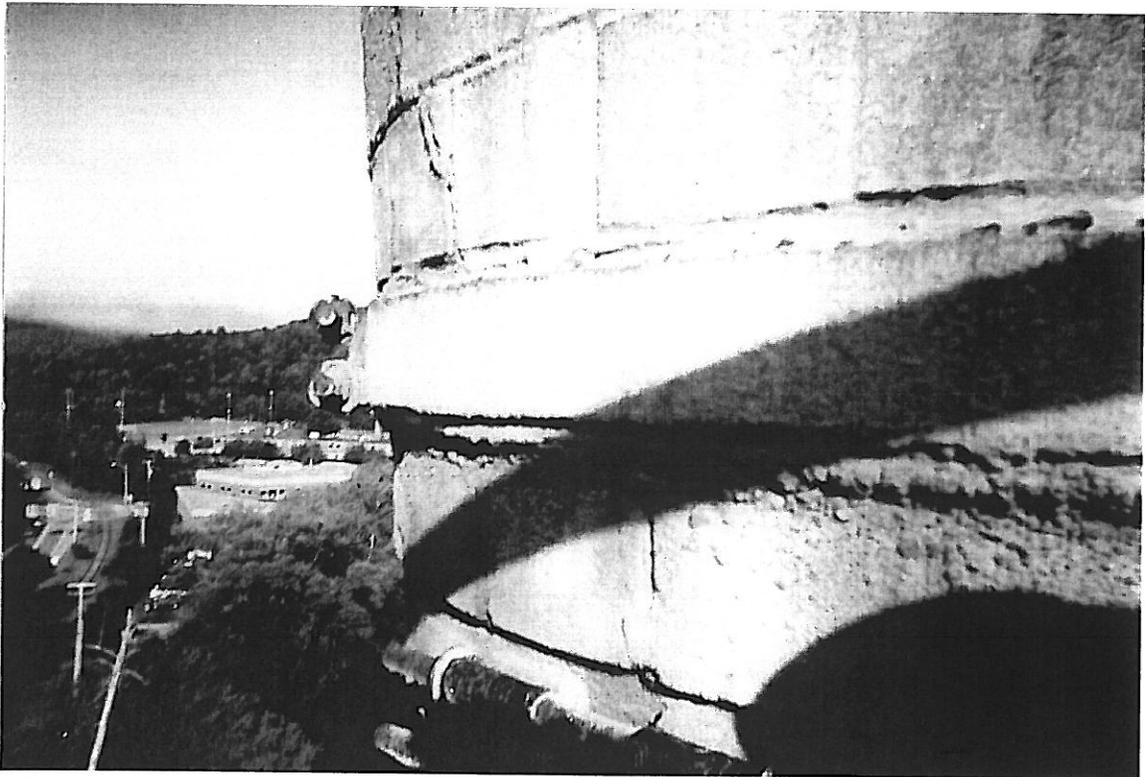
89. Exterior surface and steel tension band - north side - elevation 118' above ground level - mortar joint crack.

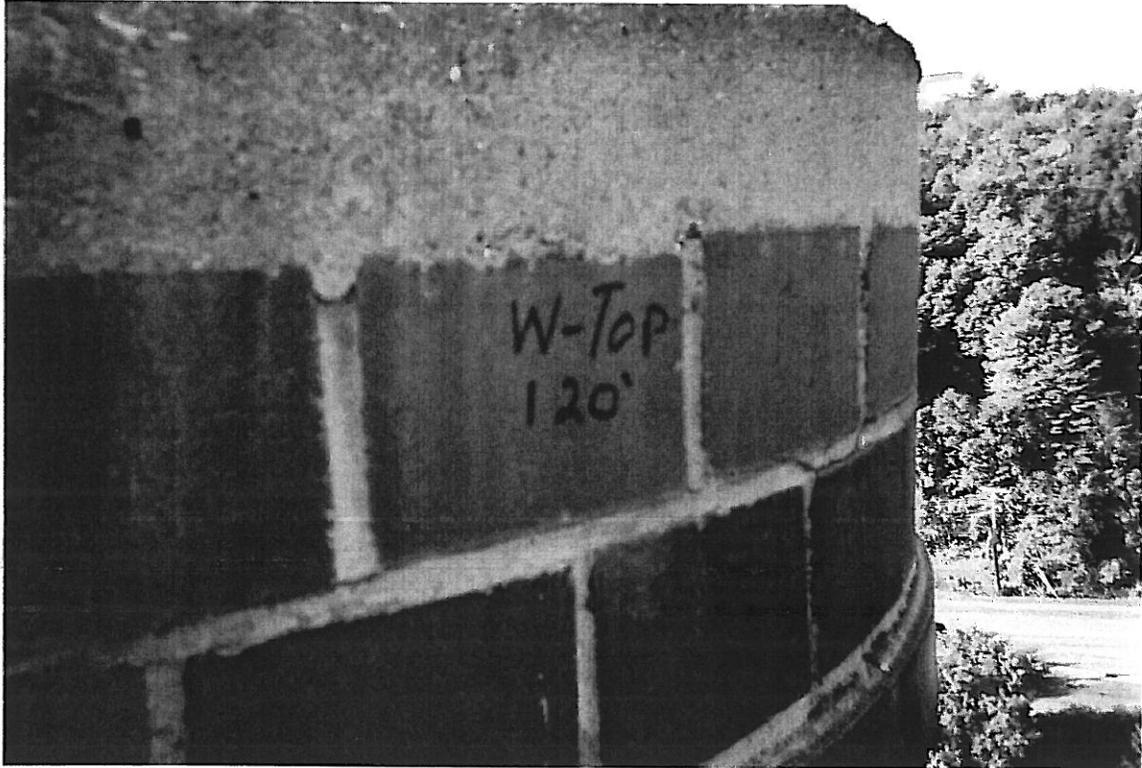
90. Exterior surface and formed concrete cap - west side - elevation 120' above ground level - mortar joint cracked and worn.

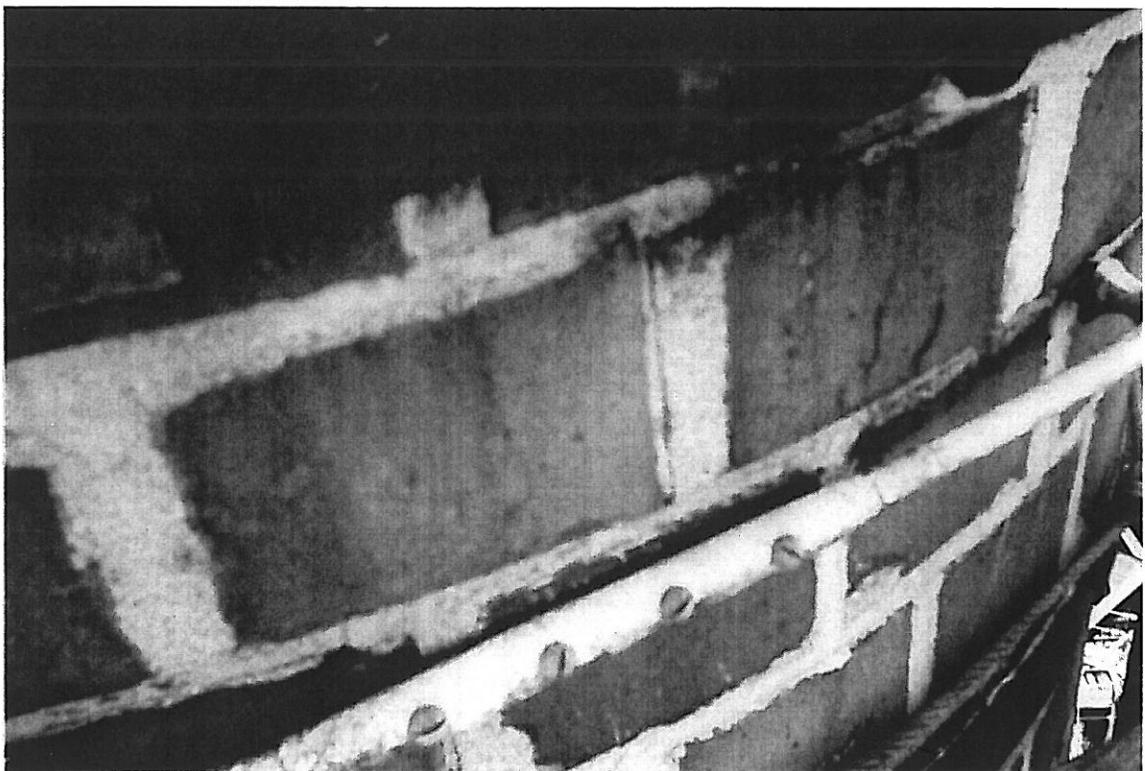
91. Exterior surface, steel tension band, and top encircling cable - south side - elevation 120' above ground level - steel tension band rusty - shell good condition.

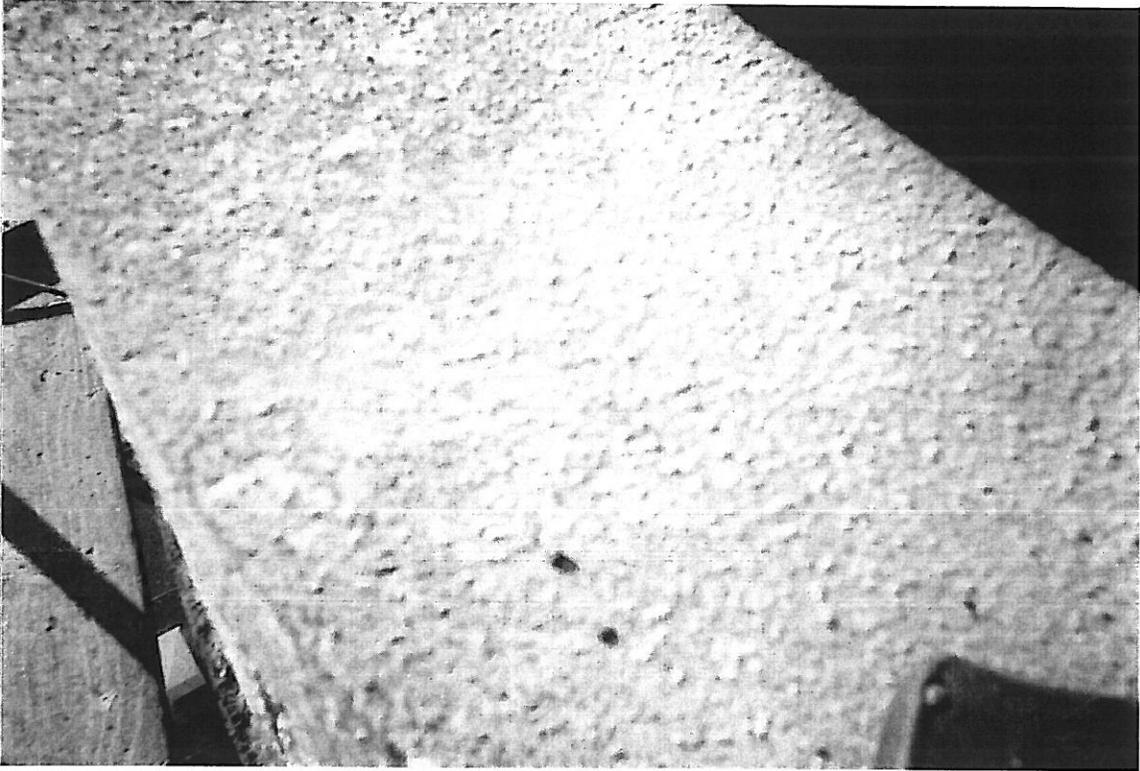
92. Formed concrete cap - top of chimney - cap worn and weathered.

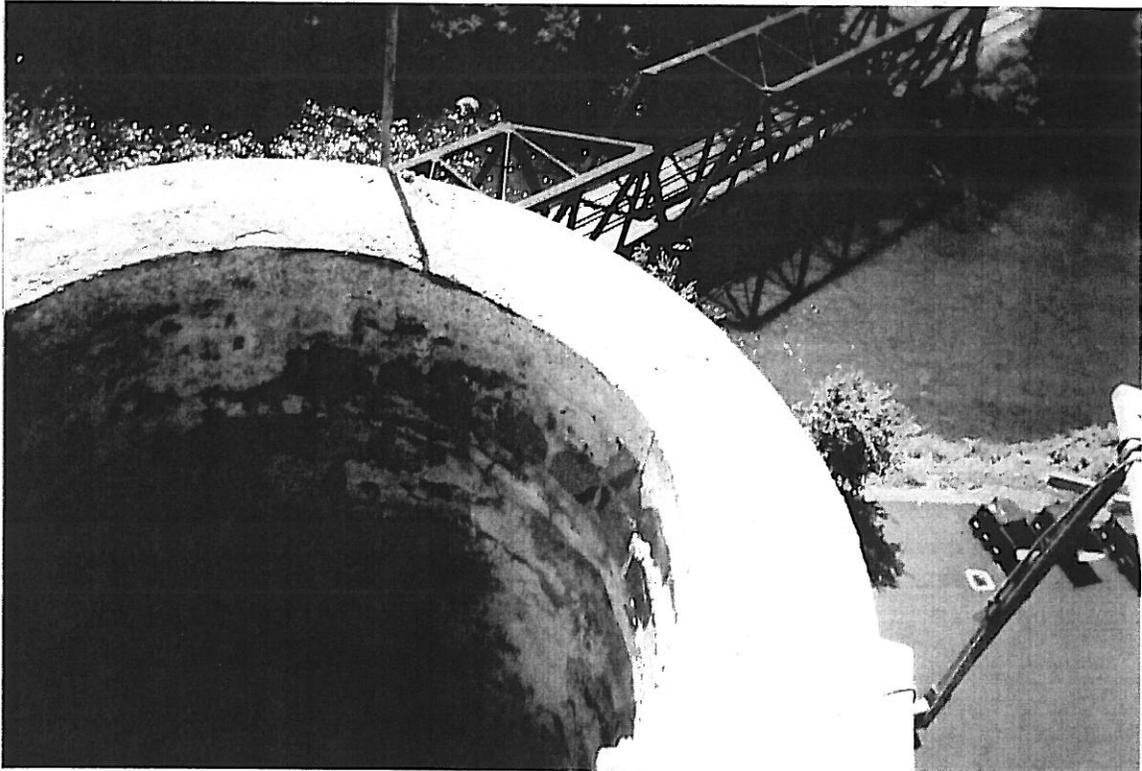
93. Formed concrete cap, air terminal, and interior surface - top of chimney - cap worn and weathered.

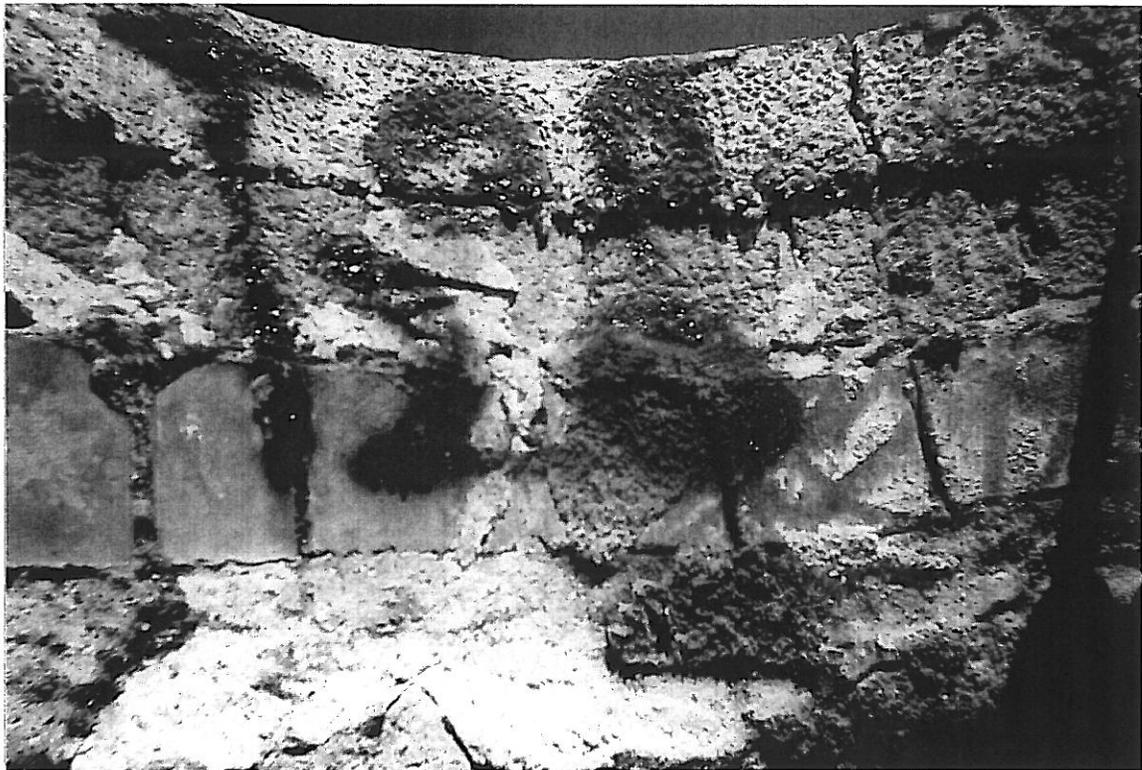
95. Interior surface - north side - elevation 120' above ground level - mortar joints cracked and missing.

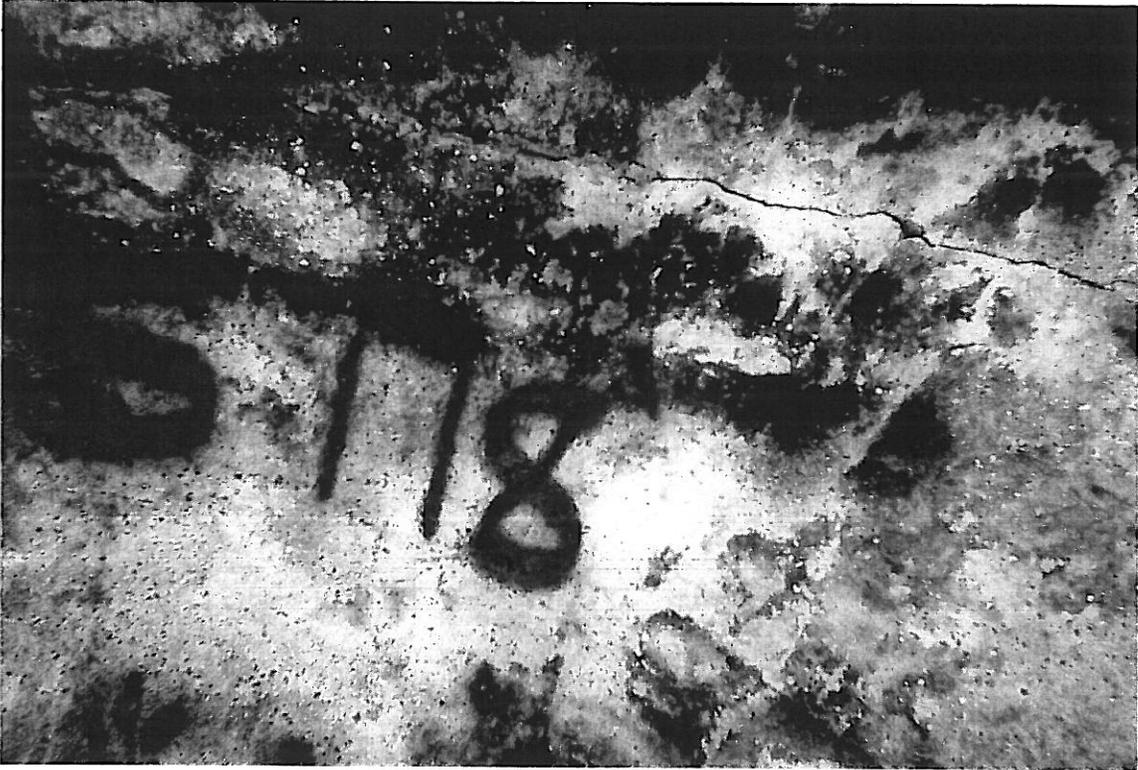
96. Exterior surface - south side - elevation 118' above ground level - 1/4" wide crack in gunite liner.

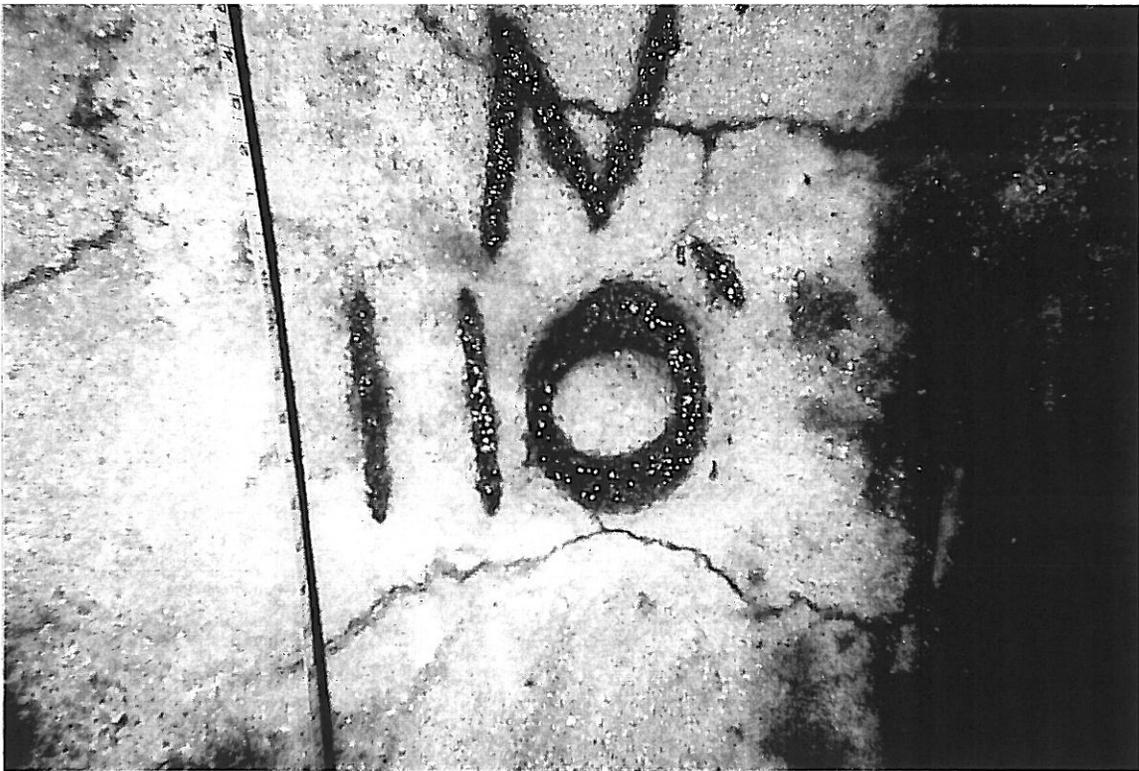
97. Interior surface - north side - elevation 110' above ground level - hairline crack in gunite liner.

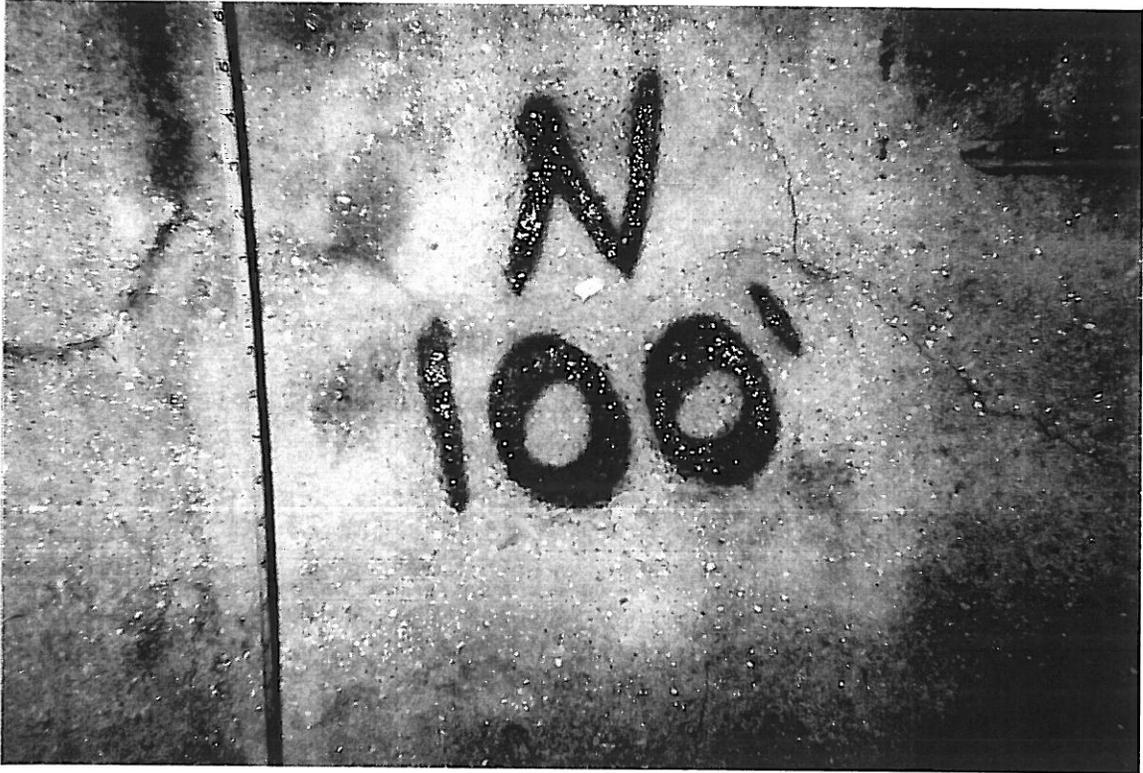
98. Interior surface - north side - elevation 100' above ground level - hairline crack in gunite liner.

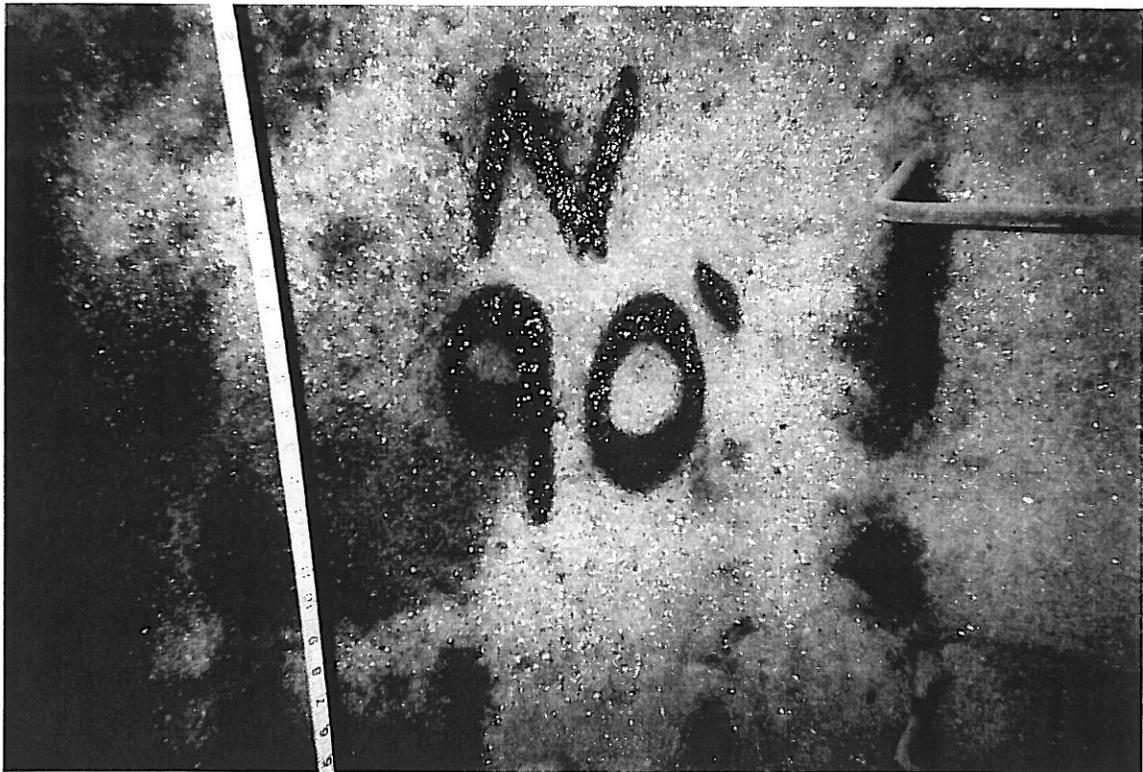
99. Interior surface - north side elevation 90' above ground level - good condition.

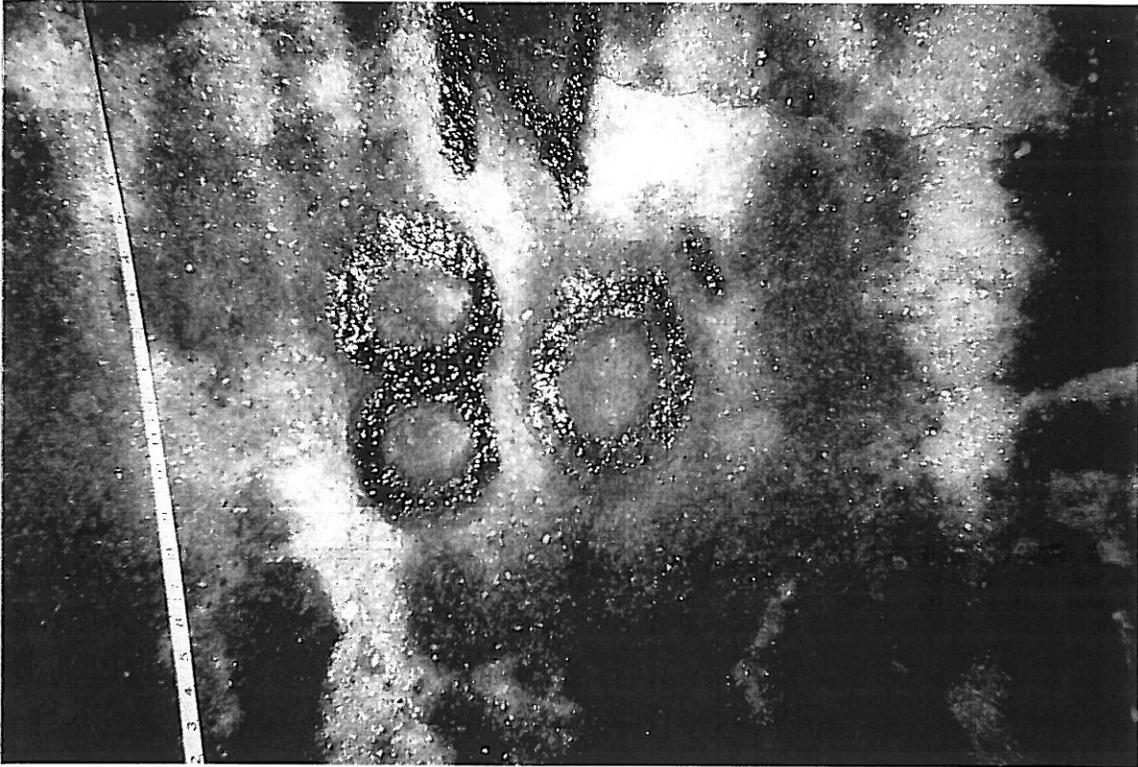
100. Interior surface - north side elevation 80' above ground level - good condition.

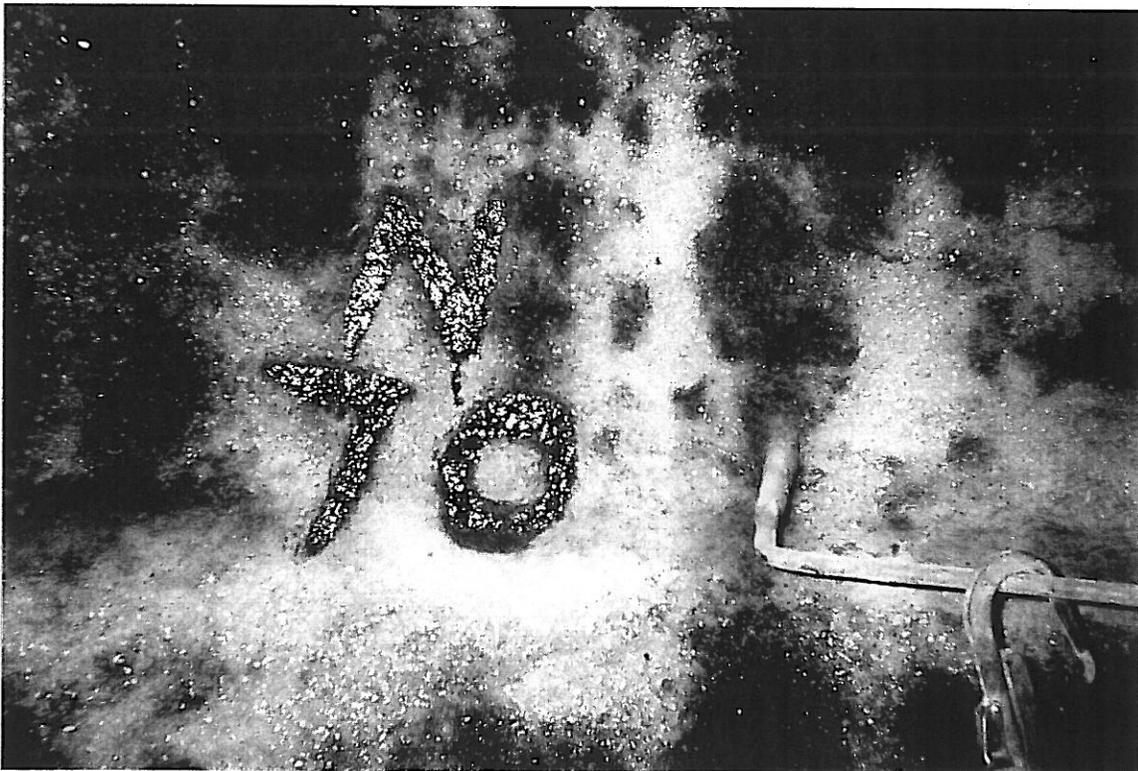
101. Interior surface - north side elevation 70' above ground level - good condition.

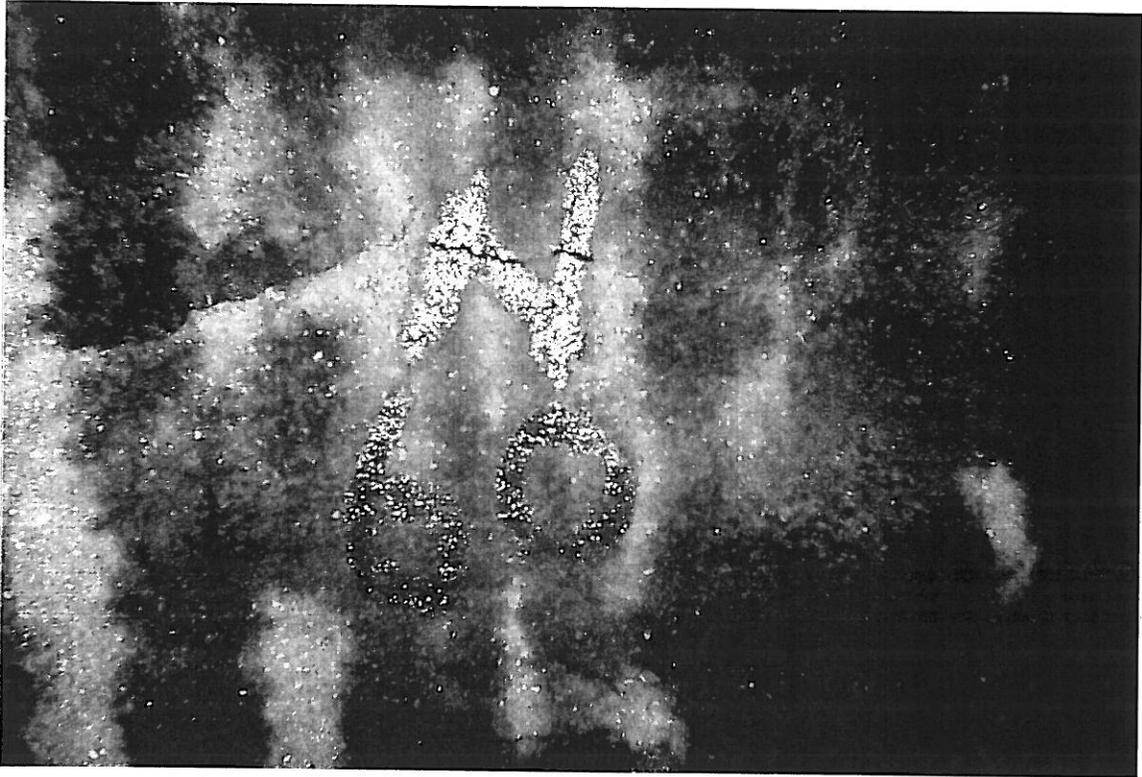
102. Interior surface - north side elevation 60' above ground level - hairline crack.

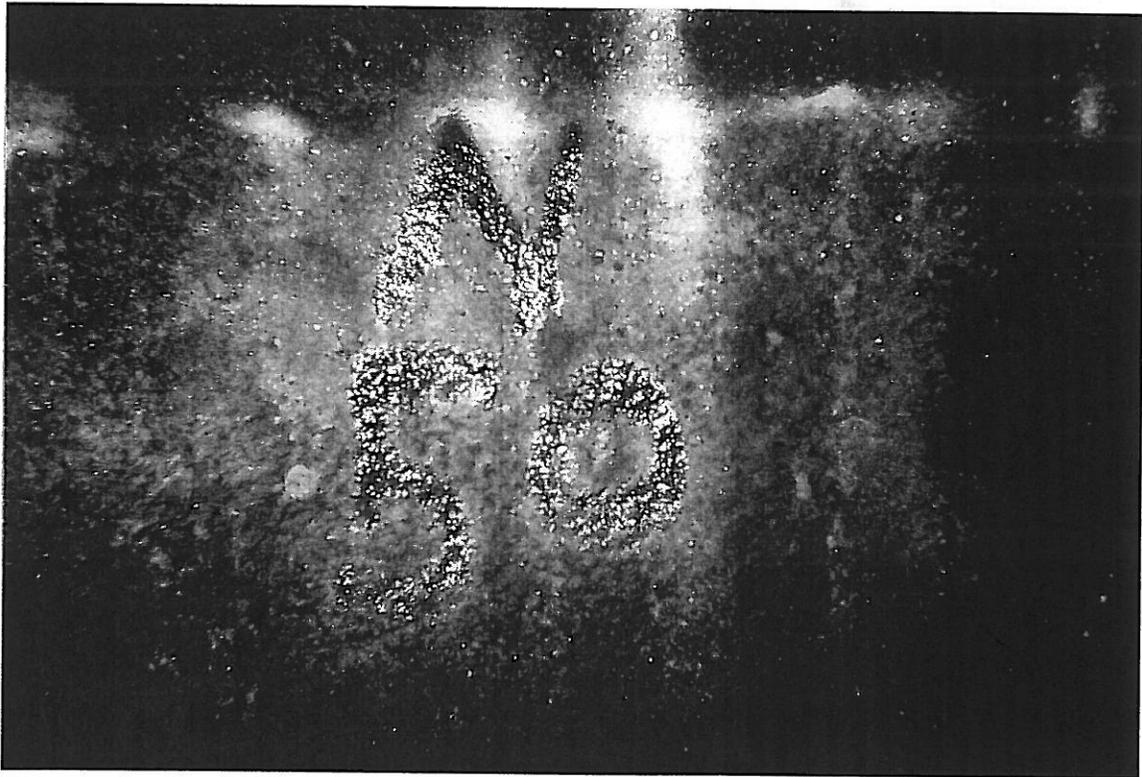
103 Interior surface - north side elevation 50' above ground level - good condition.

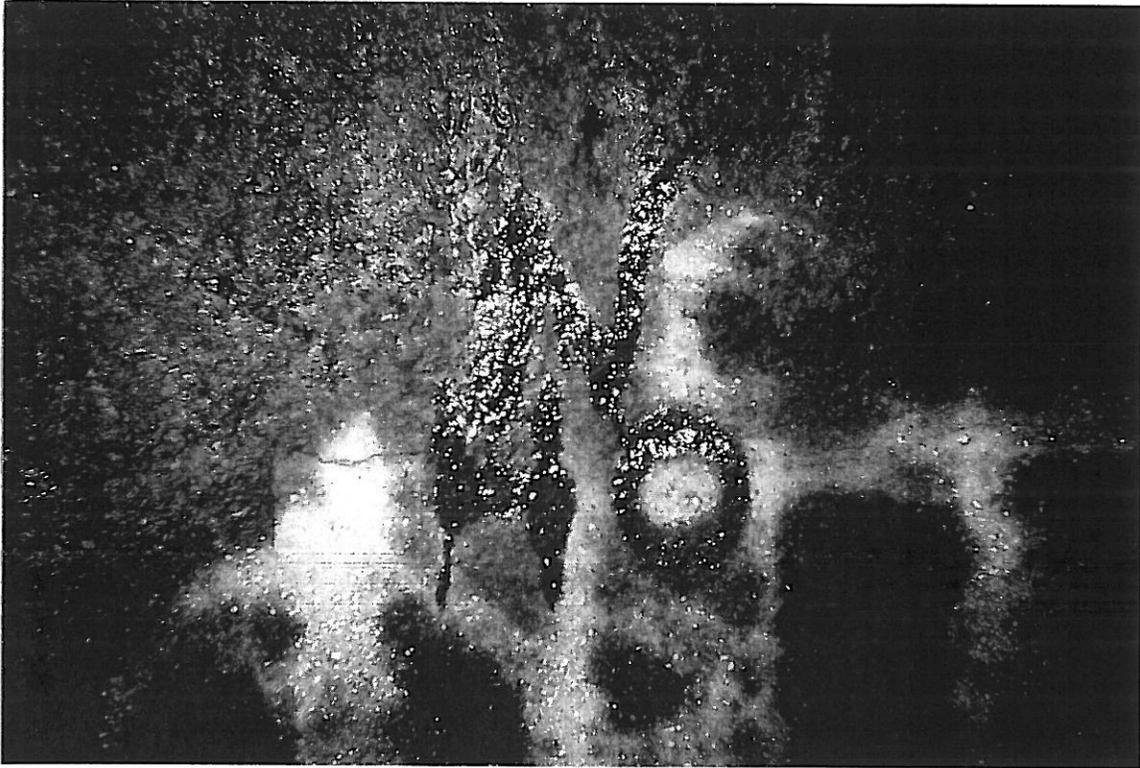
104 Interior surface - north side elevation 40' above ground level - good condition.

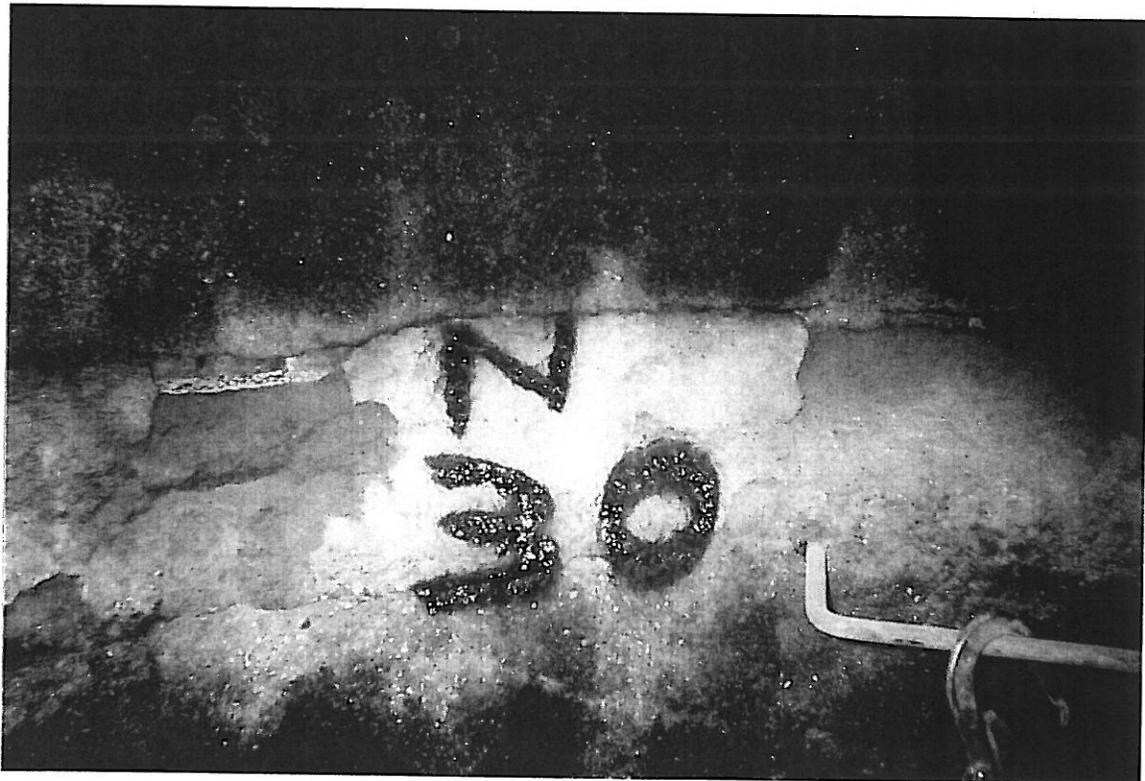
105 Interior surface - north side elevation 30' above ground level - 1/8" wide crack in liner spalled area in gunite liner.

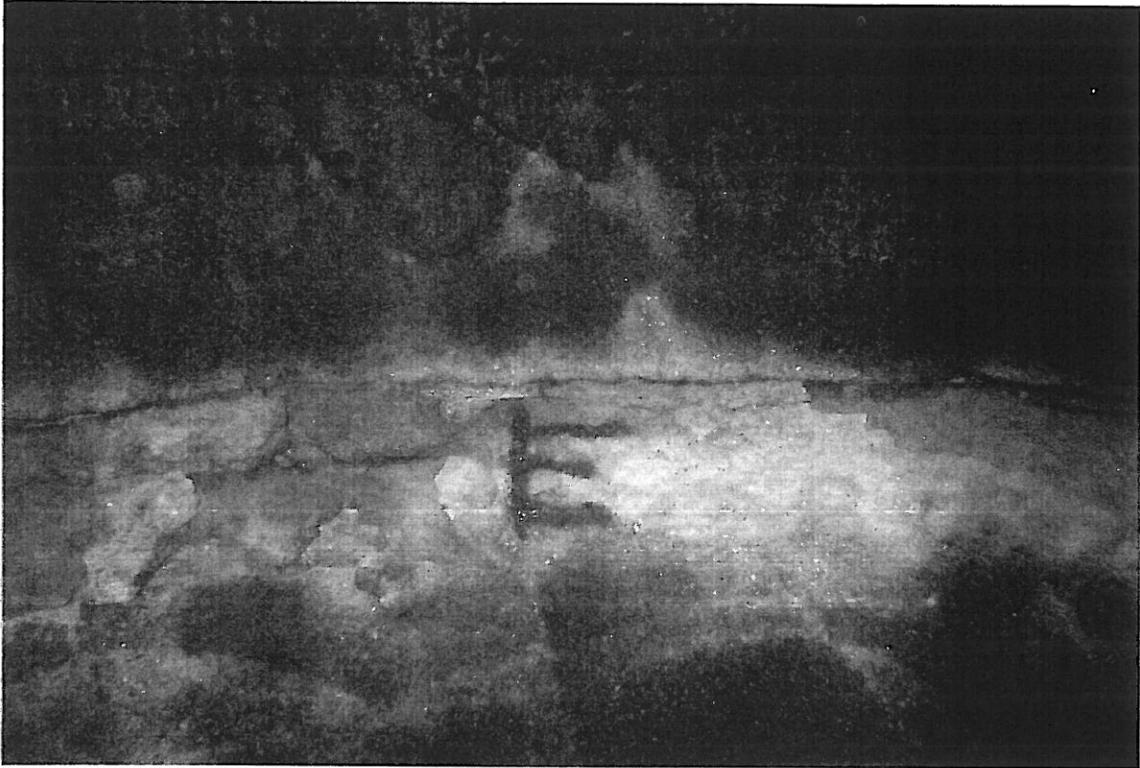
106. Gunite liner - east side - 1/8" wide crack in gunite liner.

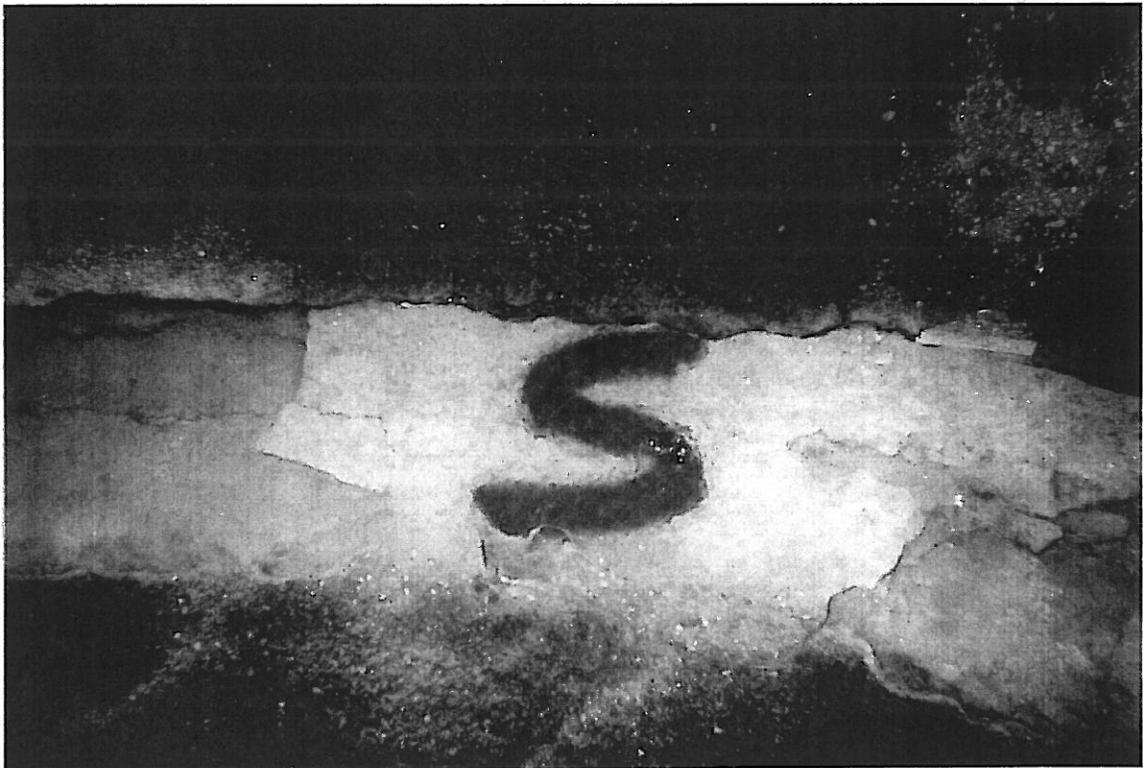
107. Gunite liner - south side - 1/8" wide crack in gunite liner.

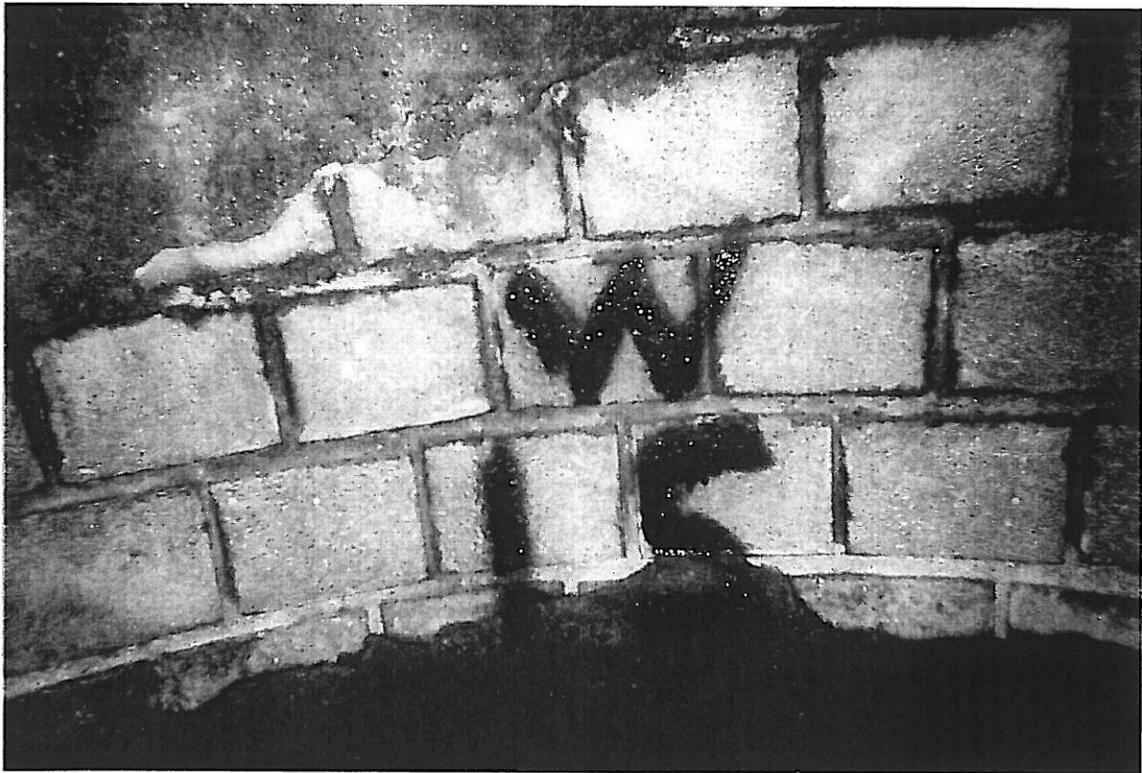
109. Interior surface - west side - elevation 15' above ground level -
gunite liner missing.

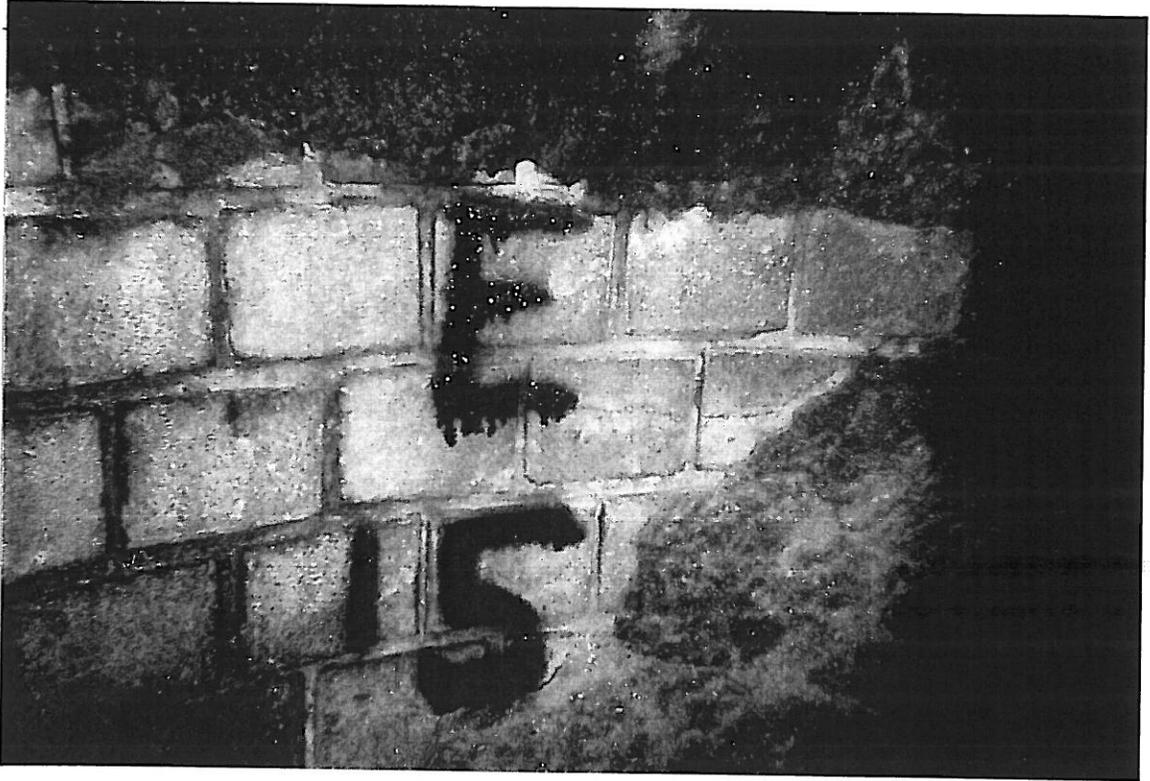
110. Interior surface - east side - elevation 15' above ground level - gunite liner missing.

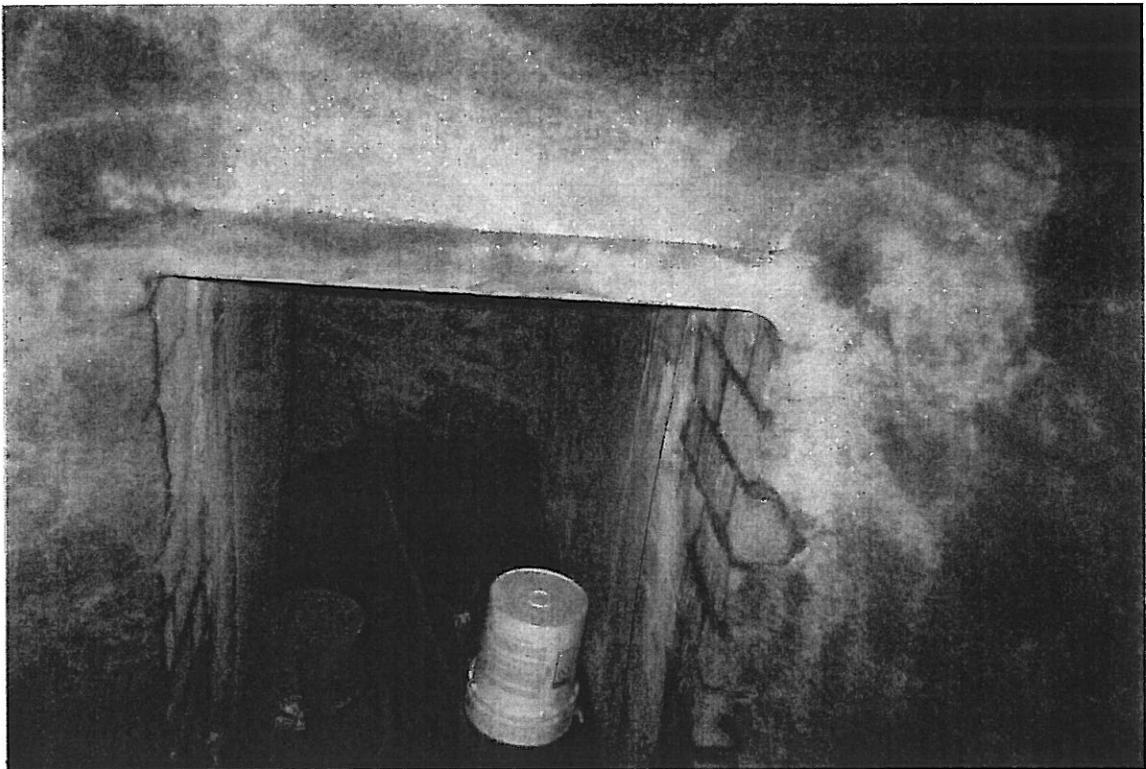
111. Interior surface and breeching entry - good condition.

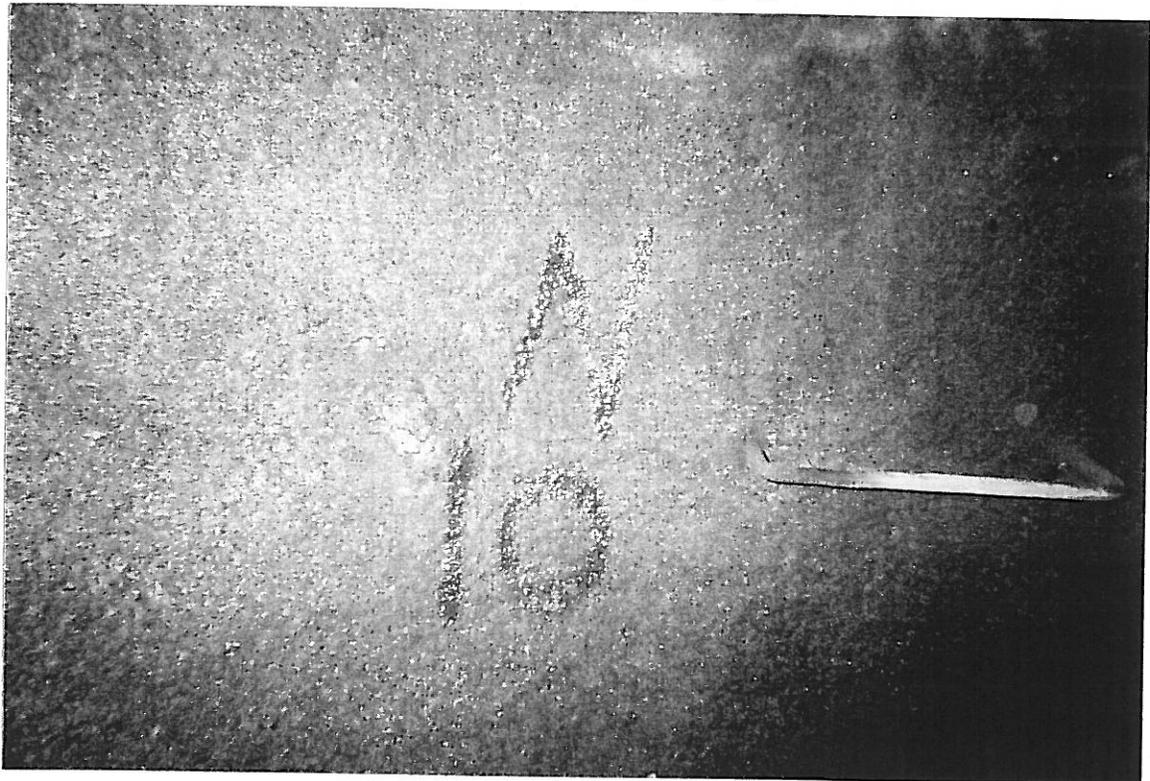
113. Interior surface - north side - elevation 10' above ground level - good condition.
